REVEALING ILLUSION: BAN MO PALACE

A Research Project Submitted in Partial Fulfillment of the Requirements for the Degree

Architectural Heritage Management and Tourism

SILPAKORN UNIVERSITY

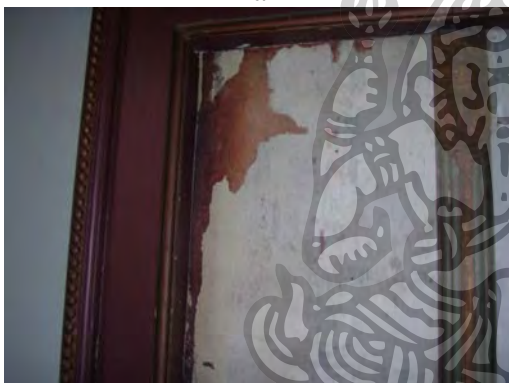
away and has been re-painted in the same color as the wall).	
5. Door	See figure 10,27		
➤ Teakwood door	Good, High authenticity	The original material is in intact condition.	Low
➤ Painting on door	Medium, High authenticity	Peeling color on two sides of the door (there is no evidence of a hidden painting on this door) caused by human action.	Medium
6. Floor			
➤ Teakwood floor	Good, High authenticity	The original material is in intact condition and it was coated with shellac.	Low
7. Column			
➤ Teakwood column	Good, High authenticity	The original material is in intact condition.	Low

Figure 10 Peeling color cause by human

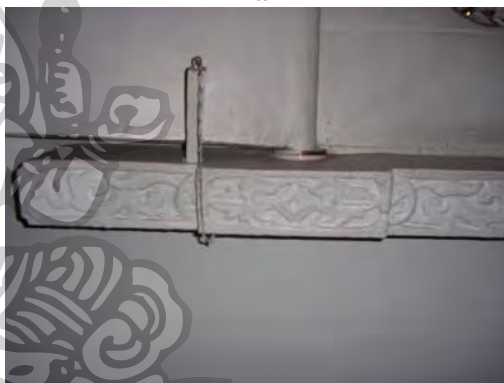
condition.	
➤ Painting on partition	Medium, High authenticity	Evidence of moisture on the corner close to the window causing discoloration on the partition painting.	Medium
4. Window	See figure 11		
➤ Teakwood window	Good, High authenticity	The original material is in intact condition.	Low
➤ Painting on window	Good, High authenticity	Re-painted the same color as the wall. (Evidence found previously show different painting on the decoration part of the window but the color has faded away and has been re-painted in the same color as the wall).	Low

Figure 11 Window Decoration

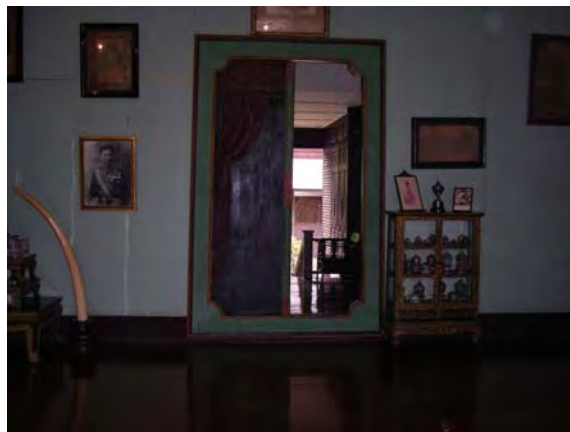
5. Door	See figure 15,23		
➤ Teakwood door	Good, High authenticity	The original material is in intact condition. The old scar on top of the main door affects only the aesthetic view on the surface of the material on the door.	Low
➤ Painting on door	Good, High authenticity	The old painting on the door shows evidence of the previous painting hidden behind it.	Low
6. Floor	See figure 15		
➤ Teakwood floor	Good, High authenticity	The original material is in intact condition and it was coated with shellac.	Low
7. Column	See figure 16,22		
➤ Teakwood column	Good, High authenticity	The original material is in intact	Low

Figure 15 Painting door and evidence of peeling color (2 vertical line on the left of the door)

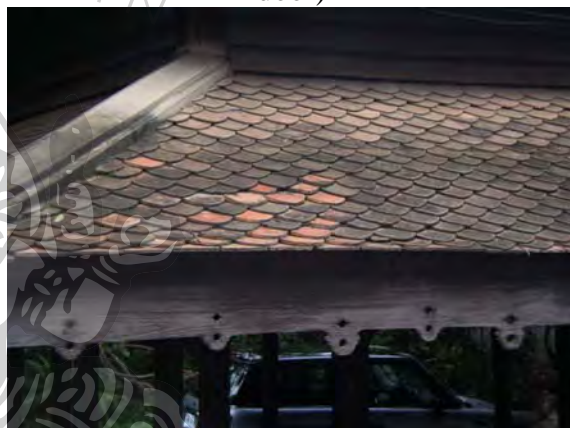
The Wooden Pavilion	Existing Condition	Description	
- Roof	See figure 17,18		
➤ Terra cotta tile	Medium, High authenticity	Discoloration on the roof tiles. Evidence of moisture and fungi on the roof tiles.	Medium
➤ Ginger bread decoration	Medium-Good, High authenticity	Discoloration on the roof decoration. The pattern of the decoration is still intact.	Medium
- Column	See figure 18		
➤ Teakwood column	Good, High authenticity	The original material is in intact condition	Low
➤ Painting on column	Medium-Good, High authenticity	Discoloration especially at base of the column.	Medium
- Floor	See figure 18		
➤ Red cement tile	Good, High authenticity	The original material is in intact condition.	Low
➤ Cement floor	Medium, High	Evidence of	Medium

Figure 17 Ginger Bread on the roof decoration of the Wooden Pavilion and discoloration on the roof tile

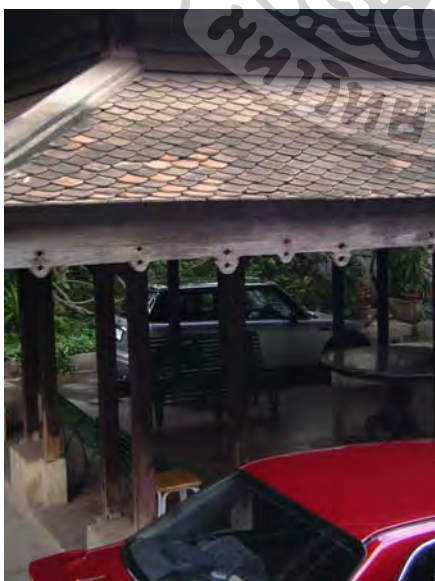
Figure 18 Discoloration on the column of the Wooden Pavilion

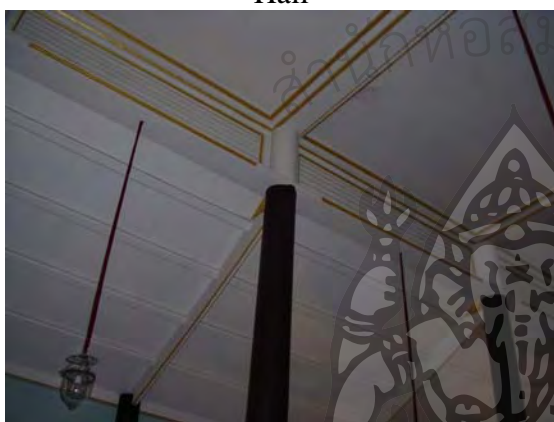
chemical formula. Peeling color and discoloration appear because of moisture on the ground.	
- Steps	See figure 24		
1. Cement cover with plaster steps	Medium, High authenticity	Intact original material but evidence of moisture apparent on the ladder due to deterioration of the original material.	Medium
- Exterior Gutter	Good, High authenticity	The exterior gutter is located on the ground and still functions efficiently.	Low
Interior			
- The Main hall			
1. Ceiling	See figure 22		
➤ Board ceiling	Good, High authenticity	Intact original material.	Low

Figure 22 Evidence of moisture on the Main Hall ceiling

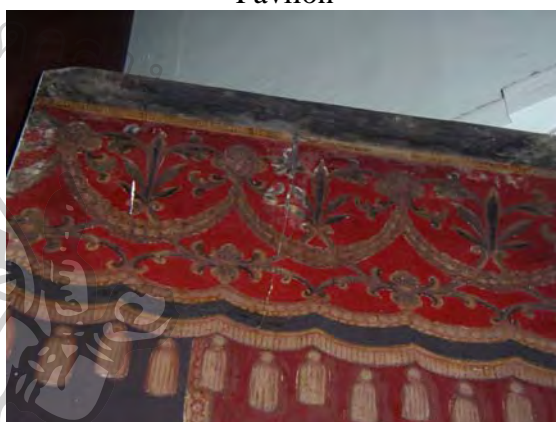
Figure 23 Evidence of crack and discoloration on the painting door

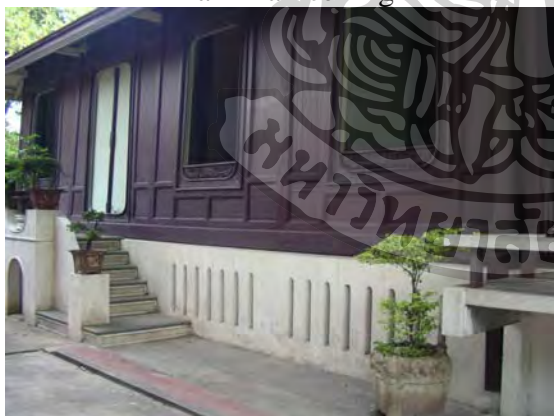
Figure 24 Re-painting on the exterior wall of the Audience Hall

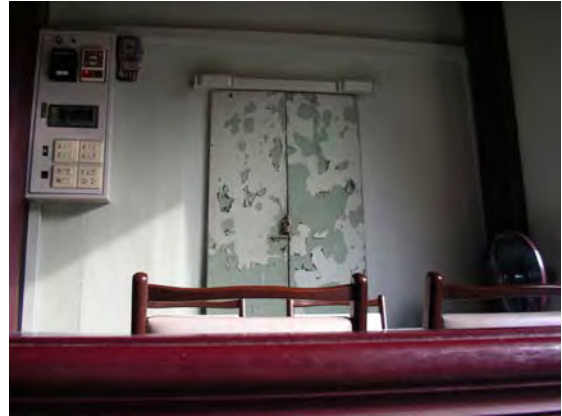
Figure 27 Peeling color on the door

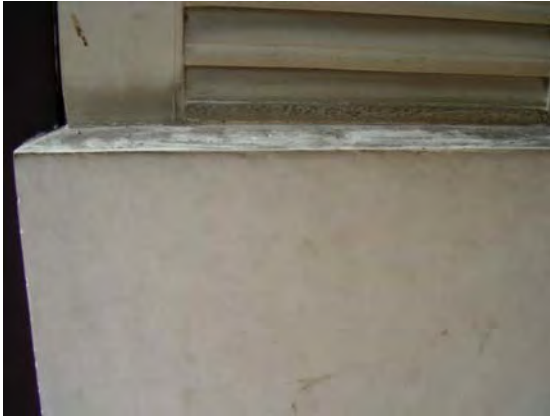
Figure 32 Evidence of moisture

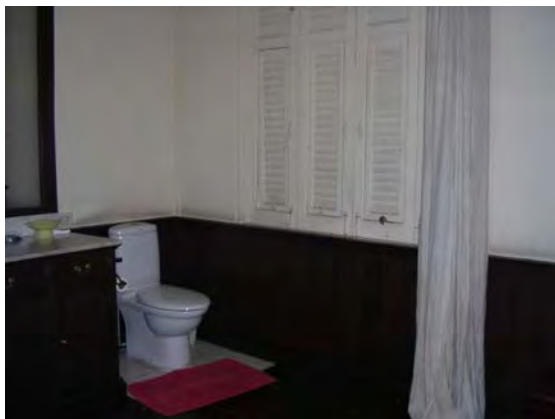
Evidence of moisture along the horizontal line under three sides of the windows.	
3. Window	See figure 38		
➤ Teakwood window	Good, High authenticity	The original material is in intact condition.	Low
➤ Painting on window	Good, High authenticity	Re-painted close to the original color	Low
4. Door	See figure 39		
➤ Teakwood door	Good, High authenticity	The original material is in intact condition.	Low
➤ Painting on door	Good, High authenticity	Re-painted close to the original color	Low
5. Floor	See figure 38,39		
➤ Cement floor	Good, High authenticity	The original material is in intact condition.	Low
- The Store room		Additional part of building built

Figure 38 Evidence of moisture on the Bathroom wall

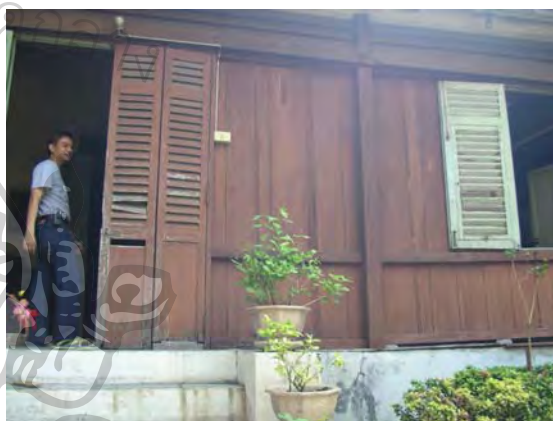
Figure 41 Deteriorate condition of the Residential Building

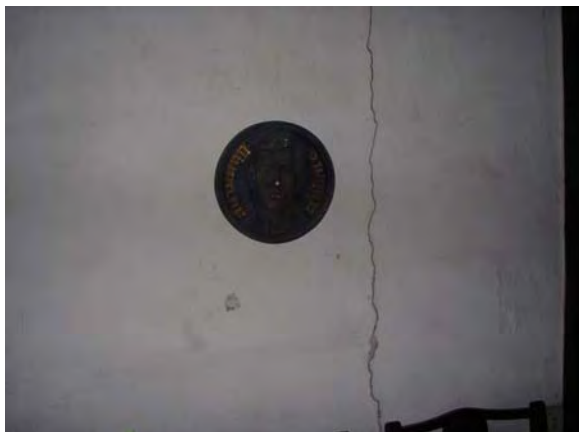
2. Wall	See figure 44,45		
➤ Teakwood wall	Poor, High authenticity	Evidence of rot on the lower part of the wall.	High
➤ Painting on wall	Medium, Low authenticity	Evidence of discoloration.	Medium
3. Window			
➤ Teakwood window	Poor, High authenticity	Teakwood is in good condition but the joining that broke has left the windows out of order.	High
➤ Painting on window	Medium, High authenticity	Discoloration on windows.	Medium
4. Door	See figure 41,43		
➤ Teakwood door	Medium, medium authenticity	New door knob was added to the front door.	Medium
➤ Painting on door	Medium, High authenticity	Discoloration on the inside of the front door.	Medium
5. Floor			
➤ Teakwood	Medium, High	Evidence of scars	Medium

Figure 44 Different settlement on the wall

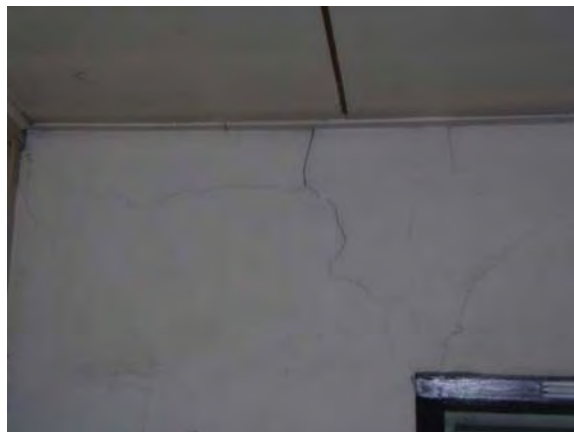
Figure 45 Different settlement on the wall

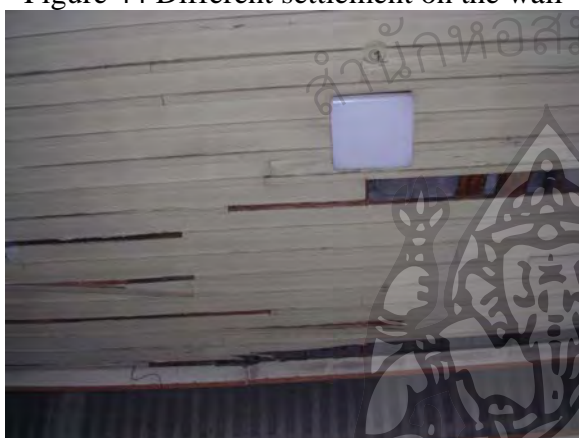
Figure 46 Rot and fungi on the ceiling.
Ceiling lighting lamp on the first room
ceiling

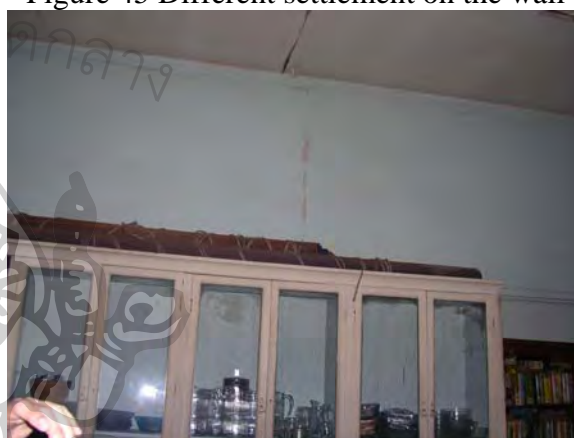
floor	authenticity	and holes on the original teakwood material.	
- Second room behind the first room			
1. Ceiling	See figure 47	Additional board on the ceiling, renovated around the year 1985.	
➤ Board ceiling	Poor, Low authenticity	Evidence of rising damp and fungi on the ceiling.	High
➤ Painting on ceiling	Medium, Low authenticity	White color painting on the ceiling has been discolored because of moisture.	Medium
2. Wall	See figure 47		
➤ Concrete wall	Poor, Medium authenticity	Vertical crack from different settlements and poor quality mixture of concrete.	High
➤ Painting on wall	Medium, Medium authenticity	Peeling color caused by crack on the wall.	Medium

Figure 47 Evidence of moisture from the
falling damp on the second room

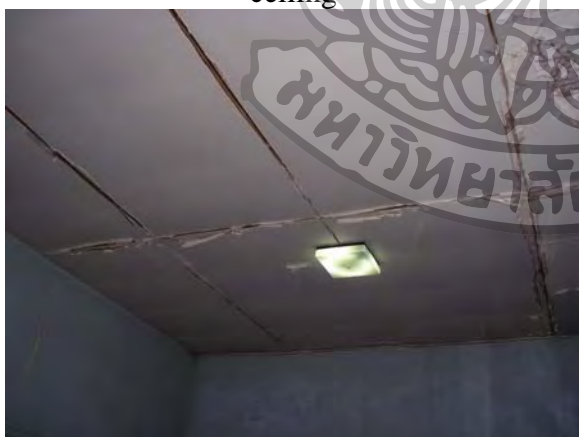
Figure 48 Evidence of moisture and color
peeling from the falling damp on the second
room

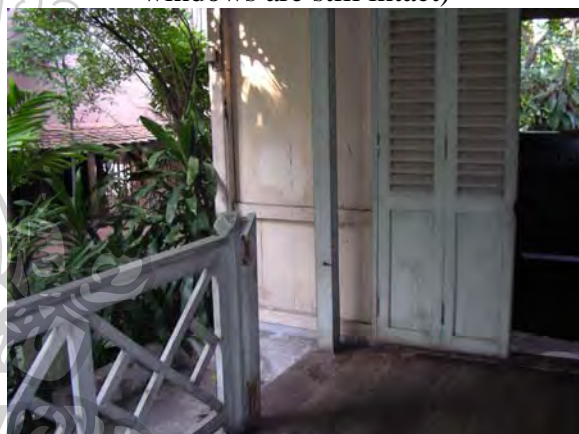
Figure 53 Dirt & discoloration

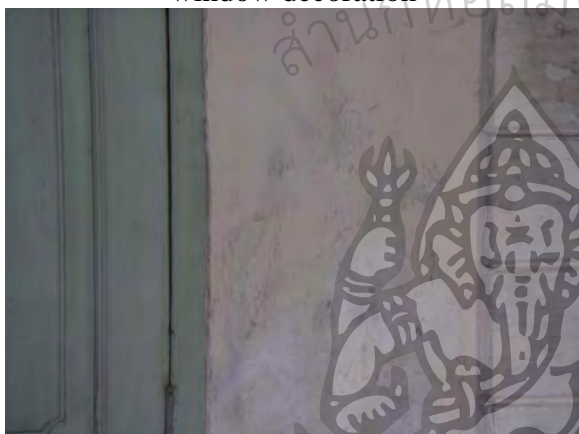
Figure 58 Evidence of moisture and discoloration on the wall (left side on the balcony)

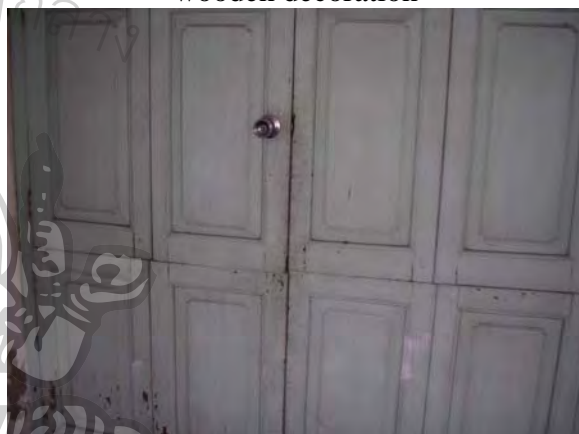
Figure 59 Discoloration on the door of the balcony

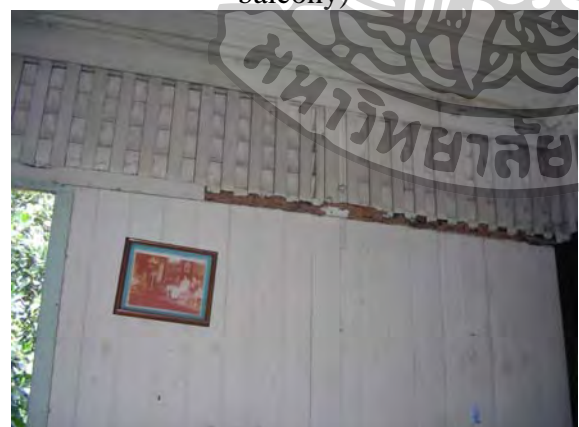
fungi appear on the ceiling	
➤ Painting on ceiling	Medium, Low authenticity	Discoloration appear on the ceiling	Medium
2. Wall	See figure 60		
➤ Teakwood wall	Medium, High authenticity	Evidence of moisture appears on the wall	Medium
➤ Painting on wall	Medium, High authenticity	Discoloration apparent on the wall	Medium
3. Window			
➤ Teakwood window	Medium, High authenticity	Some decoration on the windows has been taken away but the original material is still intact.	Medium
➤ Painting on window	Medium, High authenticity	Discoloration appears on the window	Medium
4. Door	See figure 53		
➤ Teakwood door	High, High authenticity	Original form and material on the door is intact.	Low
➤ Painting on	Medium, High	Dirt and	Medium

Figure 60 Color peeling, discoloration and fungi on the top of the wall of the forth room

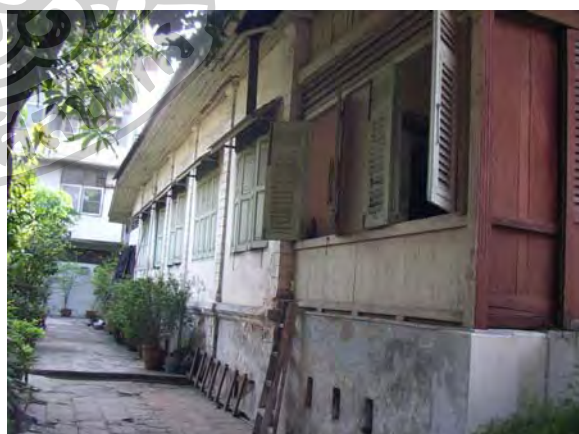
different settlements all over the exterior wall.	
3. Painting on wall	Poor, Medium authenticity	Discoloration, peeling color and fungi apparent on half the lower part of the wall.	Medium
- Windows	See figure 61,64		
1. Teakwood window	Poor, High authenticity	Teakwood is in good condition but the window hinge that broke has left the windows out of order.	High
2. Painting on window	Medium, High authenticity	Discoloration on windows.	Medium
3. Window decoration	Poor, High authenticity	Evidence of ruined decoration and discoloration.	High
- Doors	See figure 41		
1. Teakwood door	Medium, medium authenticity	New door knob was added to the front	Medium

door. Rot on the lower part of the door and hollow in an opening on the door.	
2. Painting on door	Medium, High authenticity	Discoloration on the front door	Medium
- Elevation Platform	See figure 61,63		
1. concrete wall	Poor, Low authenticity	Concrete which covered the elevation platform to the ground shows evidence of moisture at base, fungi and poor material mixture (the result of inappropriate renovation around the year 1985).	High
2. Painting on concrete	Medium, Medium authenticity	Discoloration and peeling color apparent on the elevation platform	Medium

Figure 61 Exterior deterioration on the north side of the Residential Building

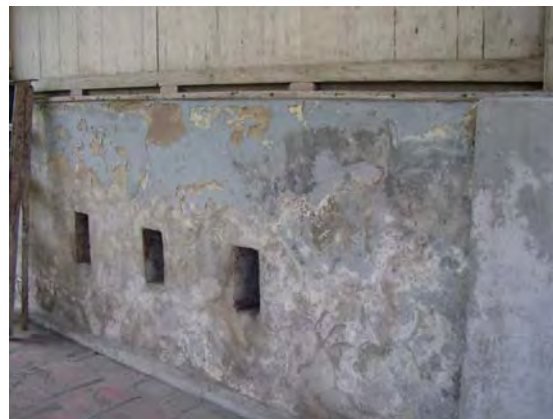
Figure 63 Evidence of moisture at base

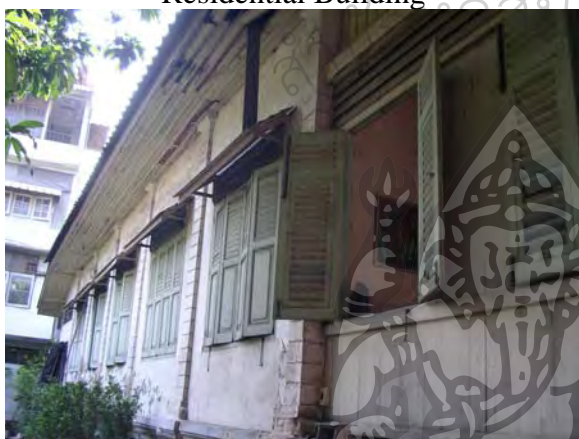
The Residential Building	Existing Condition	Description	
Exterior			
- Roof	See figure 62,64	The original roof which is a terra cotta tile and teakwood structure was unintentionally taken out and replaced by a cement tile and plywood structure around 20 years ago.	
1. Cement tile	Poor, Low authenticity	Evidence of moisture and fungi on the cement tiles causing further deterioration to the structure of the building.	High
- Wall	See figure 61-67		
1. Teakwood wall	Medium, High authenticity	Rot on the lower part of the wall.	Medium
2. Concrete wall	Poor, Medium authenticity	Evidence of moisture and cracks from	High

Figure 64 Evidence of moisture and rot on the exterior structure

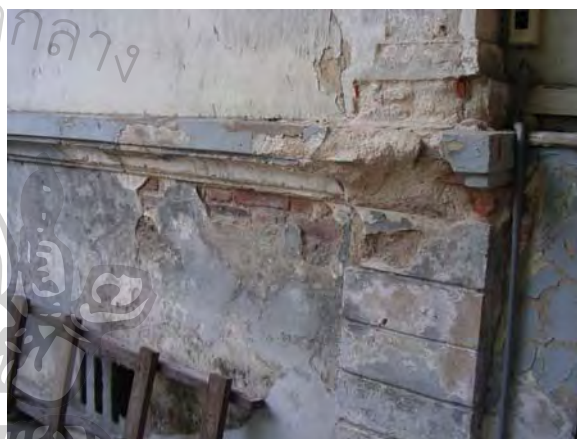
Figure 65 Deterioration of the plaster on the exterior wall

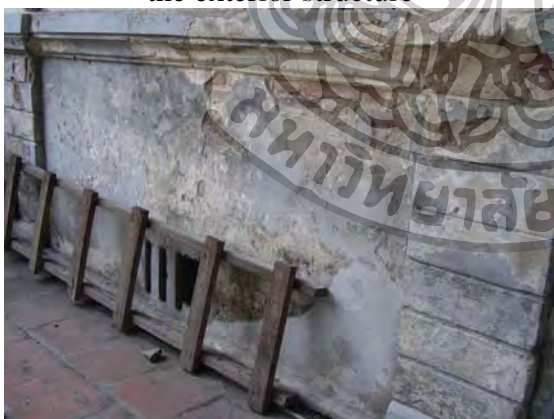
Figure 66 Deterioration of the plaster on the exterior wall

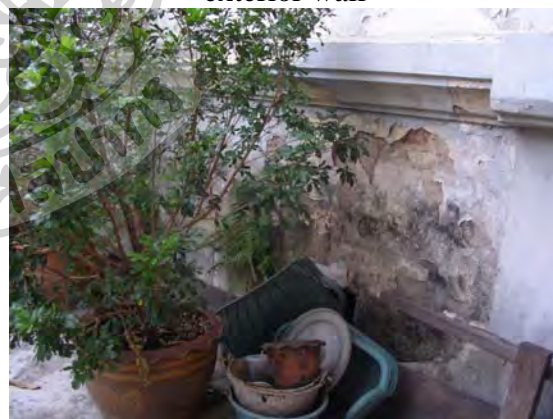
Figure 67 Deterioration of the plaster and fungi on the exterior wall

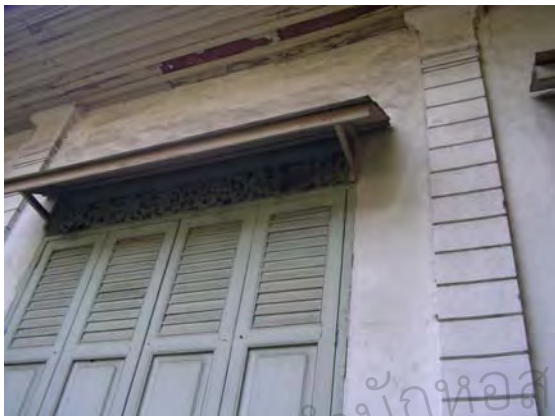
Figure 68 Intact window and rot ceiling

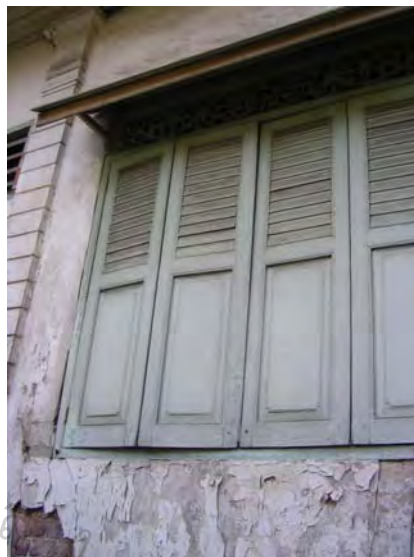
Figure 69 Deterioration of the plaster on the exterior wall

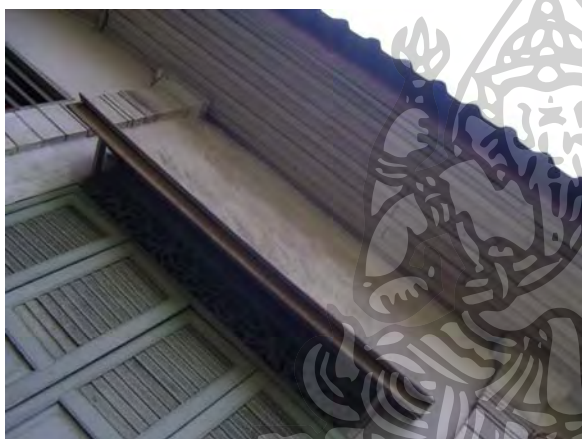
Figure 70 Evidence of moisture on the ceiling

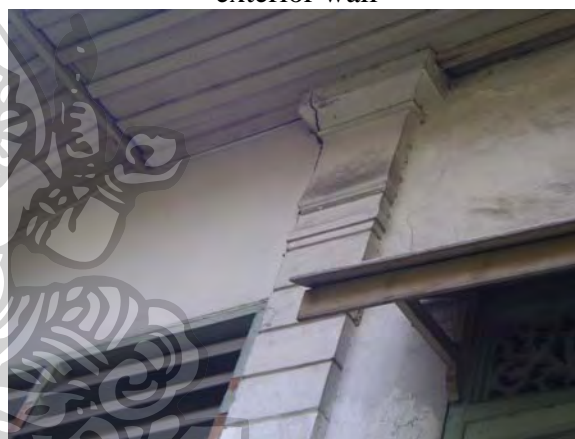
Figure 71 Evidence of moisture on the plaster under the roof
