**LANNA ARCHITECTURAL CONSERVATION:  
GUIDELINES FOR HISTORIC BUILDINGS IN NORTHERN THAILAND**

**A Thesis Submitted in Partial Fulfillment of the Requirements for the Degree**

**DOCTOR OF PHILOSOPHY**

**SILPAKORN UNIVERSITY**

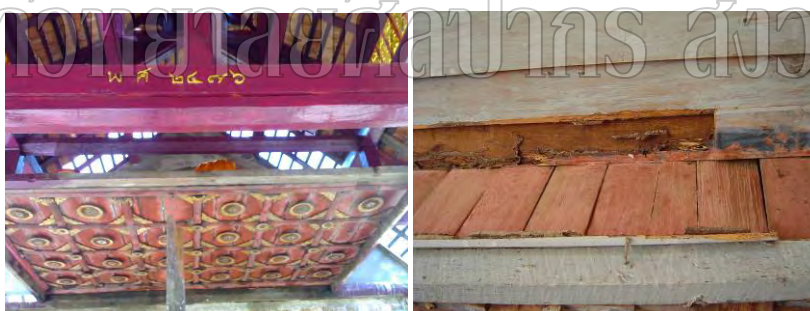
Figure 54 &amp; 55:

Sinking and leaking ceiling in the *vihara* in *Wat Seang Khao Noi*, Pasang, Lamphun (left) and termites attacking at *Wat Baan Ko*, Lampang (right) (taken by Vitul L., 17/2/07 & 19/7/06)

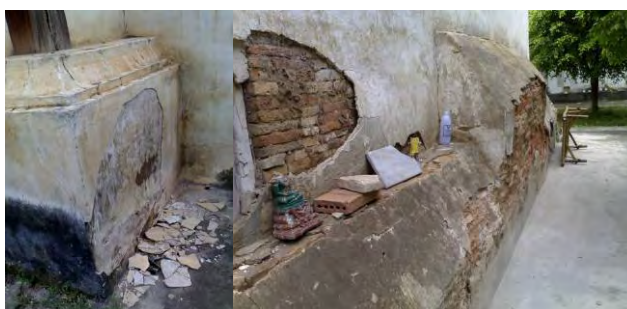
Figure 61 & 62:

Cracks of historic brickwork in the *vihara* in *Wat Baan Ko*, Lampang (taken by Vitul L., 19/7/06)

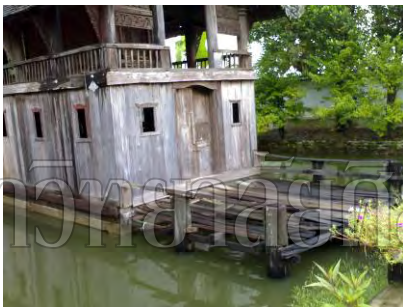
Figure 64:

- Unstable foundations, differentiated ground settlement

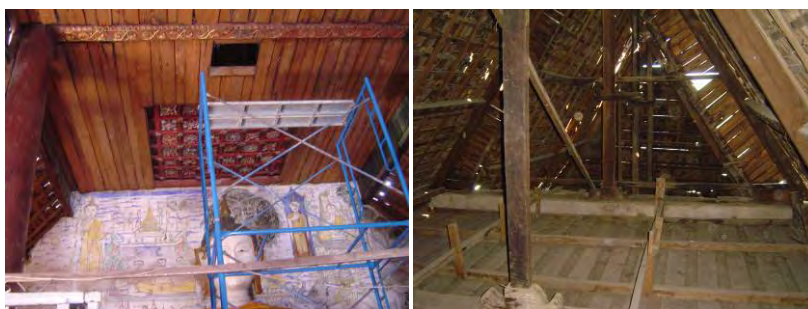
Figure 75 & 76:

The site investigation on roof and structure of the *vihara* in Wat Baan Ko, Lampang (taken by Vitul L., 9/8/06)

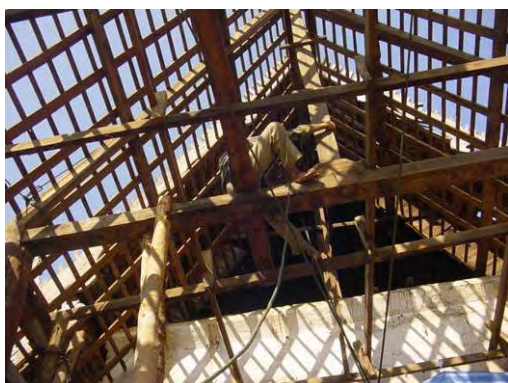
Figure 206, 207 & 208:

Replacement of a main roof structure where new and old wood must be accurately matched, *Wat Baan Ko*, Lampang (taken by Vitul L., 2/12/06)

If old timbers are badly deteriorated, they can be completely replaced. If some parts are still sound enough these may be repaired with inserted patches or pieces. The principle is to retain as much original material as possible. Such repairs are replacements of the same kind. This means that the new and old wood should be accurately matched according to all the following criteria: species, quality-first growth or second growth, cut-quarter sawn or flat sawn or mixed, color, grain direction and figure or pattern, tool marks, and the finish. Where old wood is being partly replaced the new wood is carefully inserted into the old where the unsound wood has been neatly chiseled away and usually undercut. Synthetic resin adhesives are frequently used to secure the new piece in place.
