**THE MANAGEMENT PLAN OF HISTORICAL BUILDING: SAISUDDHA – NOBHADOL  
BUILDING IN SUAN SUNANDHA RAJABHAT UNIVERSITY**

**An Independent Study Submitted in Partial Fulfillment of the Requirements for the Degree  
MASTER OF ARTS  
Program of Architectural Heritage Management and Tourism  
( International Program)  
Graduate School  
SILPAKORN UNIVERSITY  
2008**

The scope of this research project includes the history of Suan Sunandha Palace,  
the cultural significance, conditions of Saisuddha – Nobhadol Building, and management  
plan for the use of the building as Chao Wang Learning Center.

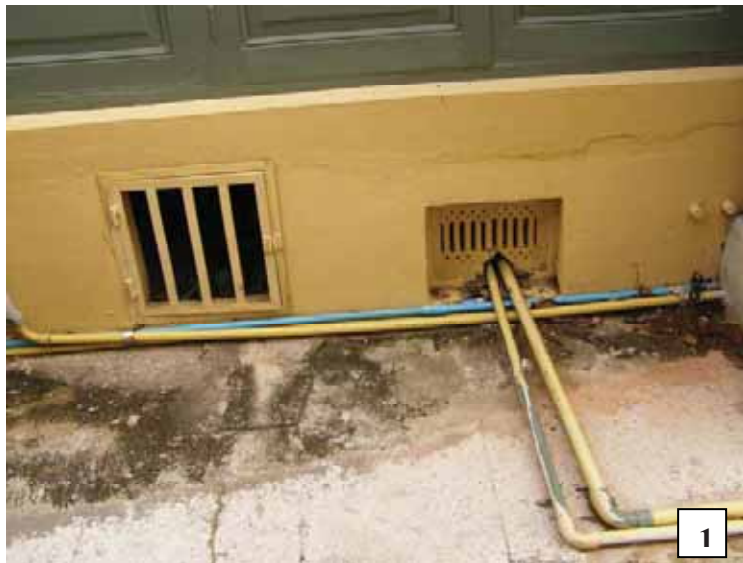
Figure 101: General condition 1  
 First floor of the building was lifted up 0.80 meters above the ground level and underneath the first floor, there are openings which functions as air vents at intervals around the base of the building.

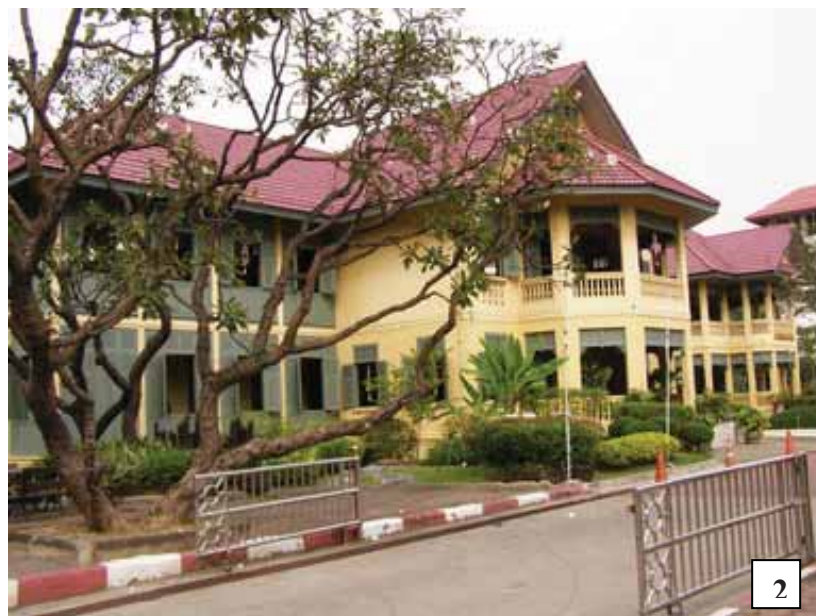
Figure 102: General condition 2  
 The architectural style of Saisuddha – Nobhadol Building is colonial style.

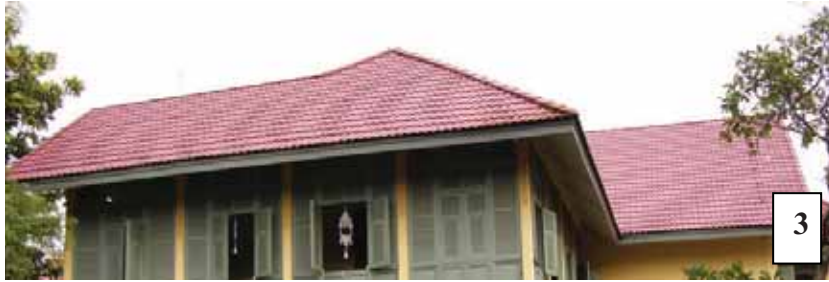
Figure 103: General condition 3

The roof was designed in a mixed forms, gable roof and hip roof with red of CPAC Monia Roof Tiles. The eaves are double fascia boards and jutt out around 1 meter from the building.

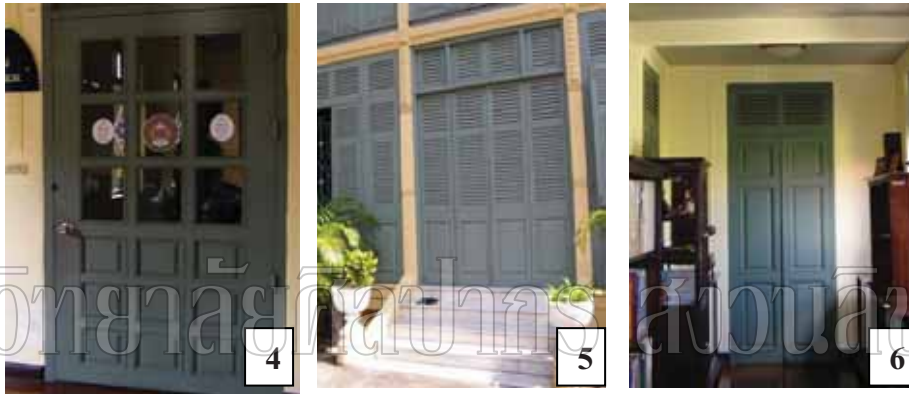
Figure 104: General condition 4, three styles of doors

Left: A half-glass door

Right: A paneled door

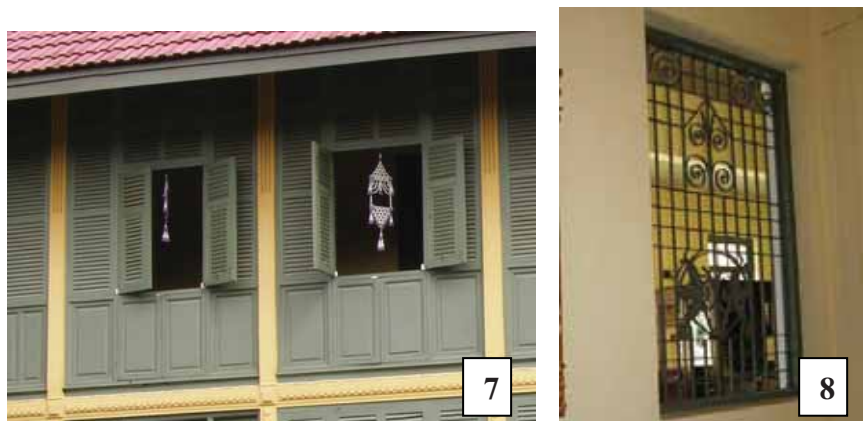
Figure 105: General condition 5, two styles of windows

Left: The louvered wooden windows

Right: A curled – steel window in leaves design

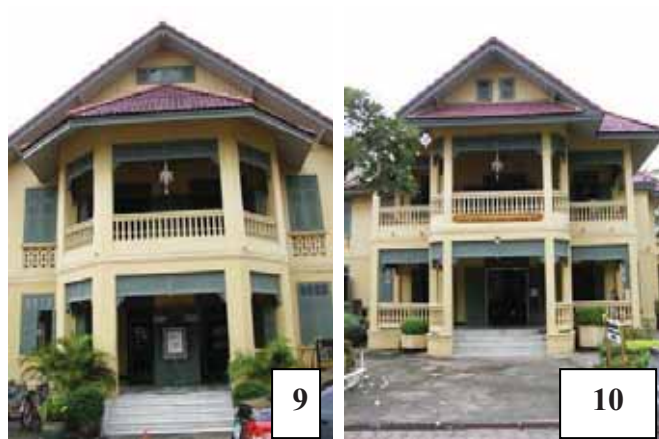
Figure 106: General condition 6.  
Two porches with marble stairs functioning as the main entrances in the south. Above each porch, there is a terrace covered with different styles of roof design.

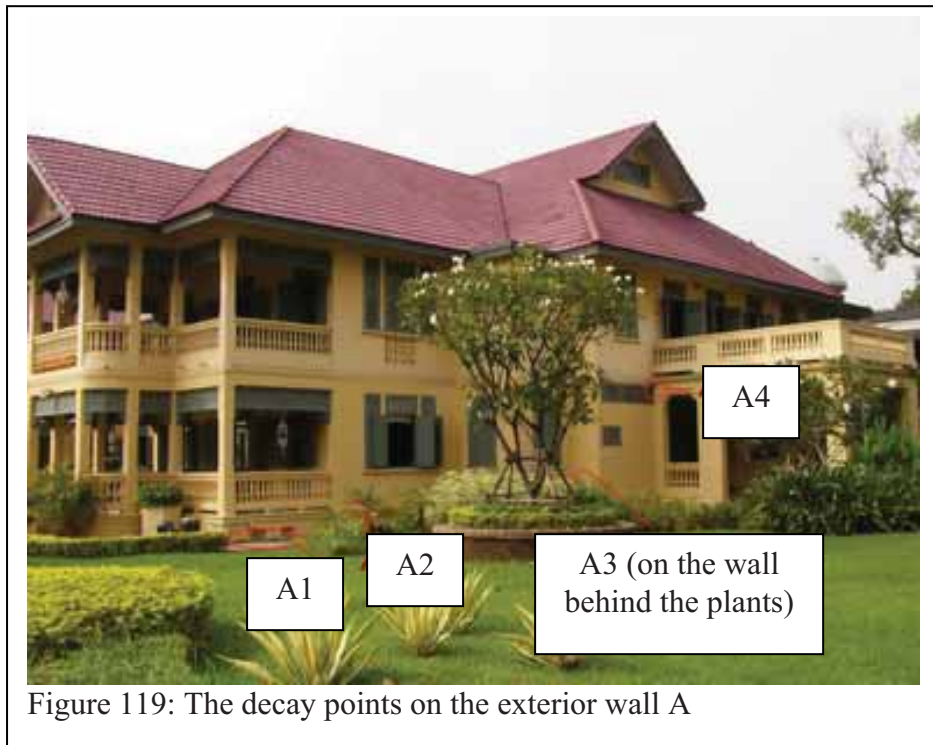
Figure 119: The decay points on the exterior wall A

1. Exterior wall: The lime cement exterior wall is in quite poor condition. Dampness, cracks, and plants can be observed, and the topcoat layer of the paint has peeled off.

The building is in the moderate conditions. However, it suffers from damage caused by dampness both from rain water and underground level.

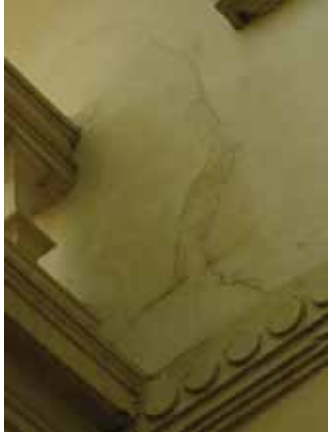
<p>Wall B</p> <p>B1</p>

<ul style="list-style-type: none"> <li>- Dampness</li> <li>- Cracks</li> </ul>
<p>B2</p>

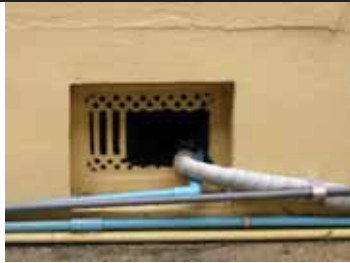
Decay's Picture	Decay Level	Decay Condition
V1

<ul style="list-style-type: none"> <li>- material destroyed by ignorant</li> <li>- Bad air – conditioner pipe setting</li> </ul>
V2

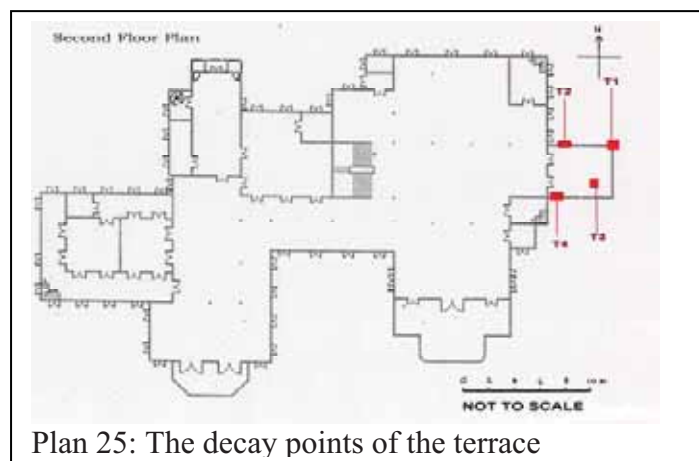
Table 6: The decays of the terrace

7. Terrace: This building has four terraces. The terrace at the east is in quite poor condition because it is damaged by roots of plants, but the other terraces are in good condition.

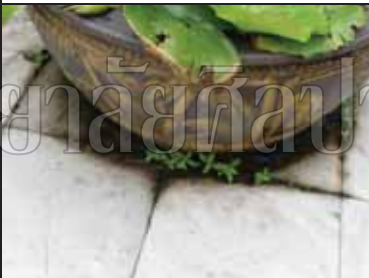
- black stains - plants
T4

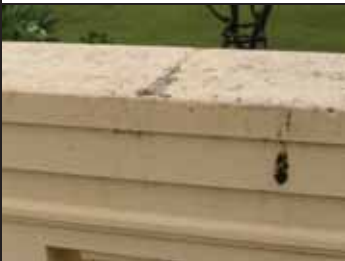
- Peeled – off top coated layer
