**REDEFINING WANG NA RATTANOKOSIN: THE HISTORY, CONSERVATION AND
INTERPRETATION OF A ROYAL THAI PALACE**

M.L.Bussayamas Nandawan

DOCTOR OF PHILOSOPHY

Program of Architectural Heritage Management and Tourism

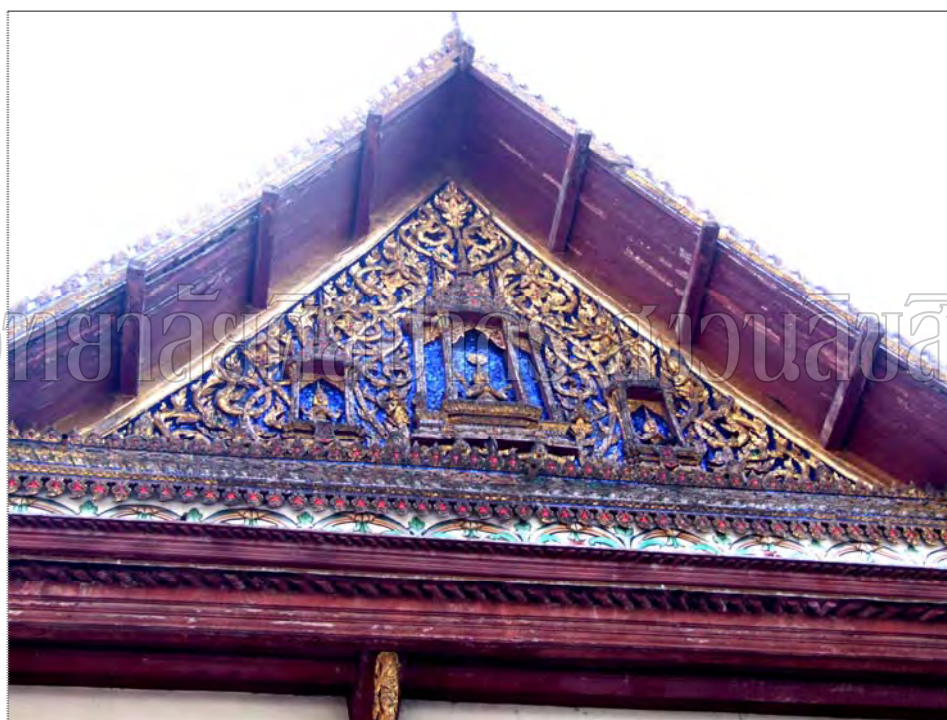
Photographed by Bussayamas Nandawan

The paintings inside the chapel are the oldest murals in Bangkok. The panels between the windows depict scenes from the life of the Lord Buddha. The murals are painted in the classic style, in two dimensions in tempera colored with mineral and earth pigments. The Phutthaisawan Chapel has a step and red poles on the lawn in front of the chapel like a howdah mount, used by royalty to mount elephant.

40. National Museum, Bangkok Thailand

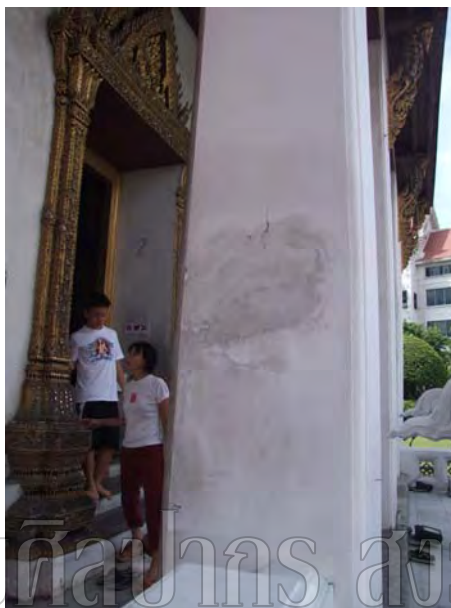
- The roof is made from clay; its tiles are covered with black fungus.

41. The pole is in a fairly good condition. One post is cracked. Some parts of the walls are clearly cracked. The walls are covered with water stains and bird droppings.

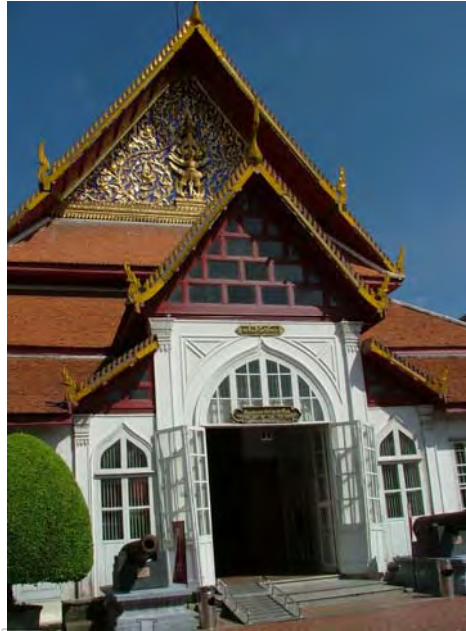
42. The front view of Phra Thinang Sivamok Pimann. The main entrance is a large wooden door that folds up vertically with glass panes. The door's strength is weak.

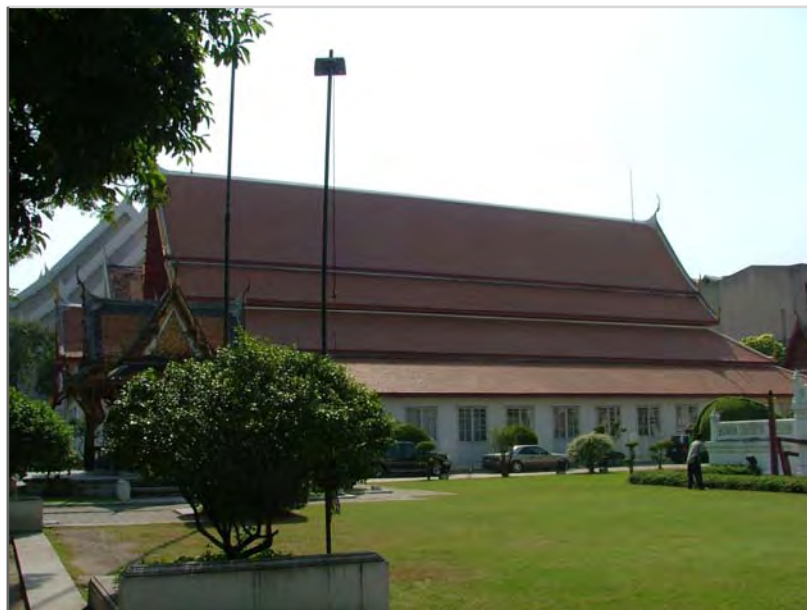
Photograph by Bussayamas Nandawan

43. The side view of the Phra Thinang Sivamok Pimann

with the typical Thai motif called *Ka Nok*. The condition of both pediments is fairly good, but dusty. Some of the glass mosaic broke and disappeared. The stucco is deteriorated.

- The wall is a load-bearing wall. It is painted white. The whole wall is in a fairly good condition. There are some hairline cracks and the entire building is damp.

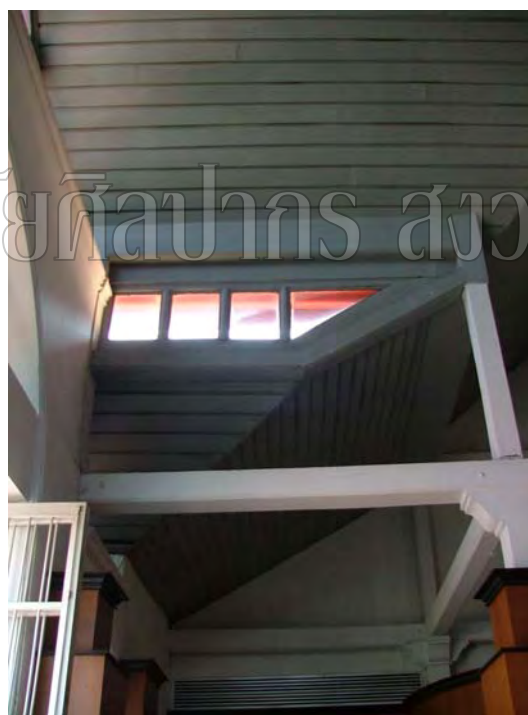
44. The interior view showing the original roof structure of the Phra Thinang Sivamok Pimann

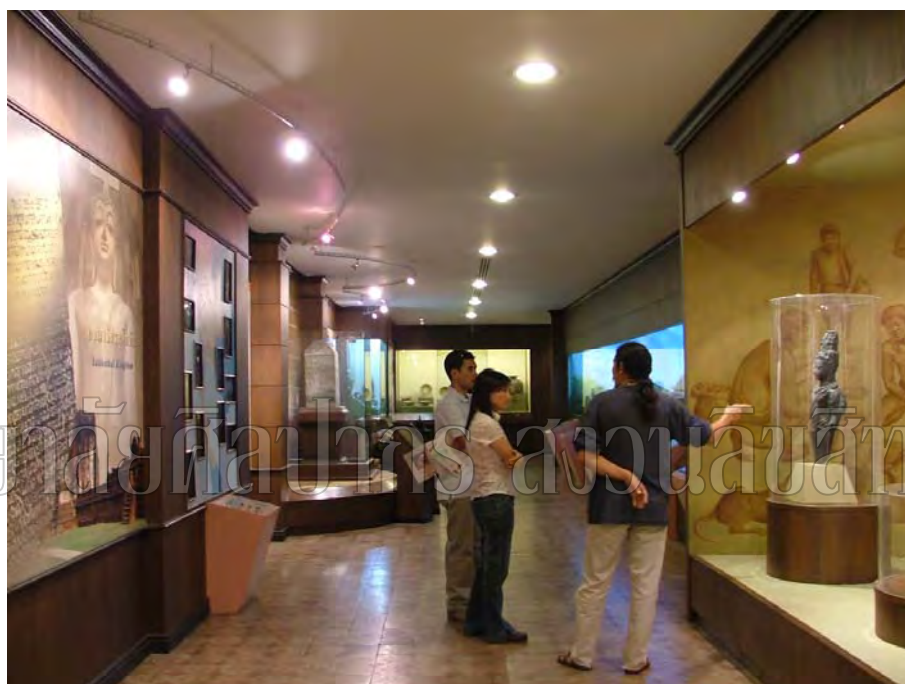
Photograph by Bussayamas Nandawan

45. The Phra Thinang Sivamok Pimann: The recent function of this building is used as an exhibition space for a display called History of Thailand.

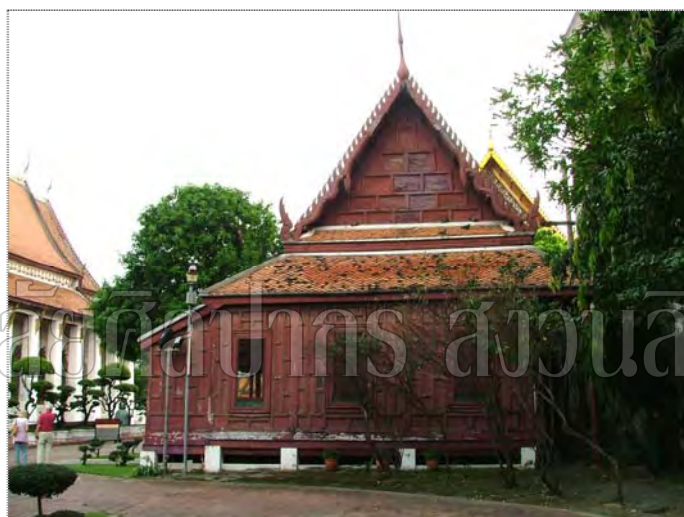
Photographed by Bussayamas Nandawan

47. The Tamnak Dang building or Red House at National Museum, Bangkok, Thailand

- มหาวิทยาลัยศิลปากร สงวนลขามร
- The door is in a fairly good condition. The threshold is worn out as visitors regularly step on it.
 - The interior of this historic house is in a fairly good condition, but there are many unclean areas. Bird droppings are visible at the corners of the rooms, walls and ceiling.
 - The furniture in the house is in a fairly good condition though covered with dust.

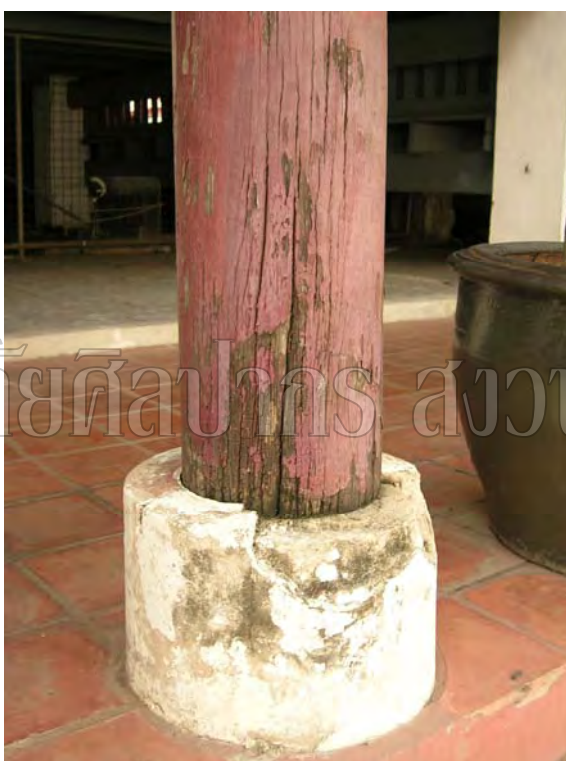
48. The wood pole is split.

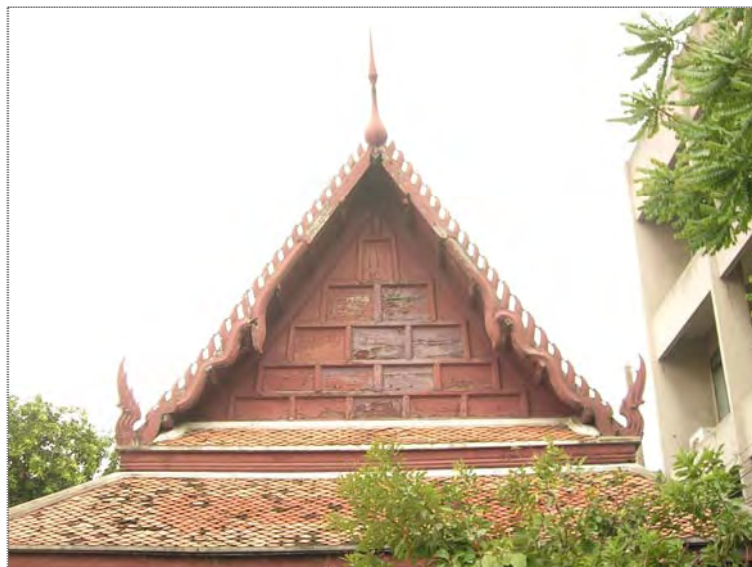
49. The pediment is made from teak wood. It is painted but the colors have started fading.

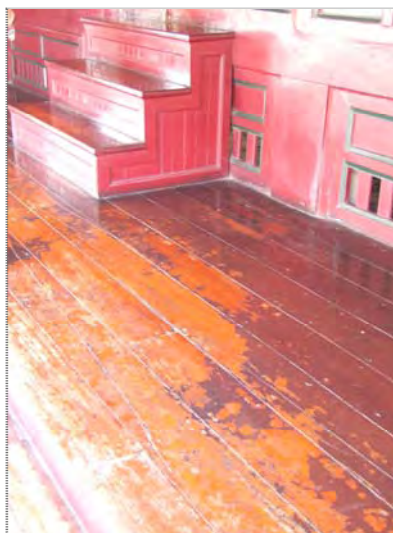
50. The patio is made from wood planks, the latter are in fairly good condition. The floor has wood stains caused by rainwater. Part of the patio area has fading colors due to the large number of visitors, frequently passing through. Deterioration is accelerated by the weather.

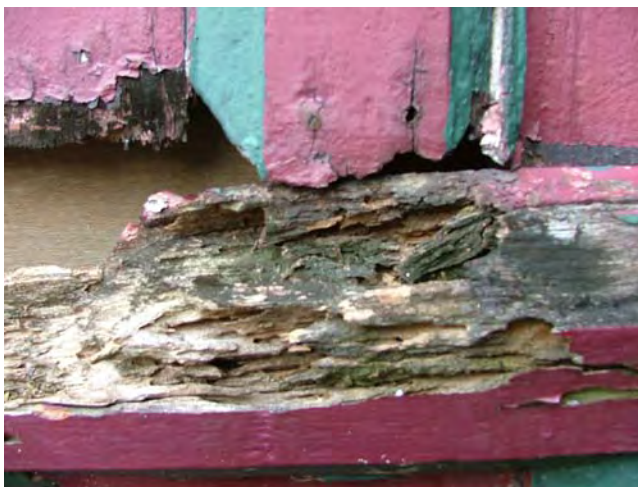
51. Exterior window frames have deteriorated due to dampness and bird droppings.

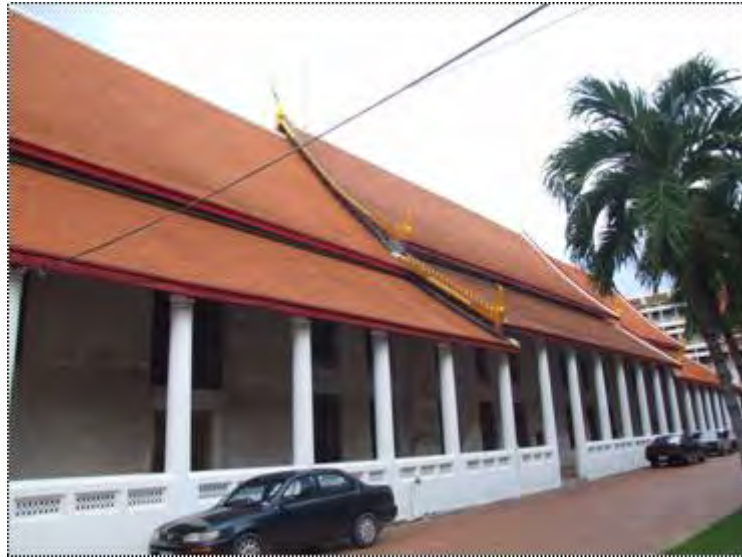
Photographed by Bussayamas Nandawan

57. The Mhu Phra Wimaan or living quarters at National Museum, Bangkok, Thailand

Roof has two slopes. Building is a load-bearing wall. The arts and architecture is unique. Form and material of this building are under design of The Royal Hierarchy. Therefore these living quarters was not decorated at the top of the building. These living quarters consisted of 9 small rooms. They connect with the same roofs.

Doors and windows are enriched by splendid mother of pearl inlay work. It seems that the tradition for employing this type of multi-colored iridescent shell and other materials such as inlay during Ayudhya period, achieved its highest fruition at this time, and continued during the Early Rattanakosin period. Examples of this tradition are seen at the Grand Palace, Wat Phra Kaew and at various building and monasteries throughout the Thonburi/Bangkok area.

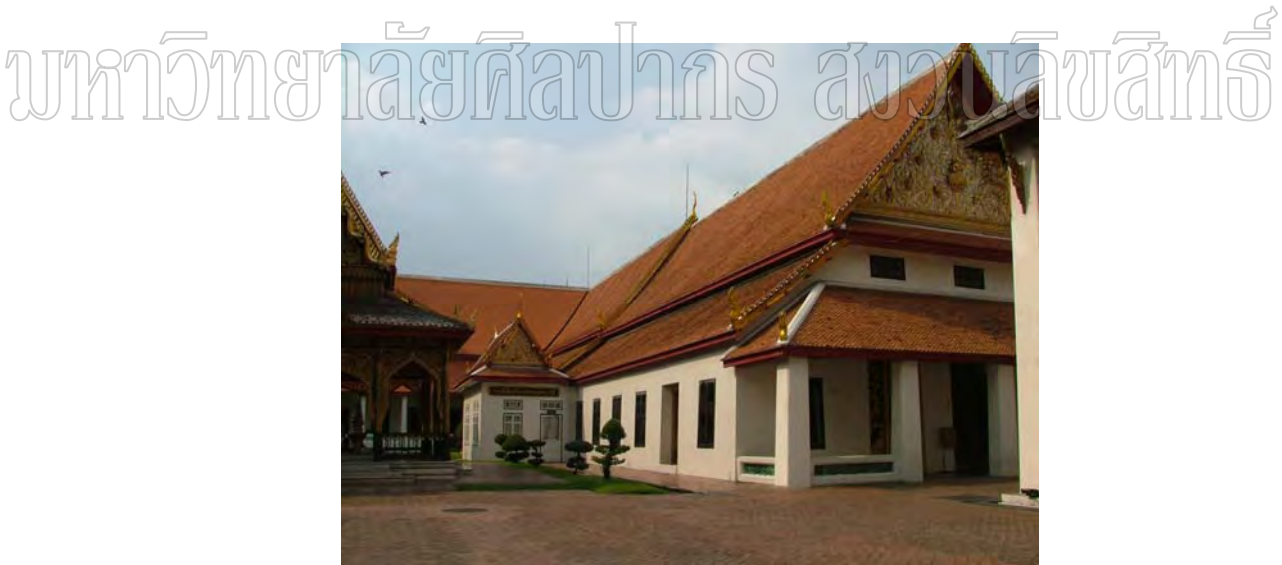
64. The photograph of Phra Thinang Issaraviniyaya

Era: Rattanakosin Period during the reign of king Rama III, functions as the throne hall for the third viceroy of Rattanakosin called Viceroy Maha Sakdiponlasep.

Style: The building has bay windows around the building.

- The roof is connected to the next buildings and is covered by clay tiles. The roof has two levels. The tiles seem to be in a good condition. There are dirty stains on the tiles.

Pediment: the pediment oriented to the east, depicts the divine or *deva* encompassed by ornamental motifs or *Kanok*. The pediment is carved wood decorated with colored glass mosaic and lacquer work. Most of the glass mosaic is deteriorated and no longer shines brightly.

- Door and window panels are also designed with gold and lacquer work or *Lai Rod Nam*. The panels are made of hard wood. The main entrance has three doors designed with the gold and lacquered work. They depict the image of a tiger attacking a cow while the other depicts ornamental motifs of flowers and birds. Mostly the condition is fairly good but there is some dirt from birds' droppings. The lacquer work is colorless.

The concrete floor and floor tiles are cracked and unclean. Moreover, termites are found at this area.

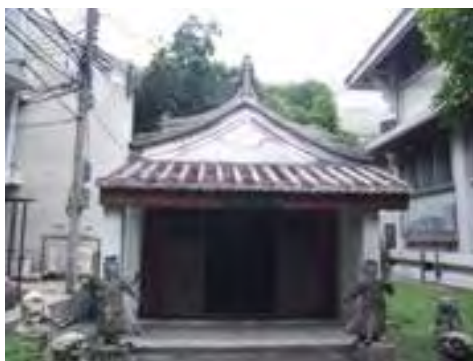
66. Photo of Kheng Nukij Rajaborihaan

- The roof tiles are covered with black stains that occurred from rain and dampness. Some parts seem to be in severe condition because there are some cracks. The pediments that depict the Chinese painting are peeling off and some of them are colorless.
- At the entrance, there is the accordion carved door and a painted Chinese vase. Its condition is only fair because some of the color is peeling and there is a lot of dust. Some parts are damaged and decayed by termites and dampness.
- There is one small door and one small window at the north. There are the ventilation windows along the south wall. There are mural paintings inside this building. There are Chinese characters explaining the historical record of *Hong Sin*. There is the marble sign carved with the golden words “Kheng Nukij Rajaborihaan”

- Most of the Chinese painting is damaged by dampness and also with aging of the materials. From observation, there are a lot of concrete patches that may have been caused by the leaking roof. Some parts of the wall were cracked but most of them are decayed and suffered from dampness. Moreover, there is a lot of debris in this building.
- The exterior and the surroundings of the Chinese house should be better managed and preserved. It seems to be abandoned in spite of its location behind Phra Thinang Issares Rajanusorn.

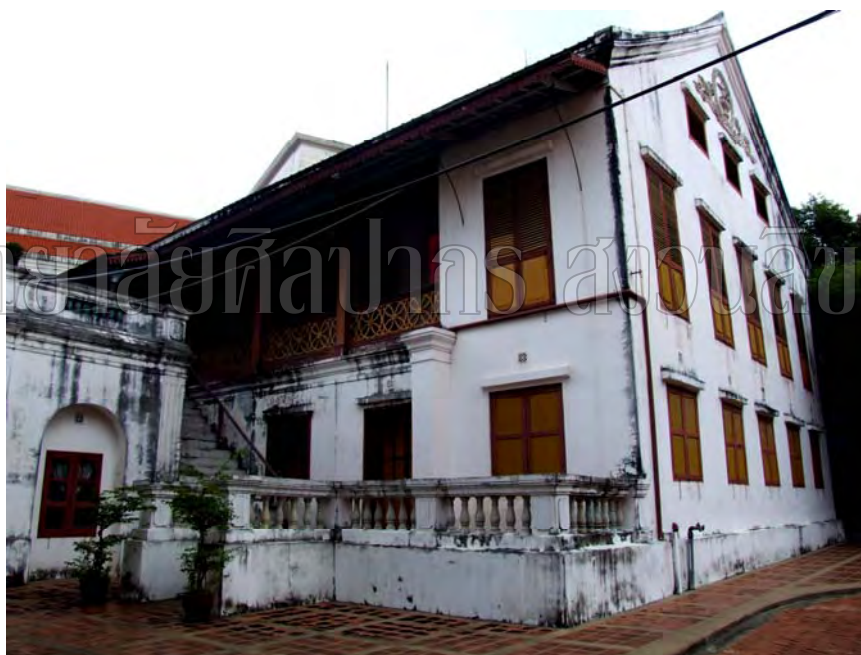
67. The Photo of Phra Thinang Issares Rajanusorn

- Roof: It is a hip roof (there is no record of the original tiles). The south and the east pediments depict the stucco of the King Pinklao emblem, the hair pin placed on the royal bowl entwined with the floral arrangement. The stucco is in good condition but has some stain spots.

- Windows: The windows are made of wood painted yellow and the window frames are painted red. The windows are rectangular, aligned in a semicircular form on the outside; this part has many stains while the paint layers are peeling off.

- Doors: The doors are made of wood in accordion style, painted in red and yellow.
- On the ground floor, there are glass rectangular windowpanes that are dirty but unseen. The wall is in severe condition because the wall plaster is covered with the black stains and some fungus. Furthermore, the painted layer has peeled off.

The wooden doors also painted in red and yellow, their condition seems to be good but the doorframes and the lintels are damaged from dampness. The wall is in a severe condition; there are patches of dampness at the ground level (around 2 ft high from the ground). Some parts of Phra Thinang Issares Rajanusorn are neglected by the museum officers, there is some debris on the floor and have no any maintenance. The north side is connected to another building; there is a lot of debris and some garbage.

- The east façade is connected to the museum restaurant, this may cause dampness because there is a wash area nearby this building and near the wall plaster is damaged.

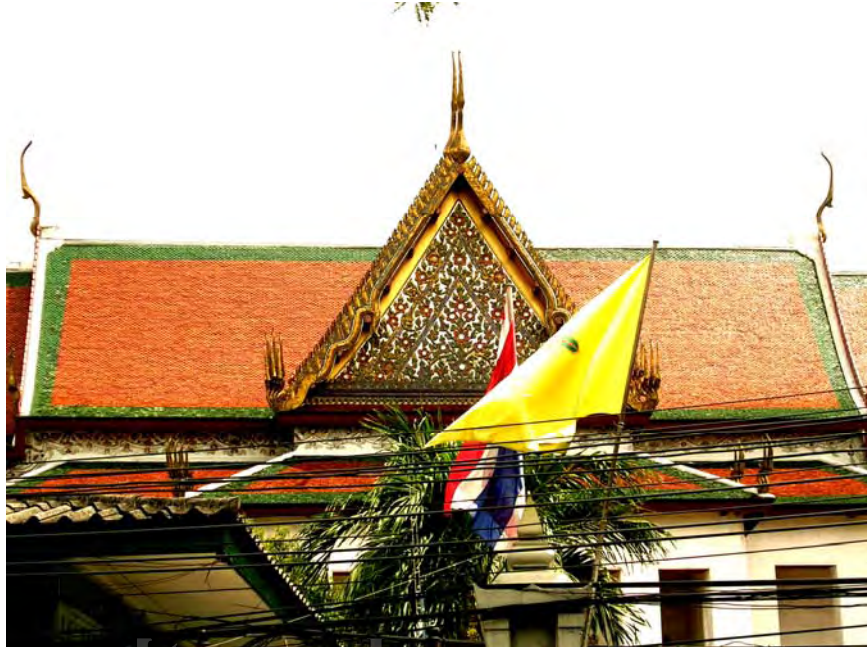
69. Wat Bavornsataan Suthawas

It is a hip roof covered with orange and green color clay tiles. The roof has two layers.

The monastery is quite tall in structure. The condition seems to be good with some black stains. The roof structure is supported by Kor Shong elements. These components are made of wood and decorated with stucco. The stuccowork molds the flower arrangements around the bottom of the roof. The floral style resembles European ribbon. At some spots the stucco condition is broken and missing.

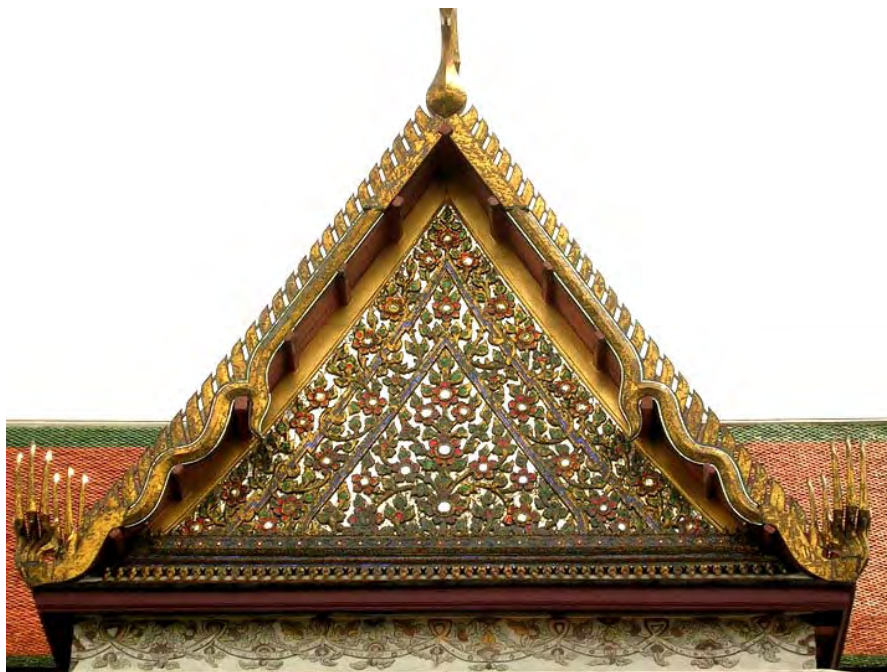
70. Pediment of Wat Bavornsataan Suthawas

- Pediment: The pediment is made from wood. Its east and west side depict the Thai flower motif. The overall condition of the pediment and carved pattern is fairly good. The decorative colored glass mosaic and gold leaves are ageing. Some mosaics are broken others disappeared. The whole pediment is dusty.

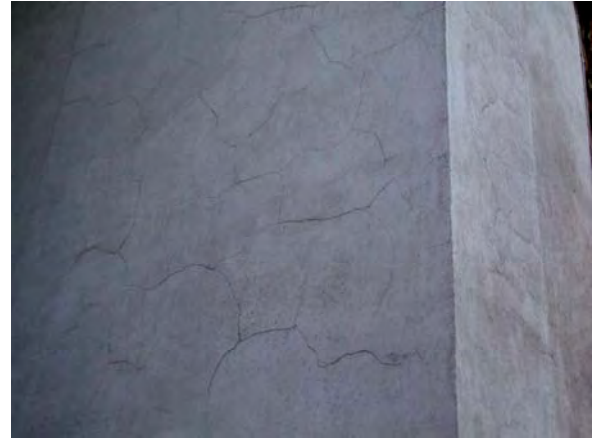
72. The wall is painted white. The whole wall is in a good condition. But there are some hairline cracks and the entire building is damp.

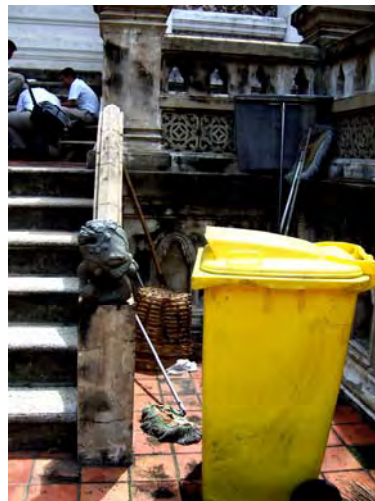
73. Wat Bavornsataan Suthawas

Garbage is disorganized. Cleaning seems irregular. Nobody seems concerned about keeping the place clean. Photographs by Bussayamas Nandawan

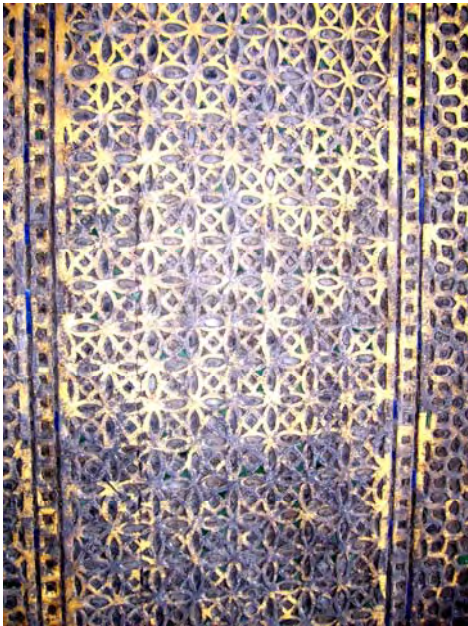
74. The door panels made of hard wood decorated with gold leaf and black lacquer on carved wood with ornamental motif or Kaew Shing Daun (pattern of composite circles of glass)

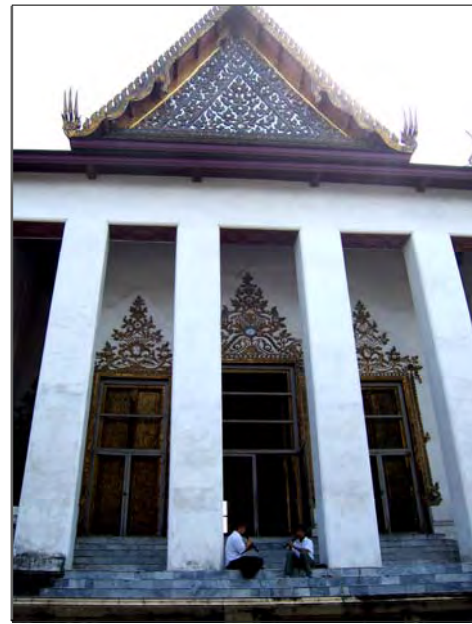
75. This monastery has three large doors with each direction north, south, east, west respectively.

- The doors components are made of wood and decorated with stucco. The stucco work molds the flower arrangements around the frame of the doors. The stucco work has Chinese ceramic and color glass mosaic in floral designs. In some areas, the stucco is broken and/or missing. Doorframes are spilt. The termite attacked the wood. Damp is widespread. The conditions are severe because the ornamentation has deteriorated. Examples are the glass mosaic and Chinese ceramic which are almost entirely missing on the Kaew Shing Daun carved wood panel of this monastery. They are covered with the gold leaf on top. Most of the lacquer works are deteriorated.

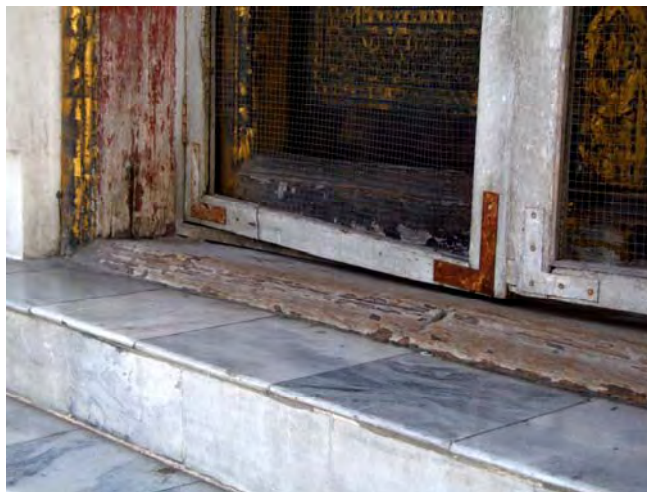
76. The condition of the threshold; the wooden thresholds are decayed and rotted.

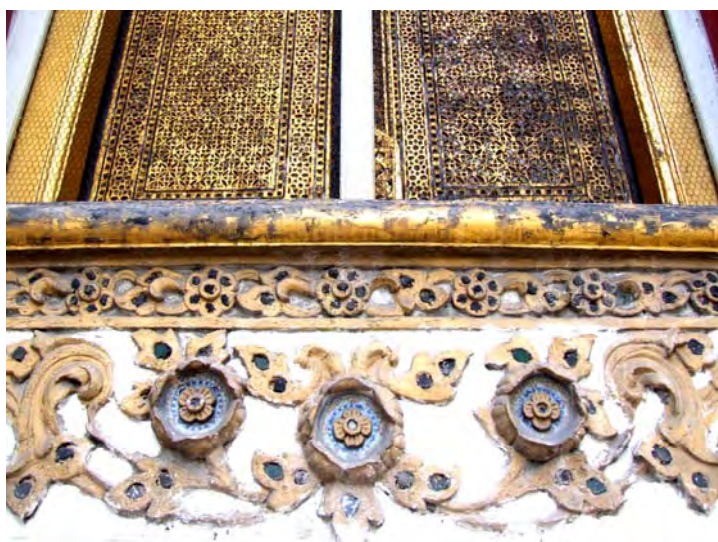
- This monastery has eight windows. The style and material are matching with the doors but of smaller size. They are in a severe condition. They are contaminated and damaged by weathering and neglect.

77. The condition of the window frame made of the stucco decorated with porcelain and glass mosaic: The glass inlay are cracked and lost and the lacquer work severely damaged.

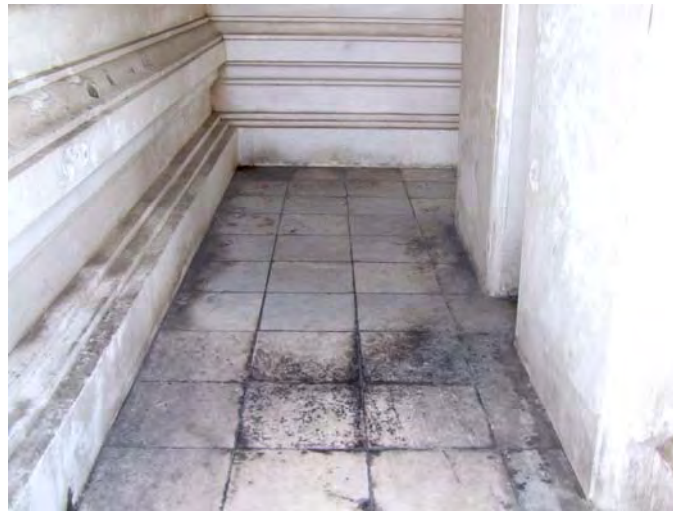
78. The upper basement of this monastery is very dirty because of dirty water.

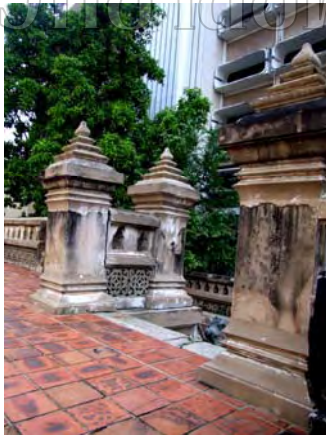
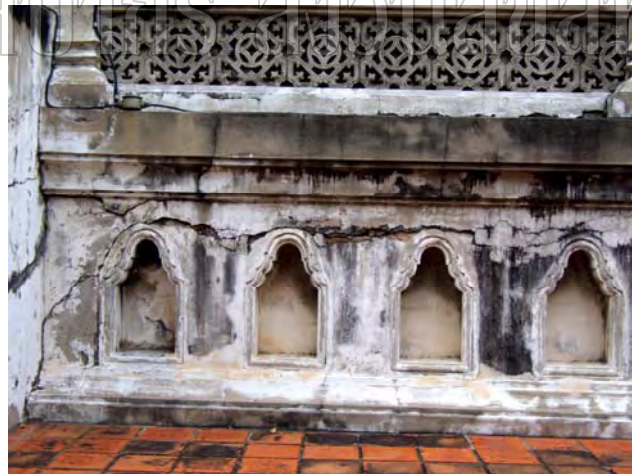
79. These are two photos to show how conditions of floor tiles are stained black.

The building base is now spilt and broken.

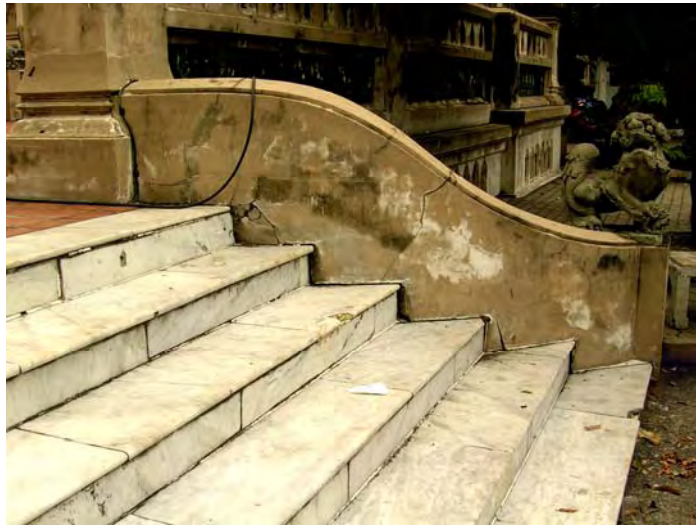
80. The platform of this monastery has small five steps. There are widespread black stains. The plants are glowing between the seams. The tiles are cracked. The floor has sunk.

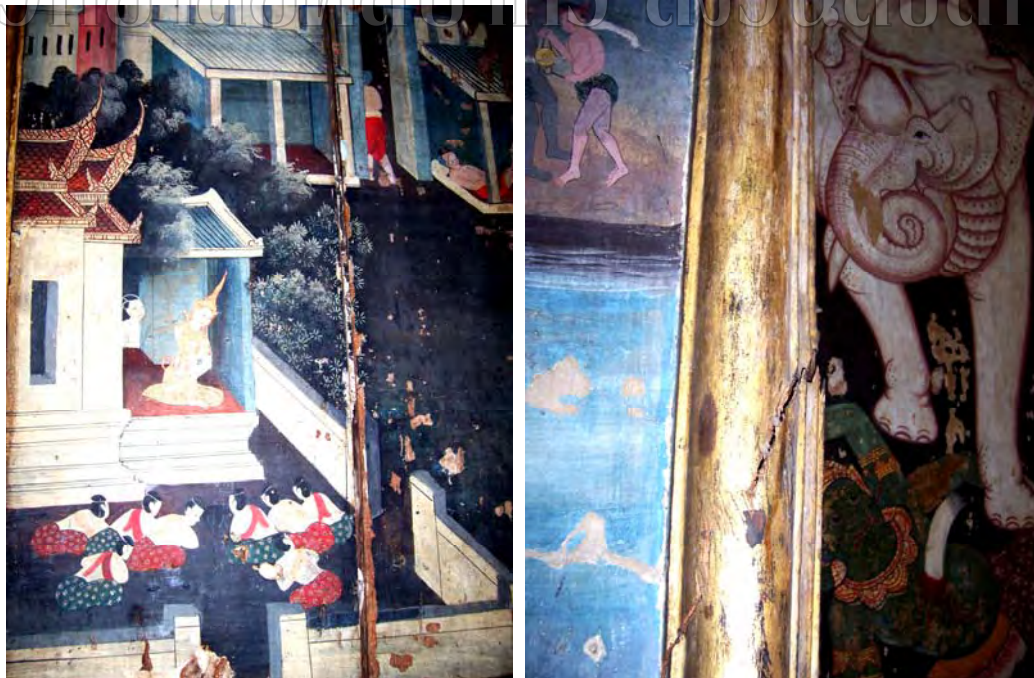
81. There some damage on the wooden materials. The doors and window have split and are scratched. The gold parts are rubbed. Photographs by Bussayamas Nandawan

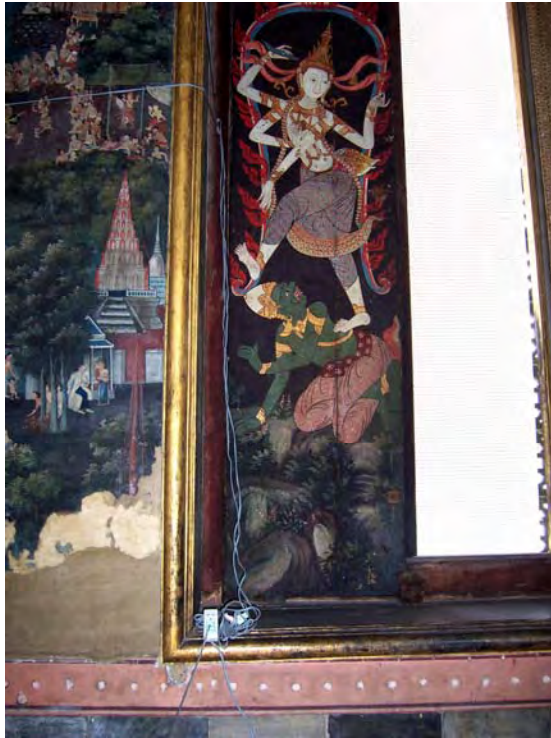
82. The electronic wires are in a mess. They jump from one window to another window. Vulgar nails were put on the wooden window panels for hanging the wires.

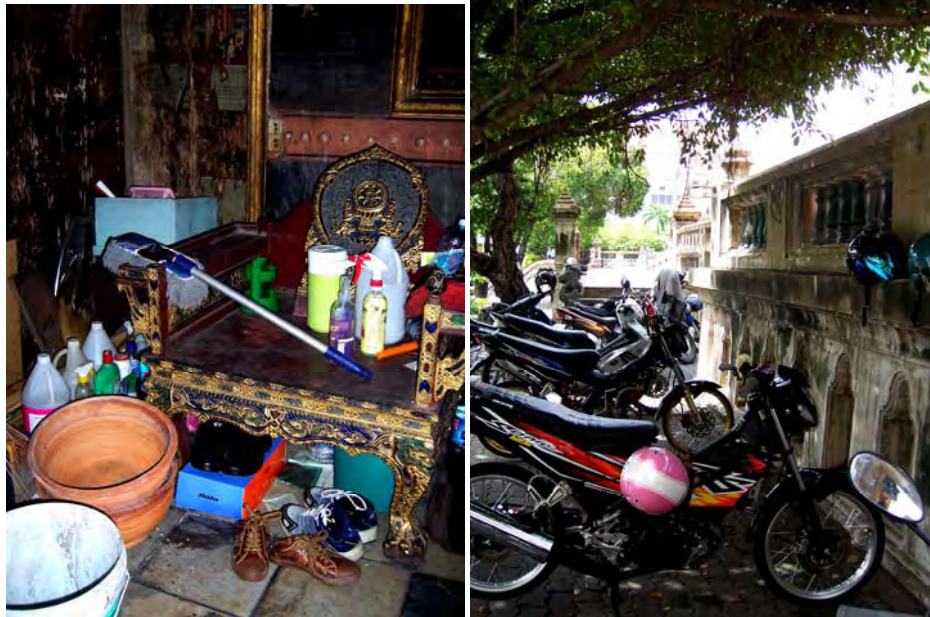
86. The deterioration is exasperated by ill use. Some people use the corners of the monastery or close to the window frames as his or her storage. There are many motorbikes parked close to the monastery.

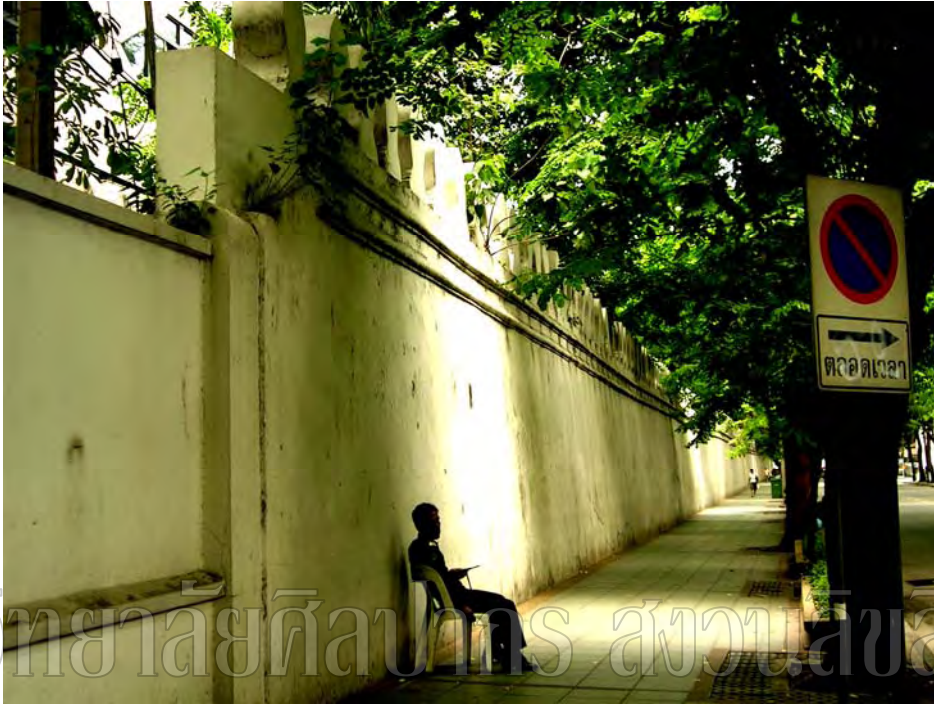
87. Photograph by Ms. Alisa Decha

This wall is made from bricks and ancient lime cement. As this was the wall of Wang Na, the Bai Sema, placed at the top of the wall, reflects the signature style of this palace. The overall condition of the wall seems to be good, especially where the wall faces the Phra Chan Road. Some parts of the wall are deteriorating and incline toward the Thammasat University. When the white plaster of the wall started cracking, it was covered with new paint. However, there are now some painted layers that have cracked and peeled off again, while some have been covered and repaired with wall putty.

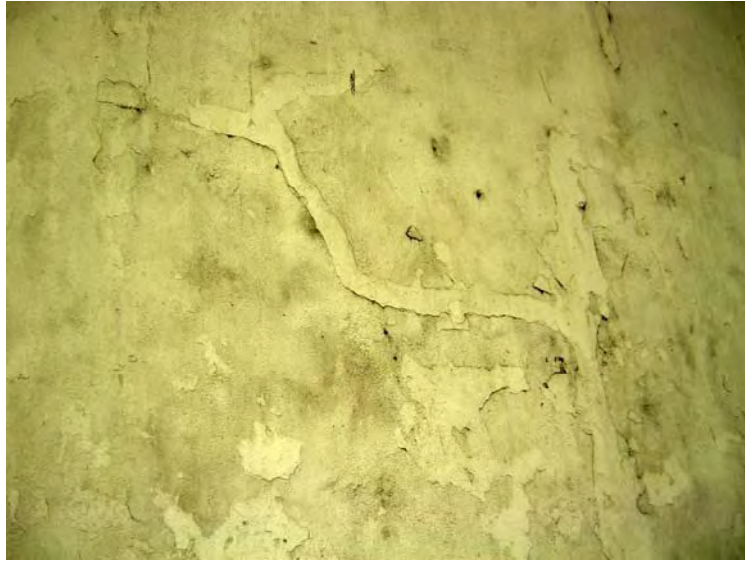
89. Overall the wall is now covered with black stains caused by dampness. Moreover, birds' droppings also affect its original identity and condition.

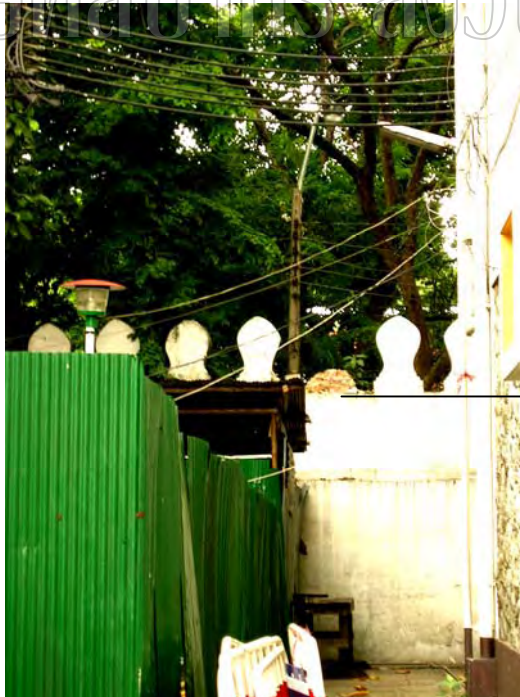
Bai Sema is loose.

Some loose Bai Sema broke off and disappeared as no cleaning is done nor is a wall conservation plan at hand. The inner wall is now part of the Thammasat University and most parts of it cannot be observed as these are now connected to the Faculty of Commerce and Accountancy, the canteen and the Faculty of Social Administration. Some parts of the wall are affected by dampness too, particularly behind the canteen, as this is an area for washing and cleaning.

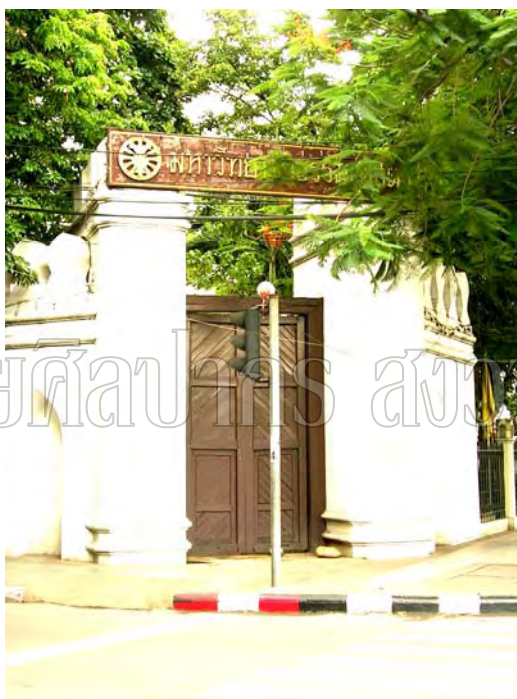
91. Main Gate of old wall of Wang Na, now enclosing Thammasat.

The main gate was reconstructed to show off its original style. Its condition is good but there is a lack of maintenance such as at the top of the ancient gate, where weed roots grew through the wood and which, at a later stage, may affect the entire wooden gate.

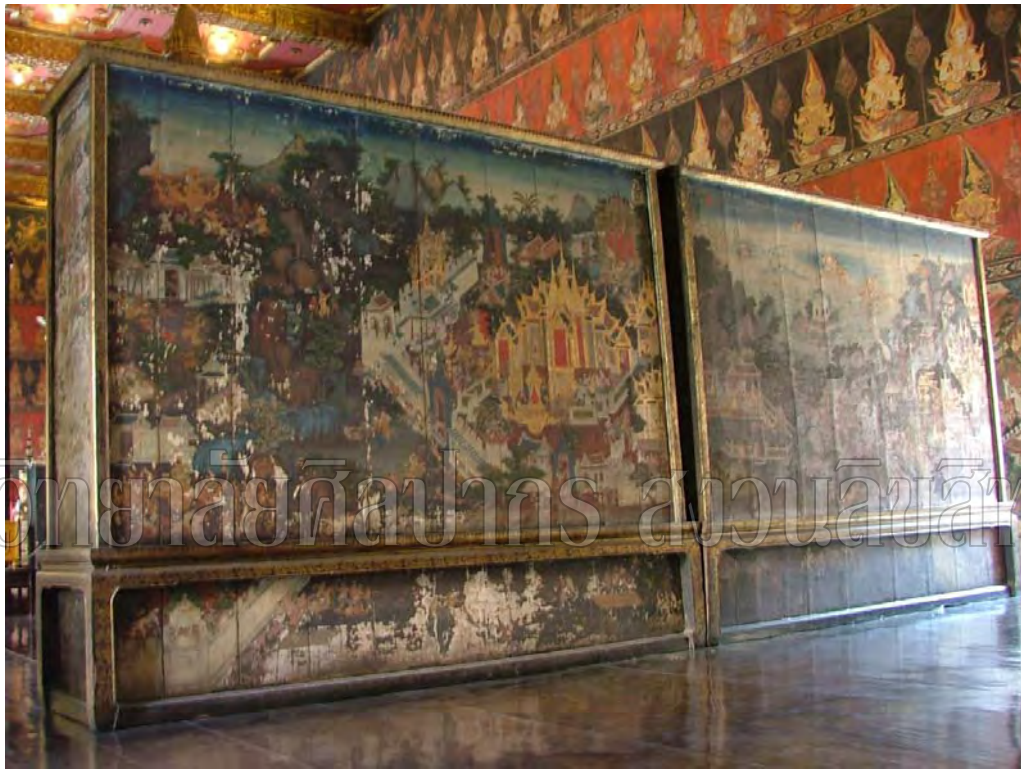
93. Three book cabinets.

There are three book cabinets for keeping manuscripts. They are decorated with gold and lacquer decoration using *lai rot nam*⁹⁰ technique, which is usually chosen for the inner surfaces of door and window panels. Some of the most valuable objects in the book cabinet are historical manuscripts.⁹¹

Gold and lacquer decoration (*lai rot nam*) begins with giving a wooden panel three coats of black lacquer. After the drawing has been traced, a yellow gummy paint is applied on the sections which are to remain black. A thin coat of lacquer is then painted on the surface. When this is semi dry, gold-leaf is applied over the entire panel. After twenty hours the wood is washed with water which detaches the gold-leaf laid on the gummy paint. The finished design is neat in every detail.

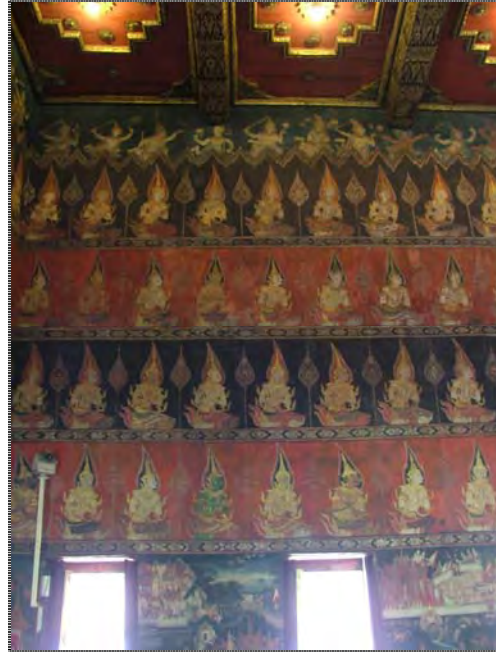
94. Mural paintings in Phutthaisawan Chapel.

The mural paintings in this Chapel are believed to be oldest and undisputedly the most valuable ones executed during the Rattanakosin period. There is an important antique that represents the masterful workmanship of artists at that time. Maha Surasinghanaj ordered prominent artists of the time to start working on the paintings around 1796.

The mural has been partly retouched at a later time but it still retains its original artistic value. In 1983 it was noted that the condition of the murals had regrettably deteriorated; the colors were flaking off in some areas and faded in others. The cover part of some of the walls has cracked on the surface and white cement has been applied to fill the cracks in such a way that some of the paintings have been covered. The inevitable result has been the destruction of invaluable elements of the cultural heritage of all Thais.
