MANAGEMENT PLAN OF HISTORIC SITE FOR CULTURAL TOURISM

ATTRACTION: SANAMCHANDRA PALACE

A Research Project Submitted in Partial Fulfillment of the Requirements for the Degree

Architectural Heritage Management and Tourism

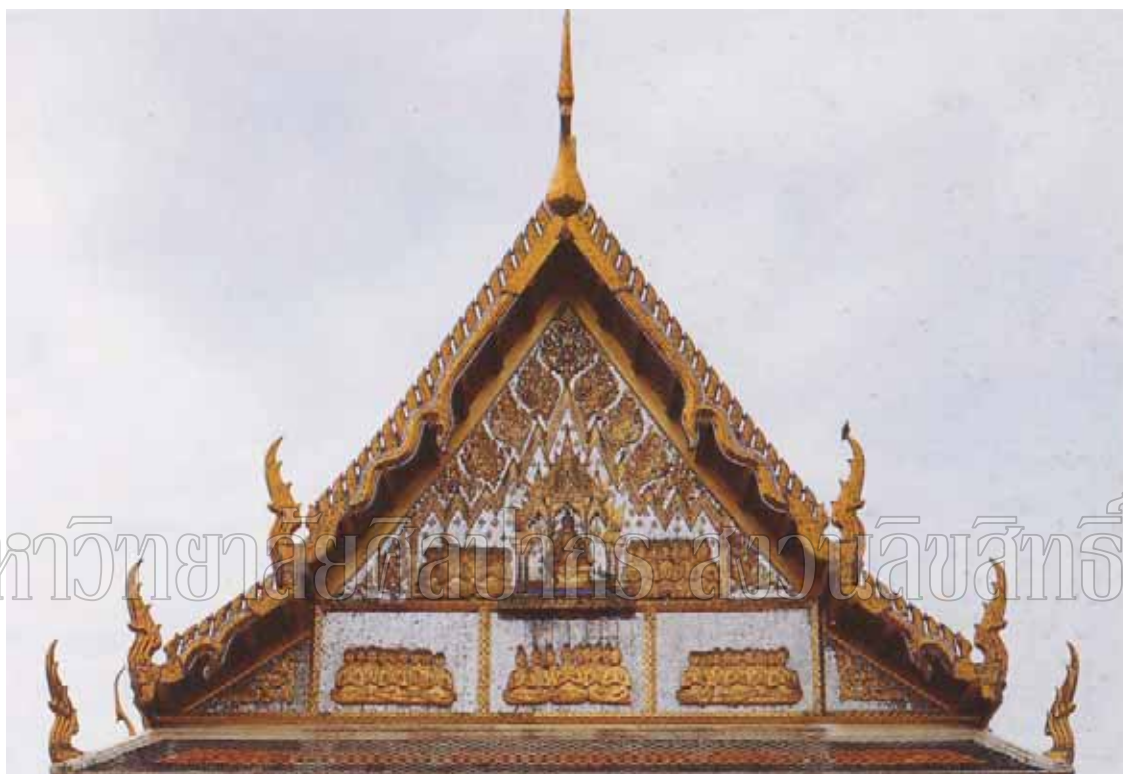
The north gable is decorated with wood carving in pattern of the sermon of god Indra under the three-spire castle. In the right hand is Vajira as his weapon. The left hand is in the sermon position. Surrounding compositions are the prayer angels and different kinds of humans. And decorated with golden leaves and attached with silver. The concept of decoration was associated to the function of the building. And thus Indra was a representation of H.M. king Rama the Sixth.

Figure 54: The north gable of Samakkeemukmataya Royal Hall.

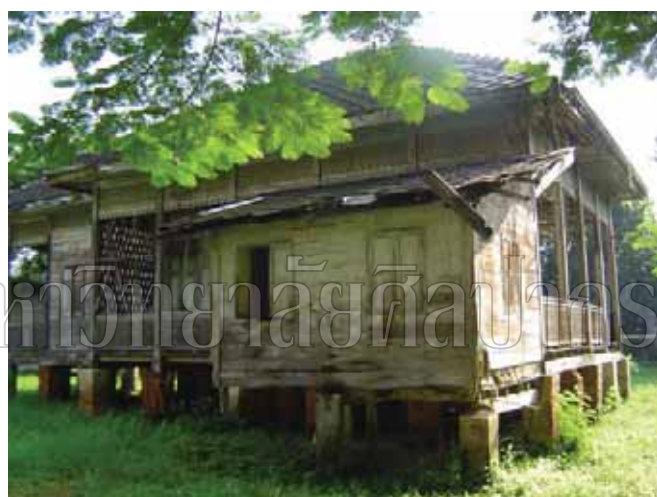
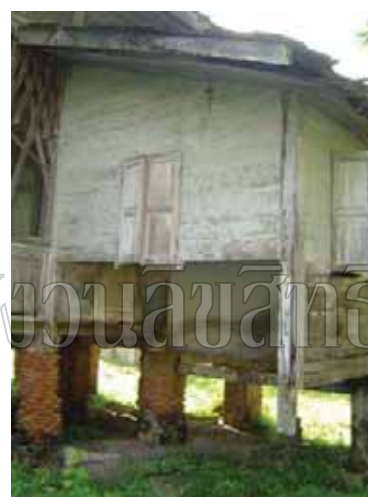
Figure 87, 88: The high degree of damage.

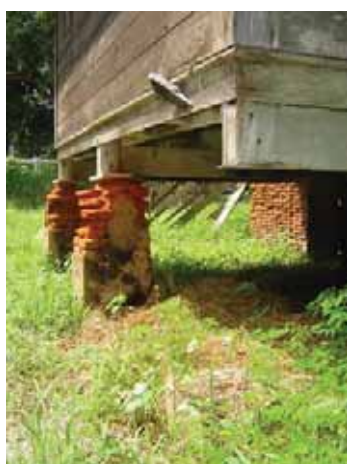
Figure 89: Cracking and ruin of the brick foundation post.

The present conditions of building are in the critical situation, and can be classified as the most damaged building in the Sanamchandra Palace.

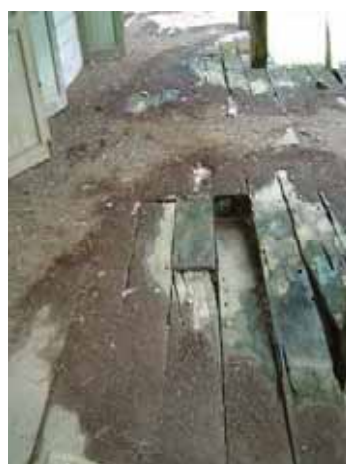
Figure 90: Floor damage.

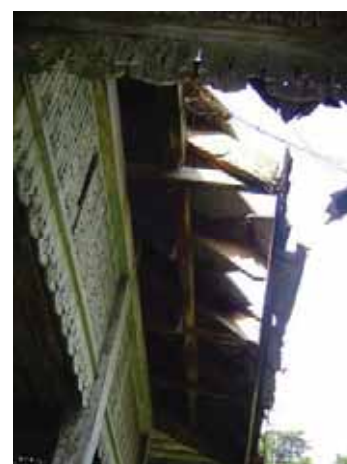
Figure 91: Roof damage.

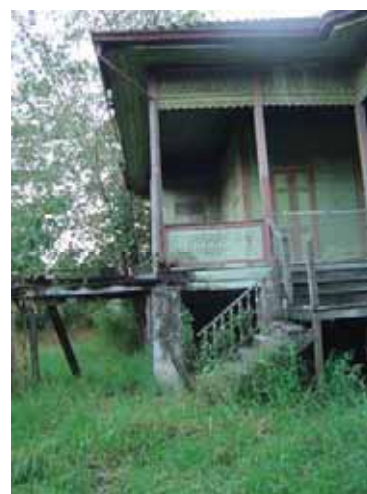
Figure 100: The high degree of damage.

Ruen chaotee is stilted teak wood. The architecture style is quite similar to Ruen Phra Kantikeya House. It is situated westwards of Ruen Phra Supalaksa House. The building was painted in pale green and the wooden frame painted in dark red. The condition of the building is in the bad situation as Ruen Phra Kantikeya House.

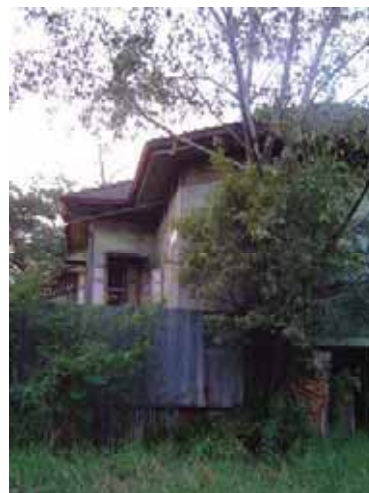
Figure 102: The banyan tree is growing on the brick foundation post.

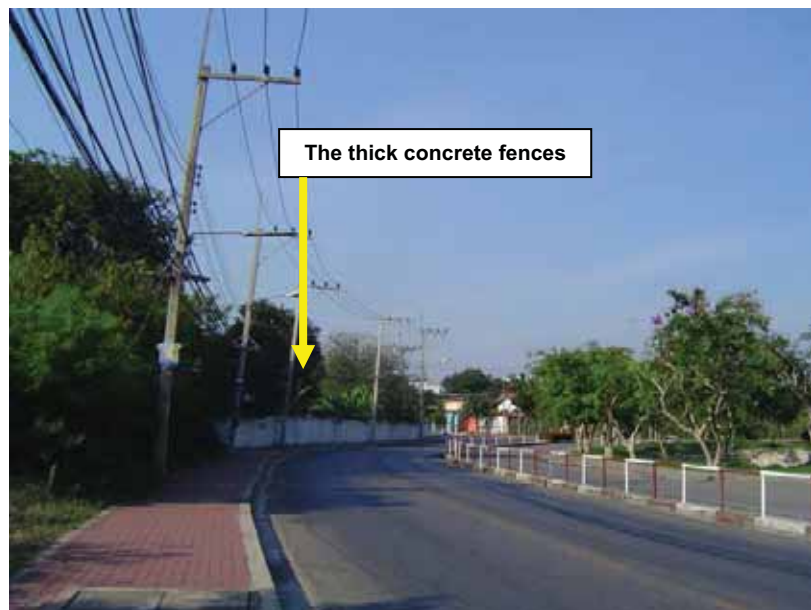
Figure 140: The thick concrete fences should be demolish and create the new entrance gate to visitor service zone. And build the clear wooden fences for showing the heritage building behind the fences.

In this case, it is proposed to demolish the added buildings to crate the open space for looking direction, and develop the area for the tourism service centre. Demolishing of the thick concrete fence along the Nah Wang Road is also should be considered in order to create the main entrance to the visitor center zone.

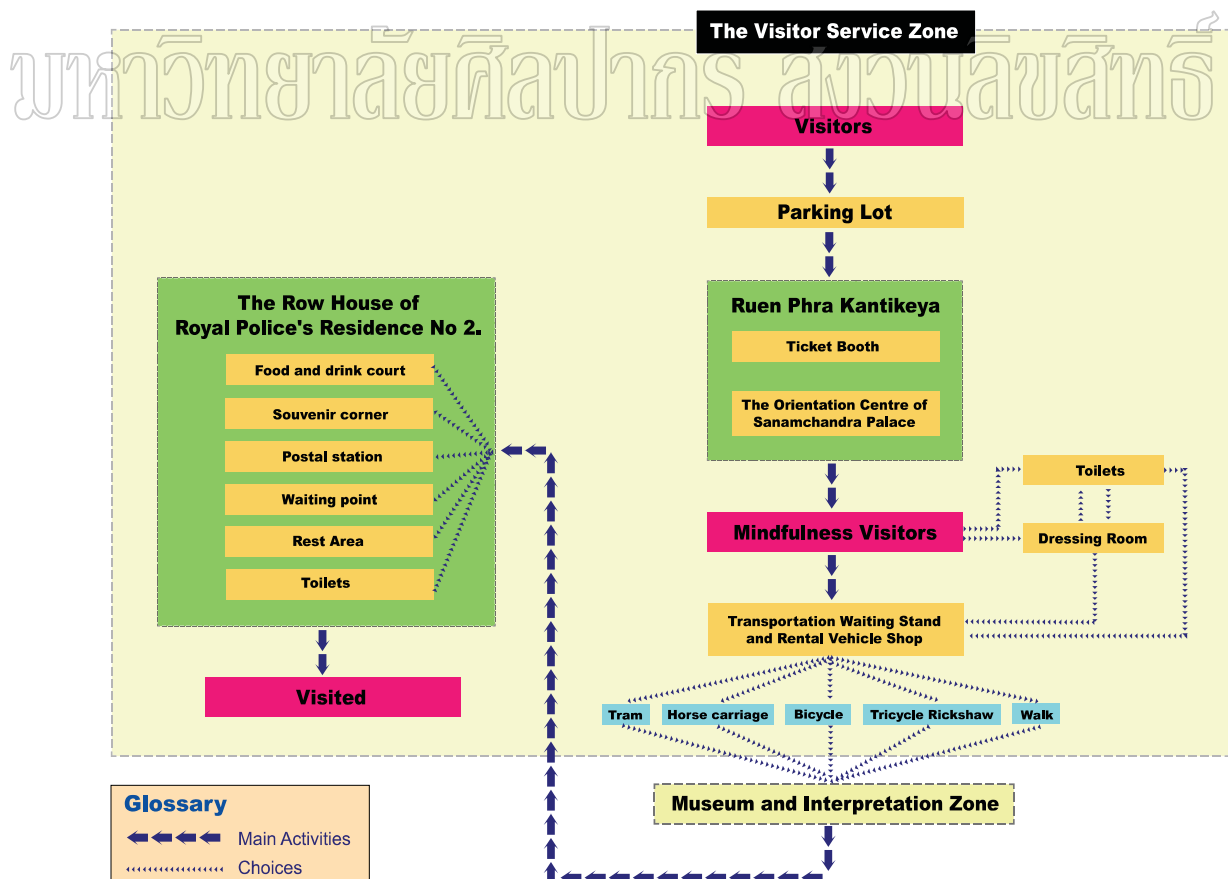
Figure 141: The diagram of visitor service zone

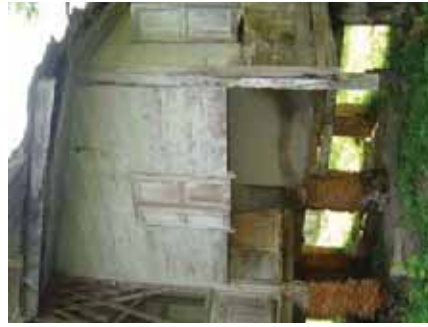
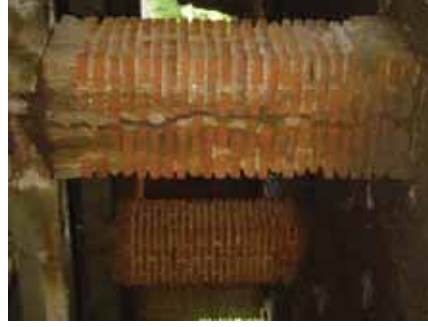
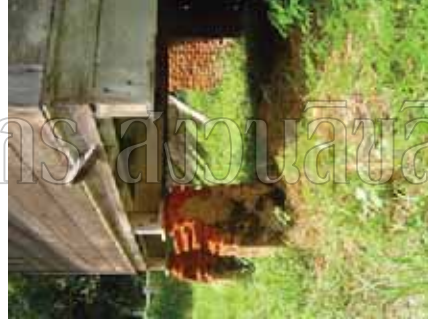
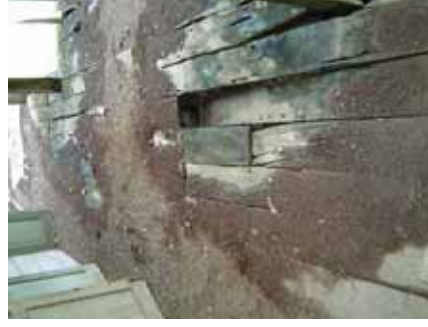
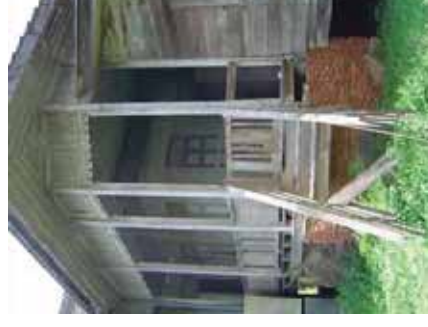
Figure 298, 299, 300, 301 and 302: The condition damage of building.

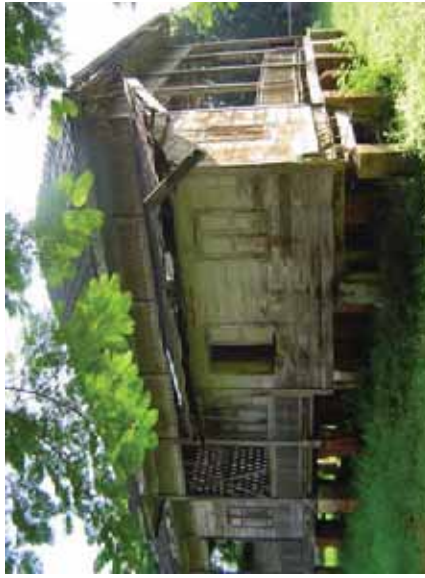
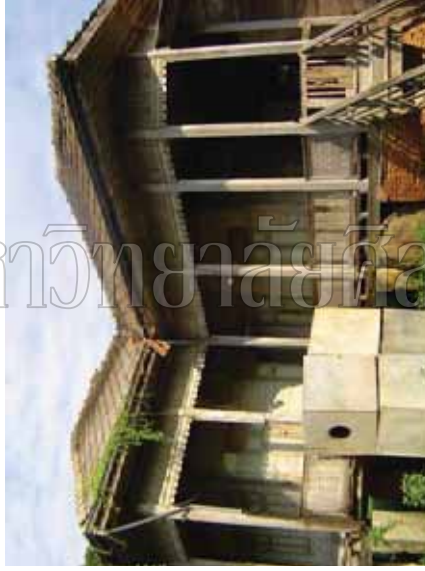
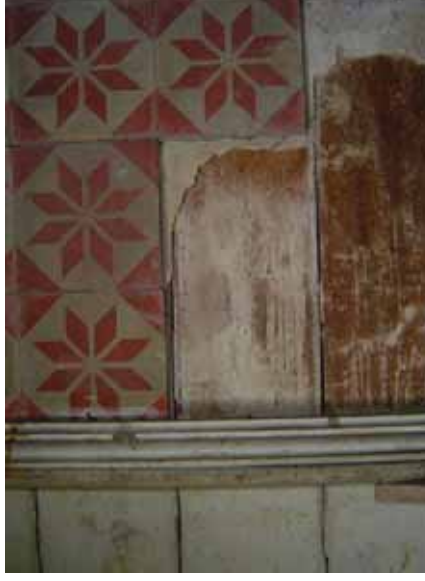
Figure 303, 304, 305: The condition damage of building.

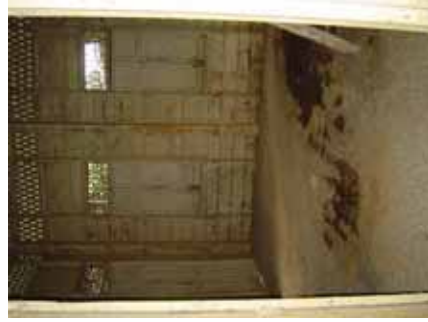
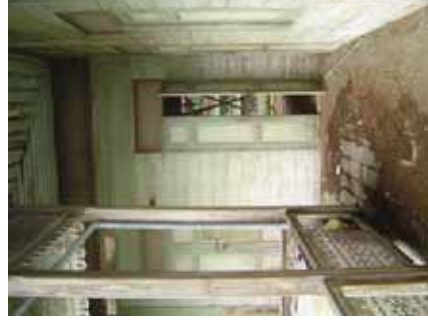
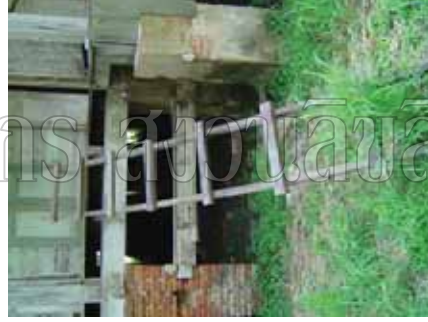
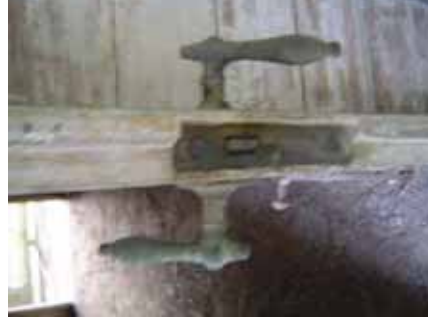
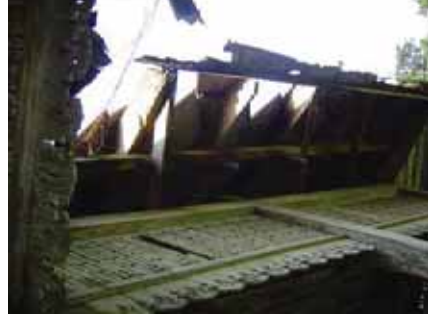
Figure 306, 307, 308, 309 and 310: The condition damage of building.
