**THE ARCHITECTURAL HERITAGE MANAGEMENT FOR WANG THA PHRA
AND WANG THANON NA PHRA LAN
: FROM THE PALACES OF BUILDERS AND CRAFTSMEN TO THE ART AND
CULTURAL CENTRE**

Architectural Heritage Management and Tourism

SILPAKORN UNIVERSITY

2003

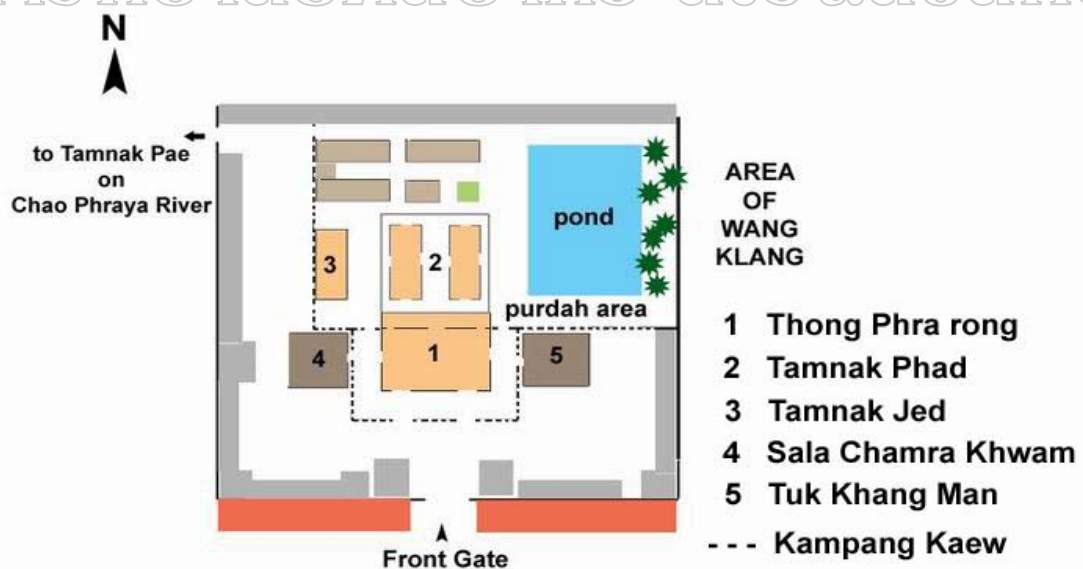
Figure 15 Lay out plan of Wang Tha Phra in the Interval between Krommuen Jesadabodin (King Rama the Third) and Kromkhun Rajasehavikrom. Drawing model from literature by the understanding of illustrator.

Almost the back-end boundary in the west had a sub-gate call "Pratu Din" led to "Tamnak Pae", a floating house in the Chao Phraya River, by passing a small gate of the city wall. Along the path from the gate to Tamnak Pae enclosed with walls called "Chanuan Kampang". Tamnak Pae was a three-span long house with terrace surrounded.

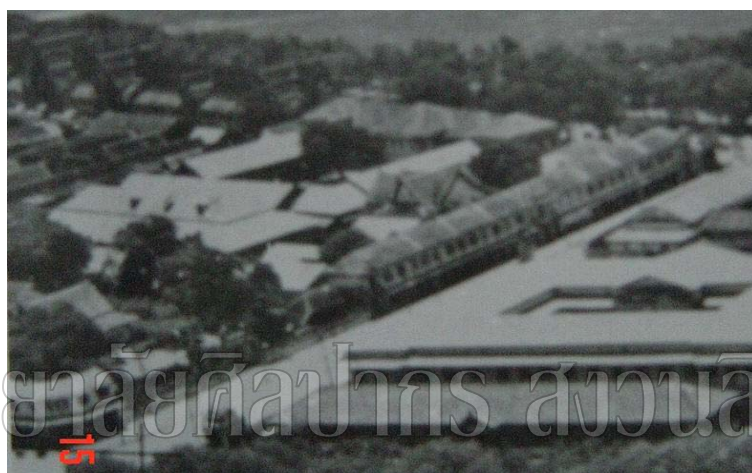
Figure 16 Bird eye view photo of Wang Tha Phra and Wang Klang, in 1946. View from Thanon Na Phra Lan.

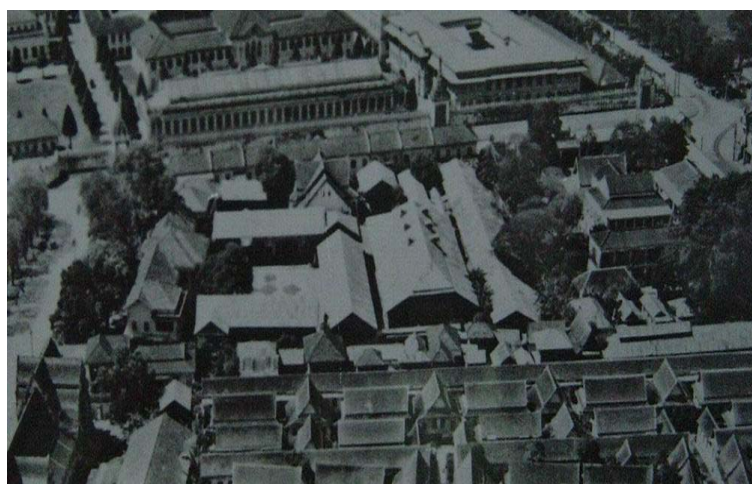
Figure 17 Bird eye view photo of Wang Tha Phra and Wang Klang, in 1946. View from the back side.

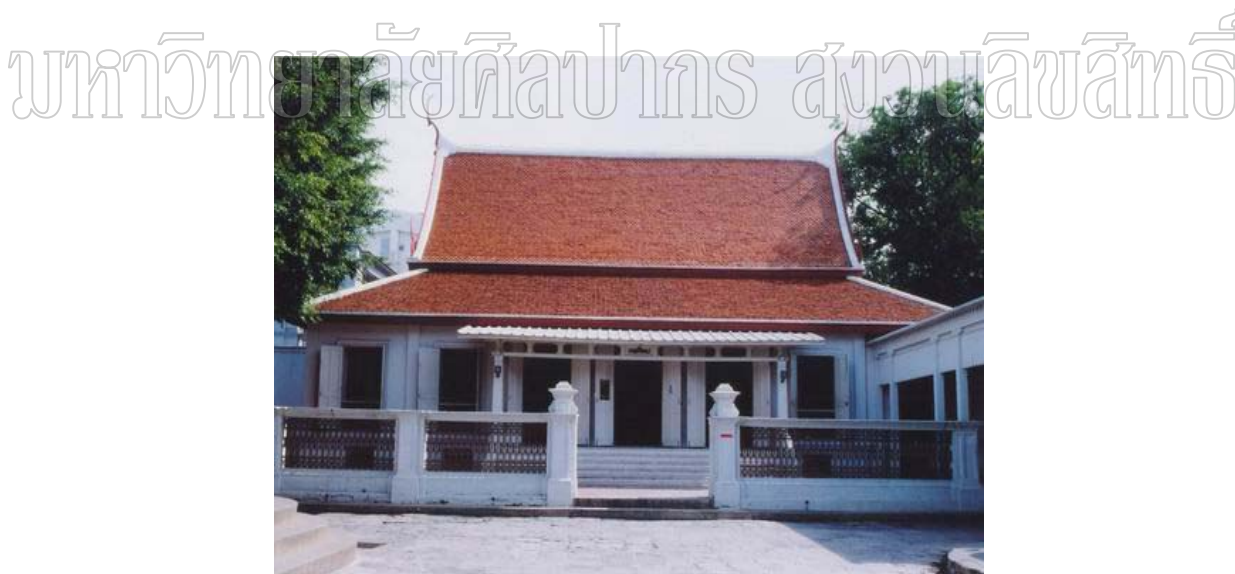
Figure 19 Thong Phra Rong Wang Tha Phra, in 1981
Source : The National Archive.

Exterior space of Thong Phra Rong is surrounded by KamPang Kaew, which decorated with Victorian Style curved metal bars.¹²

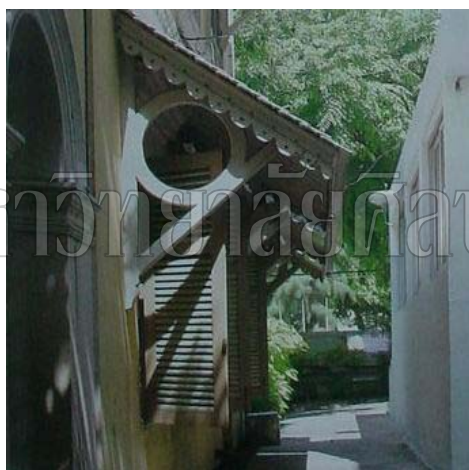
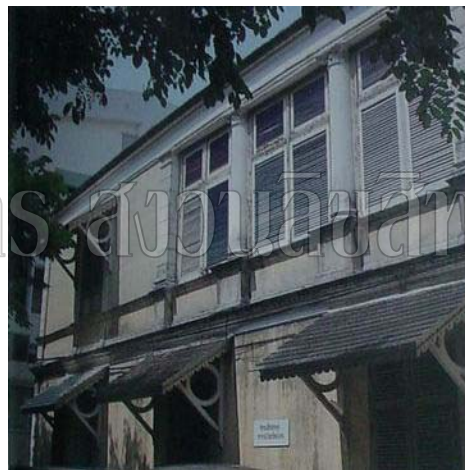
Figure 21 Tamnak Pannarai, views from the back and the West .

Out side the building in the east has a court among these three buildings. The north boundary enclosed with a cement wall. From the court one can walk through a gate door to the porch of Thong Phra Rong.

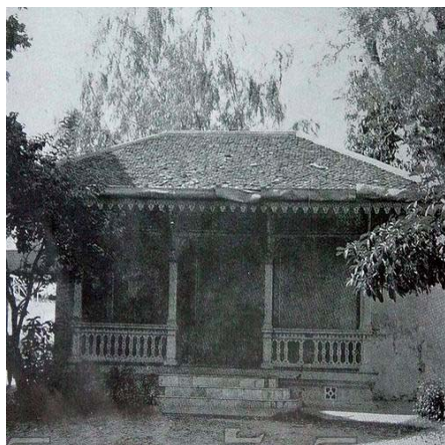
The old photo of the Pavilion in Suan Kaew
Source : Anusorn Ngan Phrarachathan Pleang
Sop Momchao Yajai Chitrapongse.

In 1989, a lace work of steel trusses were later built behind the back wooden wall to protect the Pavilion from the nearby sport activities of the student. Species of intervening plants were grown on the trusses to blend it with the garden's background.

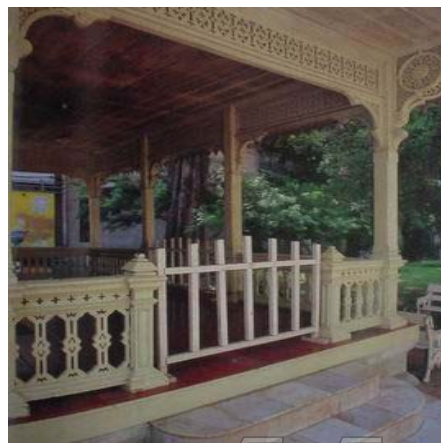
The Music Pavilion, after having restoration.
Source : S. Plynnoi, Wang Jaow Nai ,
(Bangkok : Dan Sutha Printing, 2539).

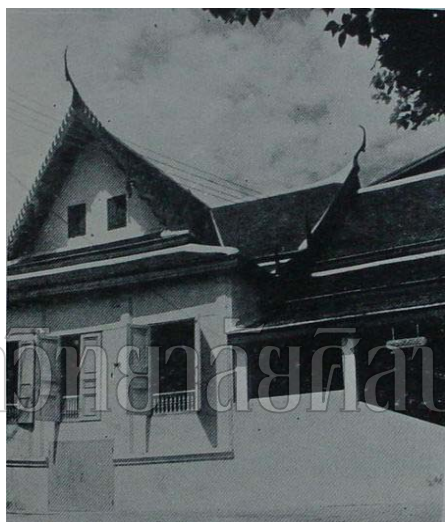
Thong Phra Rong in the past.
Source : [Prachum Pongsawadarn Part 26 : Tamnan Wang Kao.](#)

covered with glazed clay tiles. At the end of each gable, the roof was decorated with Thai art wooden crafts such as Chofah, Bai Raga, Hang Hongsa, at the rim of the triangle form. In the middle of each pediment there are two windows. The exterior floor is cover with ceramic tiles. The interior floor is wooden planks as well as the ceiling. Columns in the hall cover with carved wood.

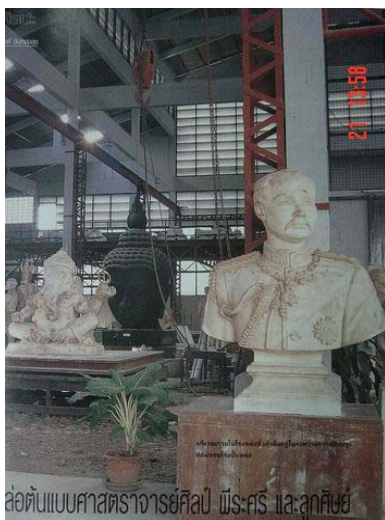
Inside of the Hall of Sculpture
Source : [Ban lae Suan Journal](#)

A large workshop located in the West corner between Thong Phra Rong Wang Klang and the palace wall. It was designed to be a foundry, so inside the building has a vast open space and some small office. Now this building has been improved of its condition and environment and used as a museum of the prototype plaster models. Some wood panel coverings were changed into glass and aluminum walls. Entrance door was redesigned and museum name label was installed. Not only the interior condition was improved but also the exterior environment. Storage room was removed and the area in front of the building was renovated. However, although having a lot of redecoration, the museum still retains the foundry atmosphere and setting.

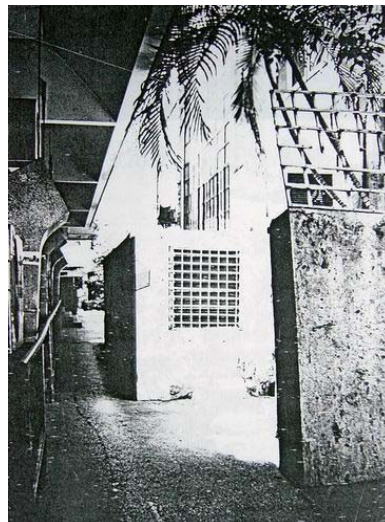
The back-side of Hall of Sculpture view from the path connecting Suan Kaew (Wang Tha Phra) and the Department of Fine Arts. In the picture show the old storage room and the original brick wall separating two palaces.
Source : Hall of Sculpture.

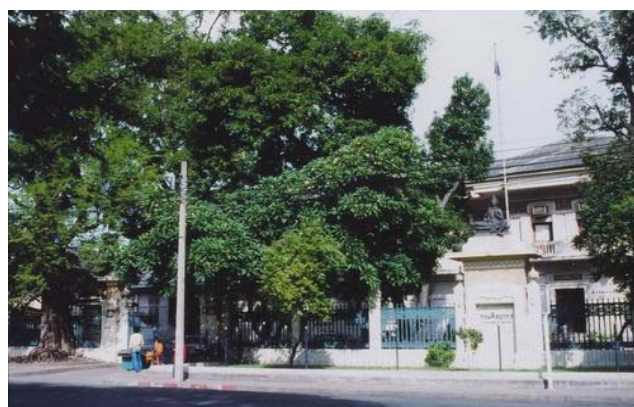
Figure 29 The front fence of the Department of Fine Arts view from Mahathat road, in 1981.

The old fence in the east boundary on Mahathat road has beautiful design with harmonious blending between Thai art and European art, and it is also well matched with the office building. It has gorgeous decorated cement posts and curved metal bars. Between its two gates is a cement wall where a sculpture of Vishnu, the deity worshiped of art works, were placed at the top.

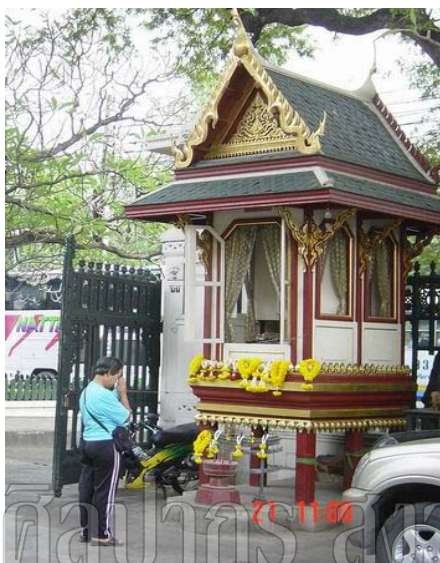
Figure 30 Sala Chao Poh Hoh Cheok, inside the front gate of the Department of Fine Arts.

Sala Chao Poh Hoh Cheok is a wooden Thai style spiritual house, situated near the entrance gate. The coil of bulky rope, which used for the elephant rounding up ceremony, is placed in this house.

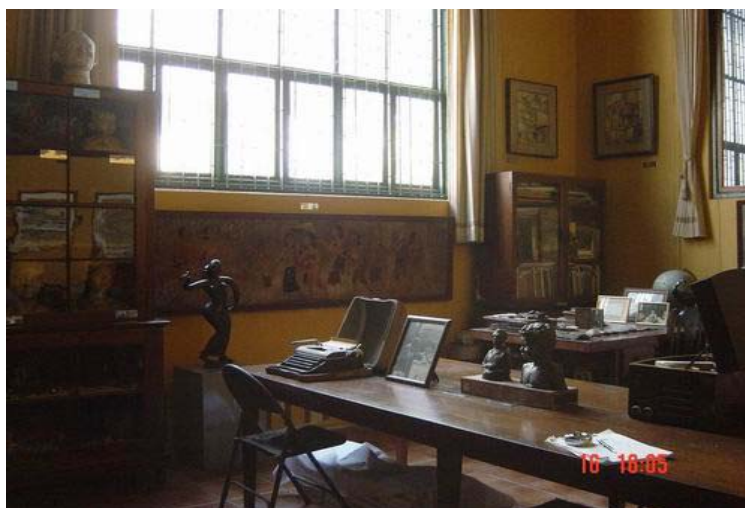
Figure 31 Inside the National Museum Silpa Bhirasri Memorial, imitate the atmosphere of Professor Silpa's ex-studio.

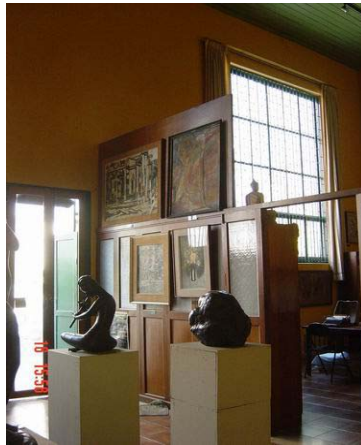
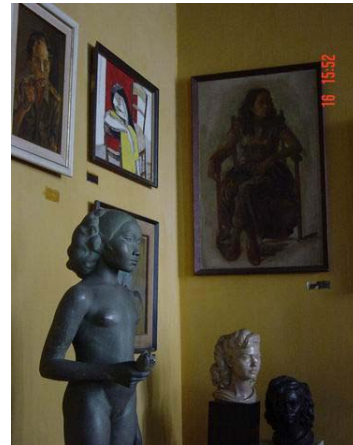
Figure 32 Fascinating contemporary style art objects from well-known Thai artists that exhibiting in National Museum Silpa Bhirasri Memorial.

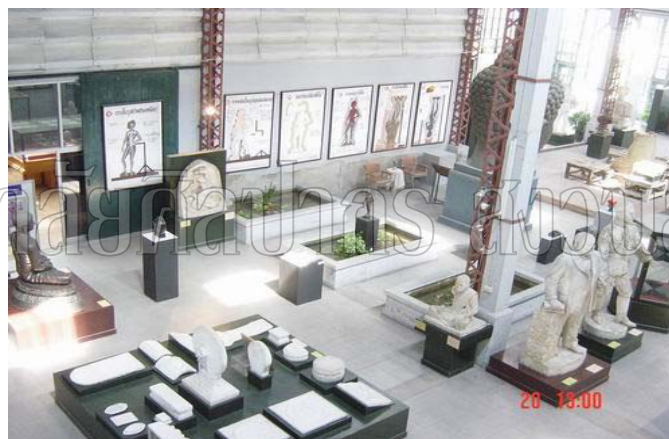
Figure 34 The atmosphere inside of the Hall of sculpture

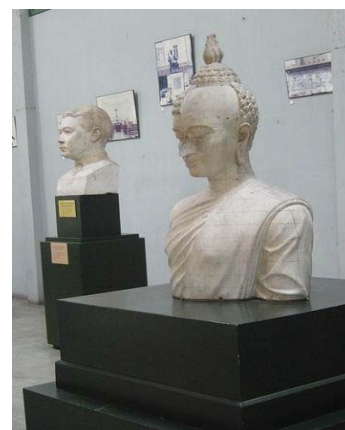
Figure 35 Interesting art objects and knowledge sign exhibiting in Hal of Sculpture. But having old fashion of interpretation.

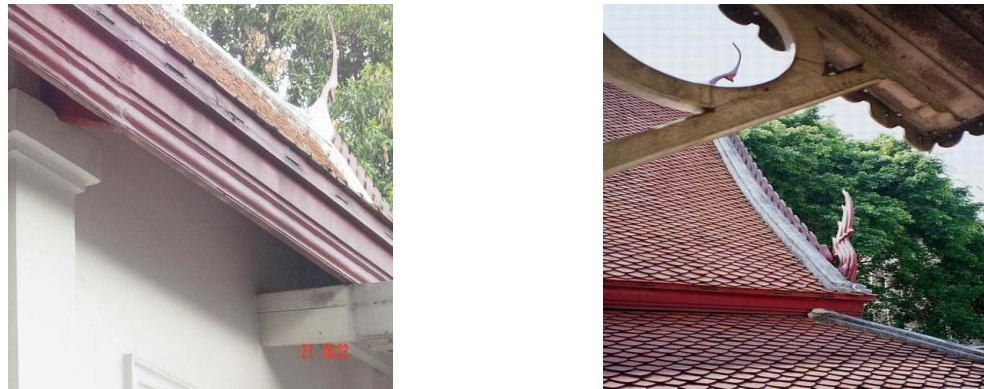
Figure 37 Show condition of roof tile, wooden eaves and cement border. Picture from front side and from back side in the West.

Most of the roof tiles are in good condition except some missing tiles at the lower step roof. The cement mouldings, border of roof's shape, are look filthy with the black stains. All the carved woods which decorating the eaves of gable roofs such as Chofah, Bai Raga, Hang Hongsa are discolored and cracked. Causes of this damage are damp from raining and heat from the sun.

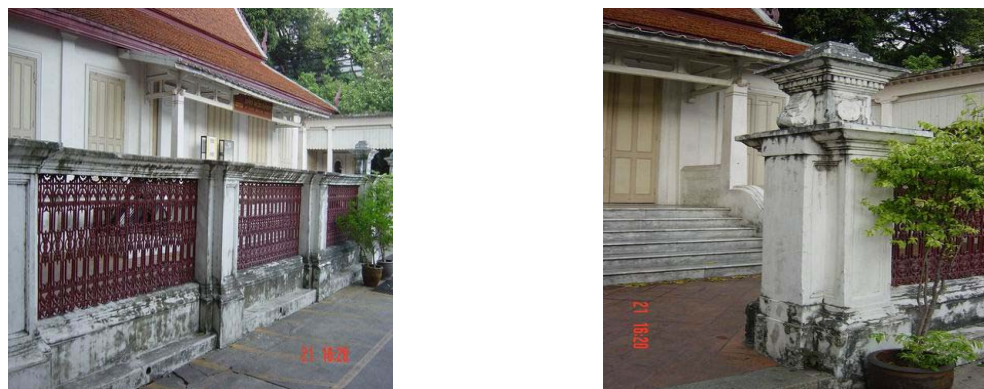
Figure 38 Cement border of Kampung Kaew look old and filthy with fungus stains.

Decoration details of plaster moulds and metal carved bars of Kampung Kaew are in good condition, only some parts of metal bars have been lost. Condition of plaster surface is damaged by humid from rain.

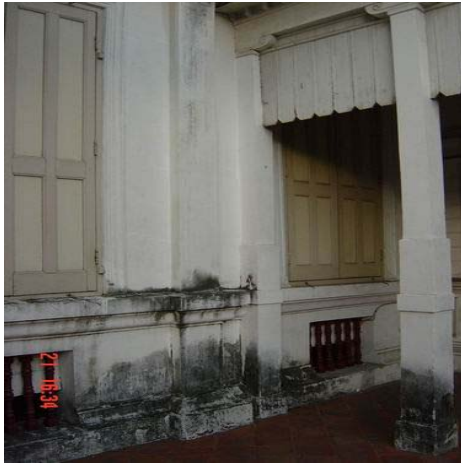
General condition of the upper part wall is fair but the lower part is bad. All along the lower part wall of the building have black and green stain of fungus. Cause of the damage is humid from ground water and splashed-rain since it has not had drain or any material to reduce dynamic of splashed. Moreover, some decorated cement mould has been broken and some of carved wood bars of ventilation voids are came off or distorted.

Picture of front elevation of the building.

Figure 39 Show damages of the walls around the building.

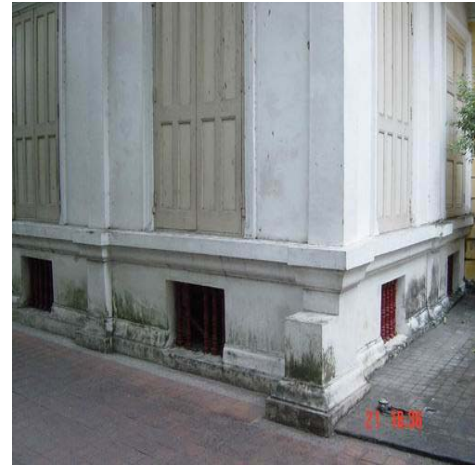
Picture from east-back corner of the building.

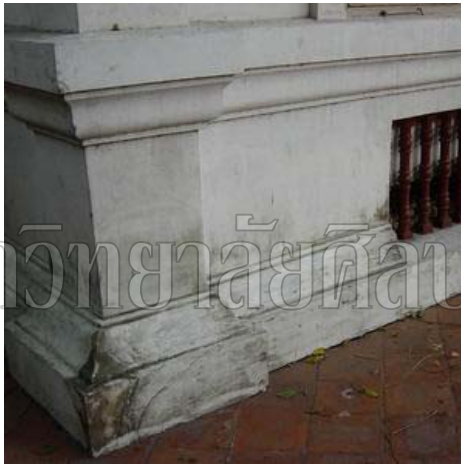
A broken decorated cement at the front elevation.

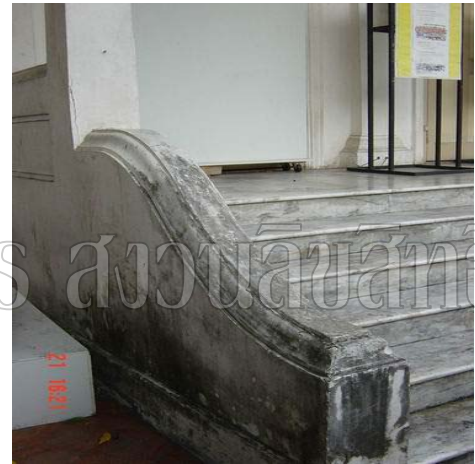
Fungus stains at the edge of the front stair.

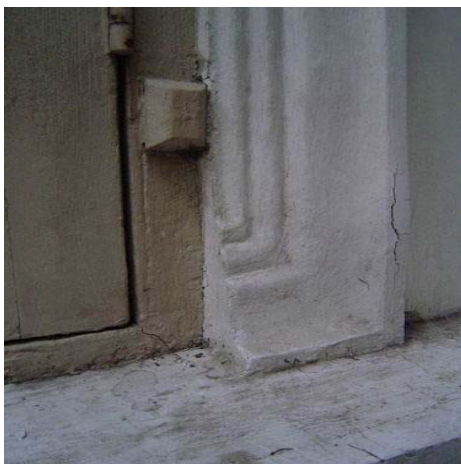
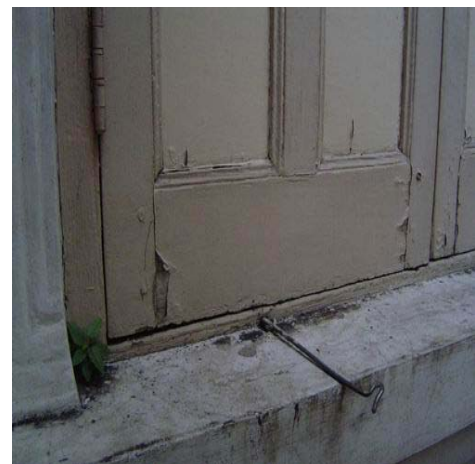
All the doors and windows are made of solid board woods decorated with plaster architrave. Conditions of three front doors are good but of windows are fair. Joints of the wooden window frames are cracked. Some plaster mould architrave swells and cracks from water percolated.

Figure 40 Wooden window and plaster architrave.

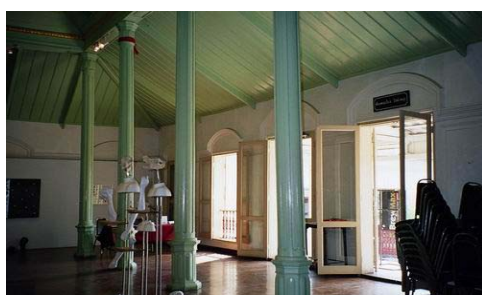
Entrance view

Figure 41 Thong Phra Rong's interior atmosphere.

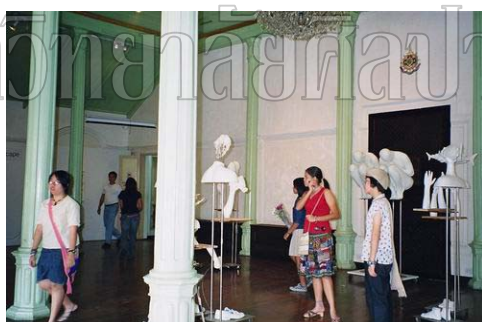
Rear elevation, far end door in the picture is used for connecting to Tamnak Klang.

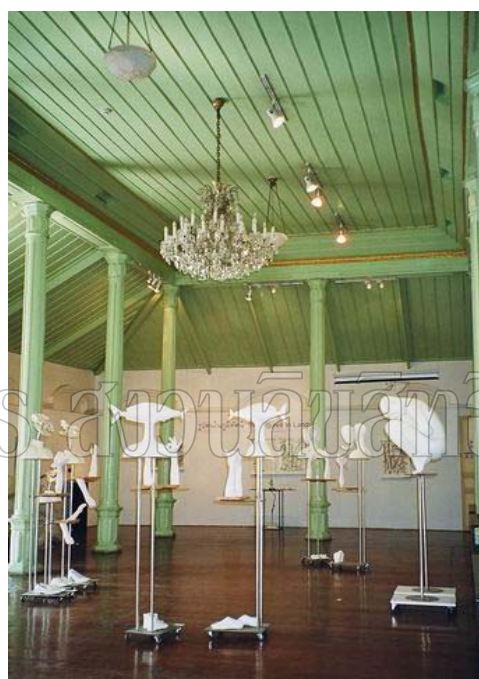
West -elevation view

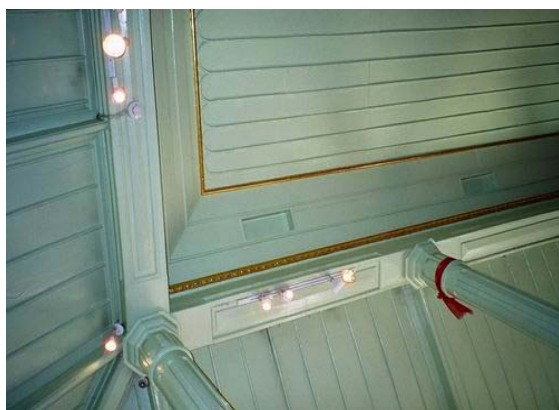
Figure 42 Thong Phra Rong's ceiling, covered with wood, decorated western style, installed track lighting and fire alarm.

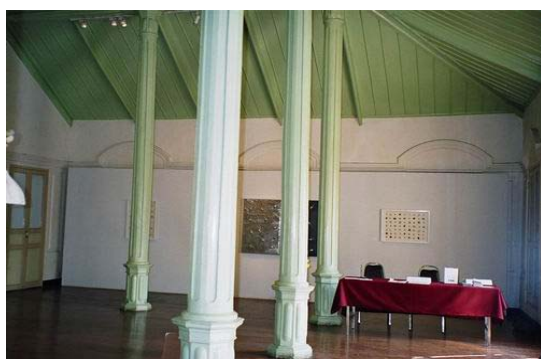
Cement wall decorated with plaster cornices, painted white. Its condition is fair, having slightly damage of color patches all around the walls. Cause of damage might stem from the quality of cement stucco in absorbing painted color or old age of the building. Both of the width-walls were attached with gypsum board boxes for exhibiting paintings. Although it is a good way in protecting old building fabric, it might decrease the esthetic value of the hall.

West elevation, decorated wall and windows were covered with gypsum board box for exhibiting paintings.

Figure 43 Interior wall of Thong Phra Rong.

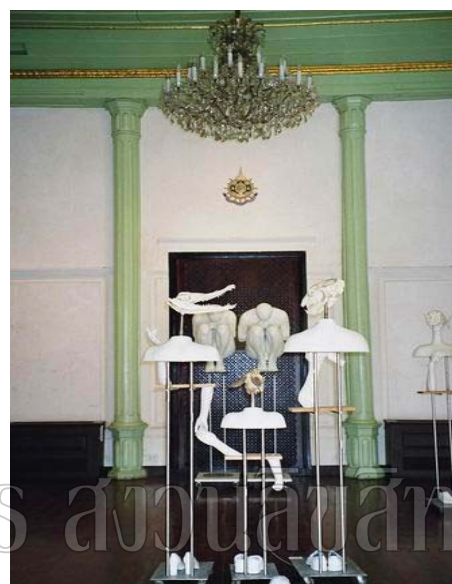
Rear elevation, showing wall decoration. Centre of the wall redecorated with openwork wood

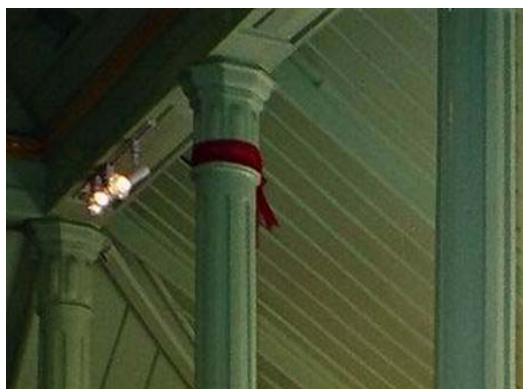
Columns are covering with carved wood in round shape. Having clear carved details and good condition.

Figure 44 Detail of column, this second column from the east has been believed that in the area where Krom Muen Jesadabordin, becoming King Rama the Third, regularly conducted works when he had been living in this palace.

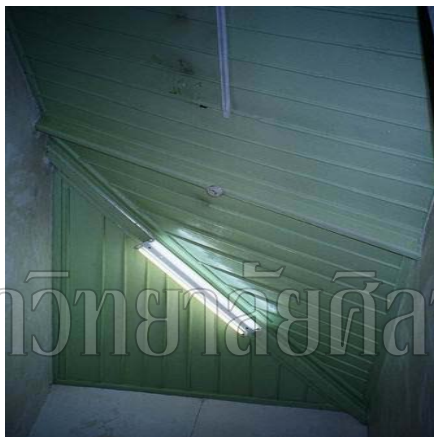
This room has inclined ceiling as a roof construction, decorated design and color are the same as the hall. Lighting and smoking detectors were installed. Condition of the ceiling is good, except some damage from installed track lighting.

Angled ceiling seen from east to west.

Figure 45 Ceiling of room no.2 , balcony behind Thong Phra Rong.

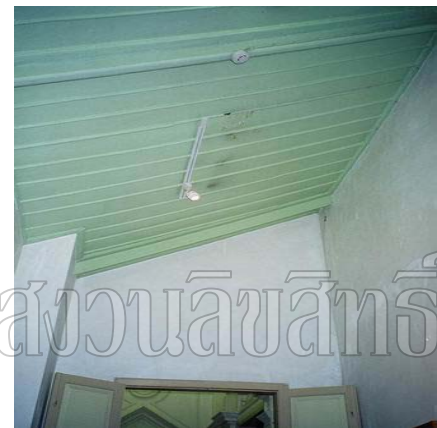
Angled ceiling over a connecting door to stair hall.

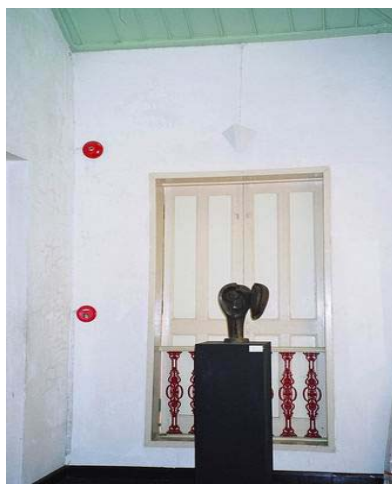
West elevation, having decorated light and fire alarms.

Figure 46 West room of the balcony behind Thong Phra Rong.

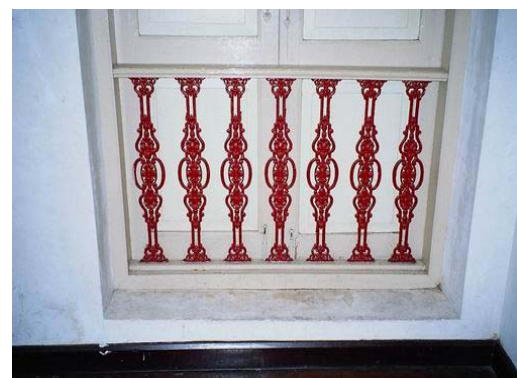
Cement wall is painted white color. Surface of the wall has color patches and discoloring. Near and below windows have brown stains of dry percolated rain.

Window at back wall has dry water stain.

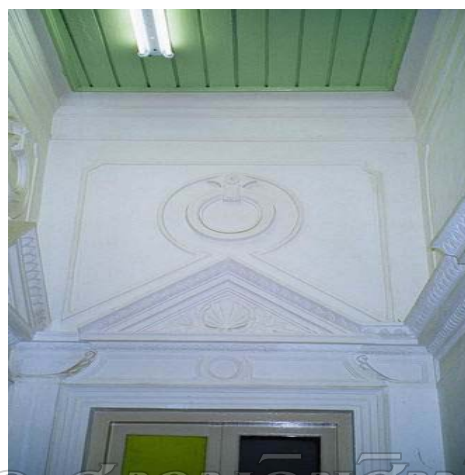
Wall decoration in European style, in the picture is the west elevation. Both of opposite walls have the same decoration.

Figure 47 Middle room of the balcony behind Thong Phra Rong, connecting room between Thong Phra Rong and Tamnak.

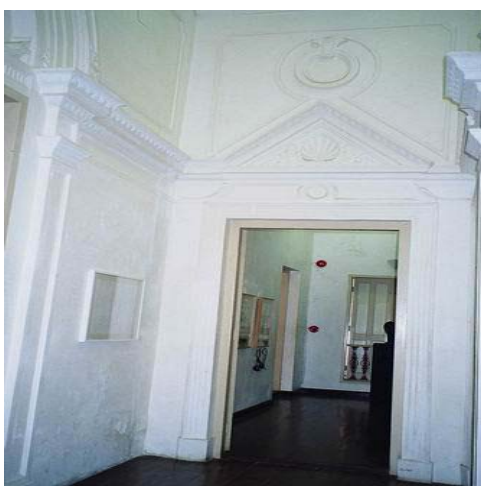
Condition of decoration works and overall materials in the room are good, except for lower parts of the walls. Its has jagged surface and discoloring.

Wall between room no.1 and room no.2, jagged surface and discolor wall can be seen at the lower part of the wall in this picture.

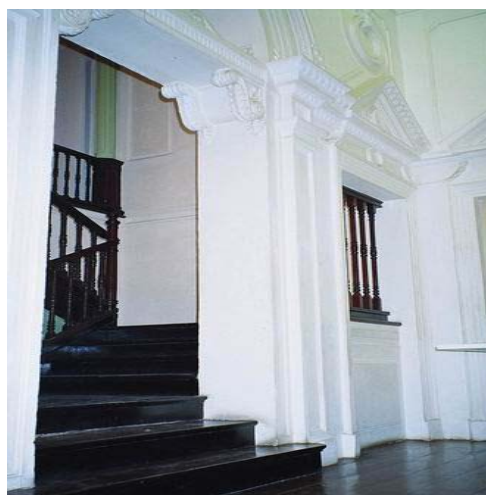
Connecting room between Thong Phra rong and Tamnak Klang (having stair case)

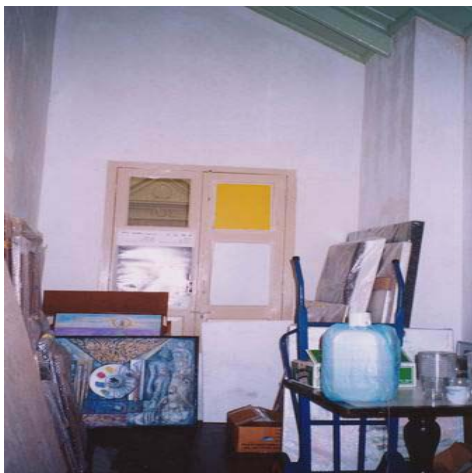
Inside the storage room, behind the door is the middle room. The glass panes of door have been covered with paper to hide view inside storage room but the paper was carelessly selected.

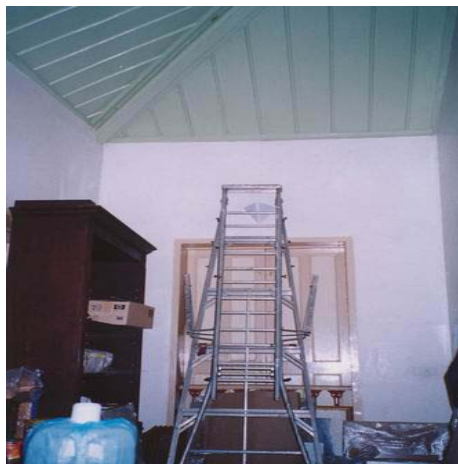
The existing condition of the room, see from inside the room to the east.

มหาวิทยาลัยศิลปากร สงวนศิลปกรรม
Figure 48 West room of the balcony behind Thong Phra Rong.

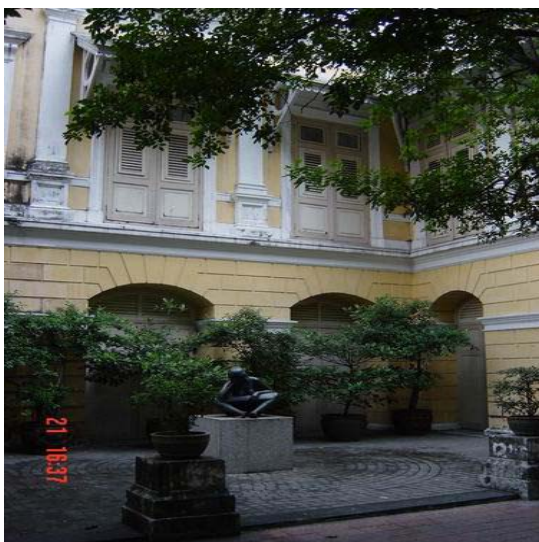
The architectural style of the building has been well conserved. Details and character of building are intact. Surrounding area was improved, particularly where showing to public. Anyway, deterioration of fabric has been occurred in some part of the building.

Brick-like pattern wall and arch doors of lower part of building are in good condition as well as plain wall with decorated columns and sun shades over the windows of the upper part.

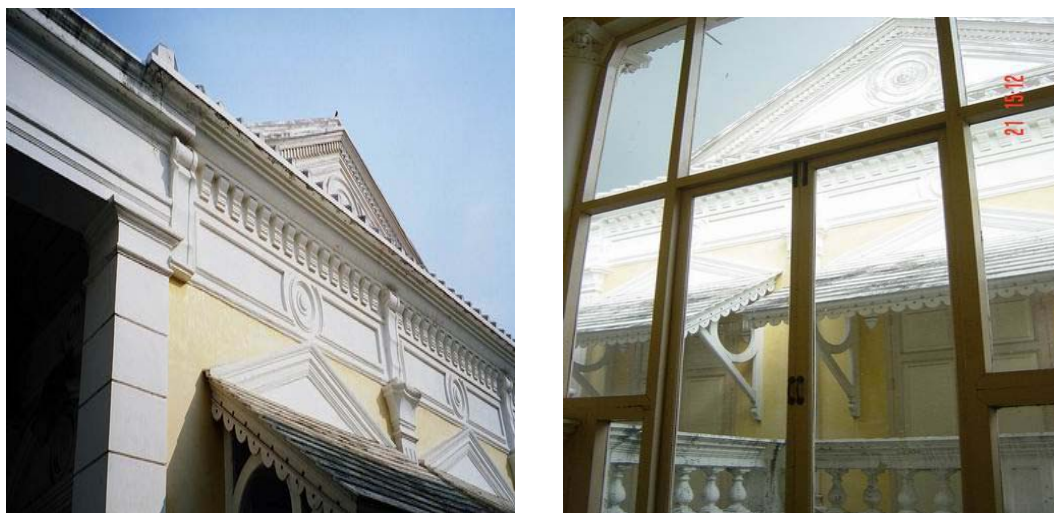
Figure 50 Gable roof with Western style ornament, view from the west.

European style roof and plaster moulds decoration, the significant character of Tamnak Klang building. The condition of plaster moulds is good but looked old and filthy with layer of color peeling and black stains of fungus. The damage was occurred by nature; heat from the sun and humid from raining.

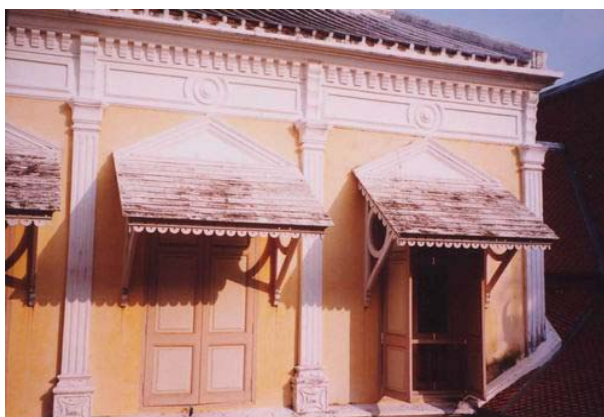
At the overlap roof between flat roof of terrace and main building's roof (see figure 4.18), plaster edge of flat roof has been cracked that might be the result of humid from rain and un-drain water above the connected roofs.

Figure 51 Upper wall of Tamnak Klang connected with Thong Phra Rong, view from Tamnak Pannarai.

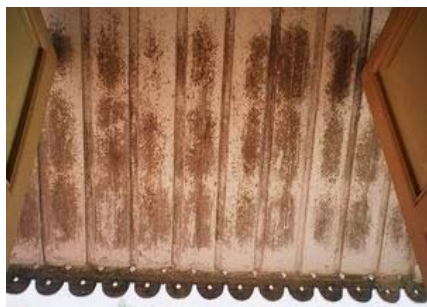
Condition of sunshades are quite bad in the part of wood covering. All of the wood covering has fungus stains on both sides, over and underneath. Wooden cantilevers and eaves are in good condition.

Picture of sunshade, view from inside the building. Below the sunshade, condition of the wood covering is bad, discolor and scattering of fungus stains, for instance.

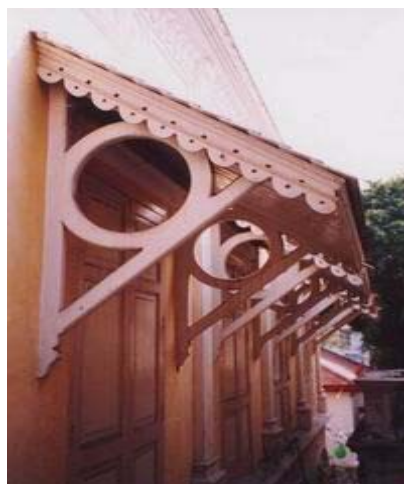
Sunshade over the upper floor window, view from the west. Condition of wood cantilever and eaves are good.

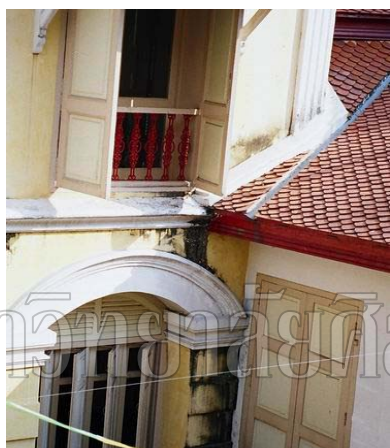
Connected part between Thong Phra Rong and Tamnak Klang, view from the west

Jointed wall between two buildings has serious damage from rain flow that caused stain of fungus and lichen, and humid inside the wall.

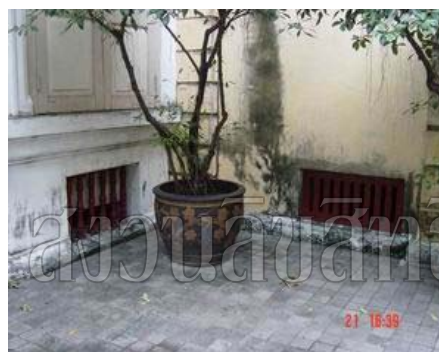
Connected walls, view from the east.

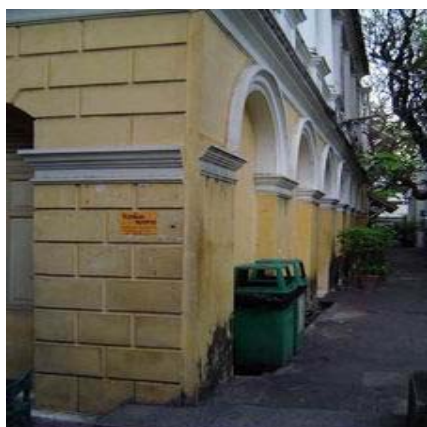
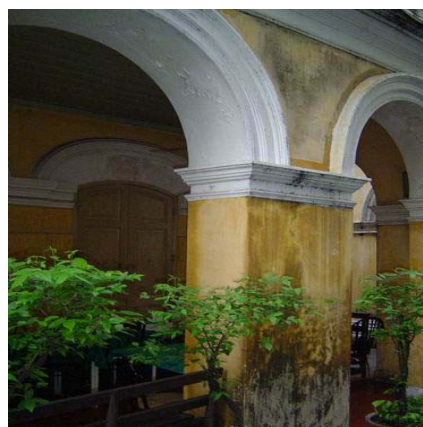
Back corridor of the building has been used for the gallery café at the present.

All the walls have huge damage of humid from rain and ground water. Apart from large stains of fungus and lichen, painted color of arch has been scratched.

Figure 52 Exterior deterioration of Tamnak Klang.

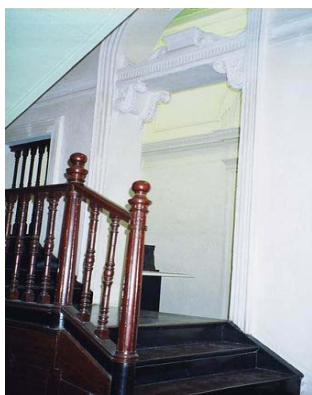
Plaster curved wall decoration, wooden stair rail and stairs are in good condition but the wall has painted discoloring. Wooden board floor and wall at ground floor have some deterioration.

Staircase, view to Thong Phra Rong's terrace

Figure 54 Physical existing condition of stair hall of Tamnak Klang.

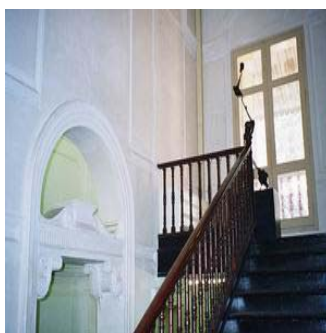
Stair case and walldcoration, view down from upstairs.

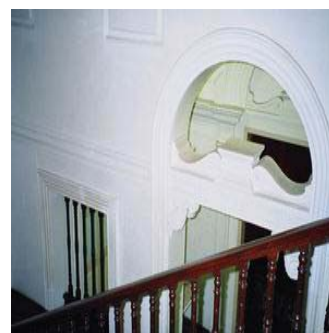
Stair case and wall decoration, view to upstairs.

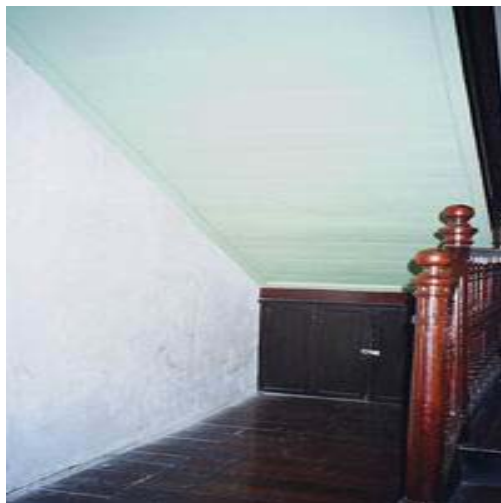
Wood floor and wall under the stair have cracking. Surface of wall is jagged and has powder (efflorescence). Its cause might come from humid from basement floor.

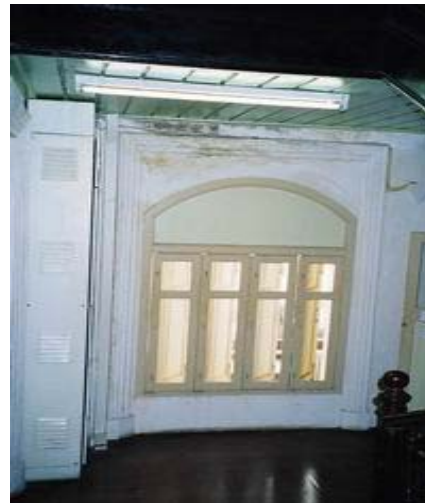
Wall opposite the stair has serious damage of rain penetration, it causes huge stains of fungus and lichen, and dirty brown patches of dried water. This problem needs urgent care because it might create worse effect to the electrical system, which installed in the main electrical circuit box near by.

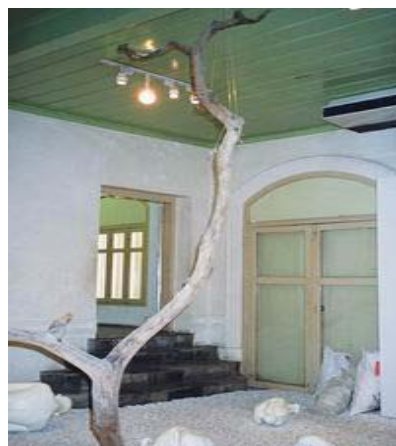
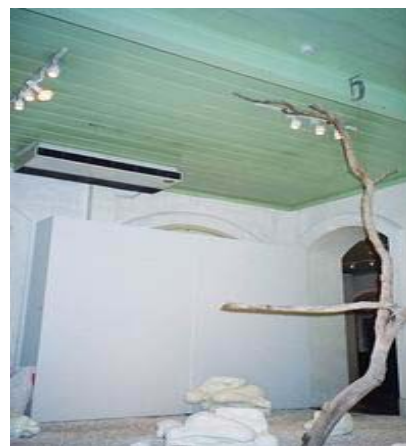
Wood board ceiling of room no.2 has been supported with an I-beam metal to strengthen the floor about. Some parts of wall have been covered with the gypsum board boxes for art exhibition function. Although, it has been done for the old fabric protection, it effects esthetic value of the room.

Figure 56 Room no.2 of basement floor (see number of room in plan) view to west elevation.

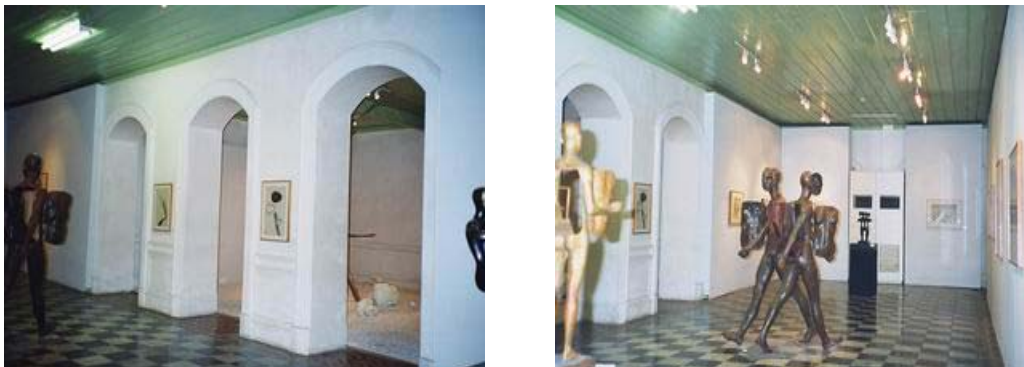
Figure 57 View of room no.3. The original decoration and materials remain such as arch void, marble floor and old style clay tiles border. Some parts of wall were attached with gypsum board wall. Electrical lights and facilities were installed. There are some cracks on the wall.

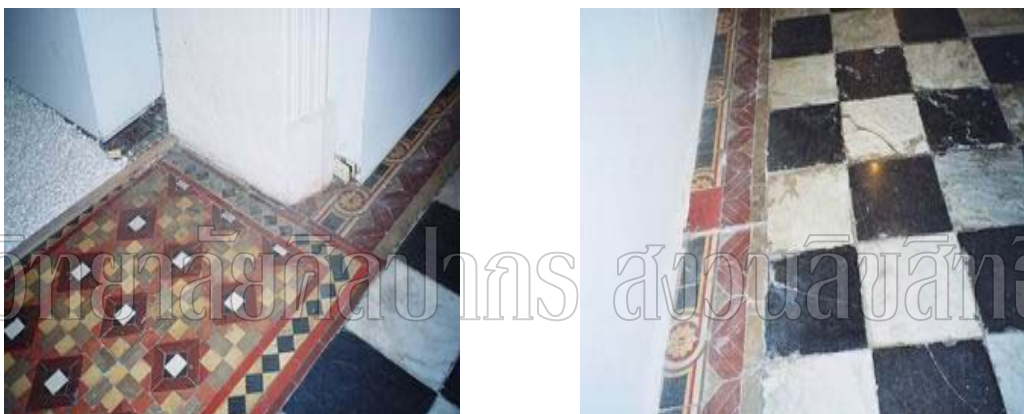
Figure 58 Detail of the old floor pattern in room no.3. In the picture terracotta tile has been replaced where the old tile lost. Those materials seem disunity, it should be replaced by other harmonious material or replica of the original.

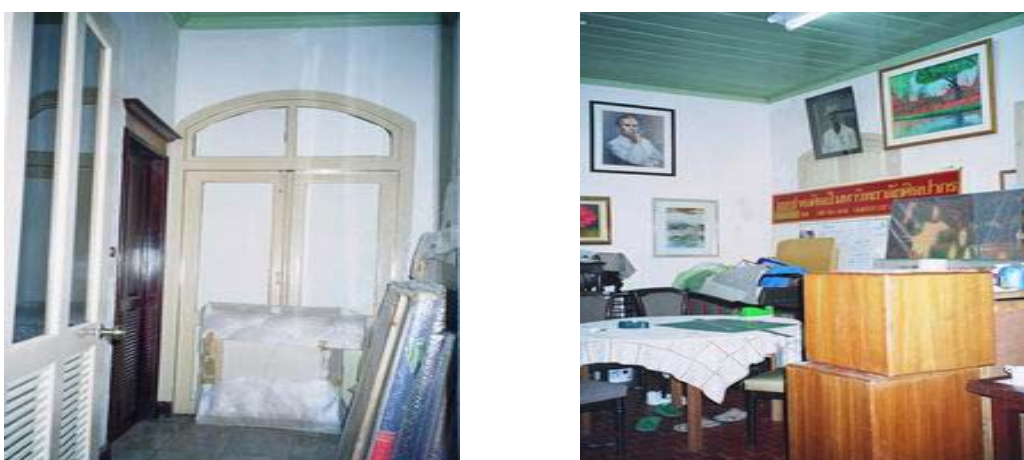
Figure 59 Room no. 4. East and middle sections have been used for an art collection storage room. West section is a staff room.

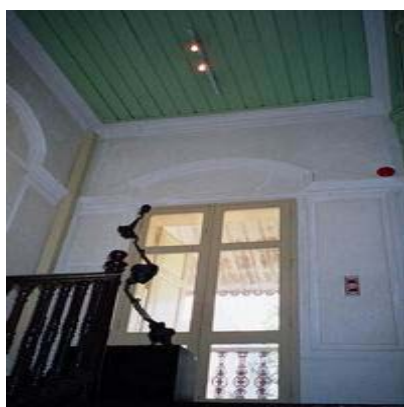
Stair hall, upper floor, electrical facilities and safety have been installed. At the wall has a prohibit sign asking for not taking a picture. Wall painted discolors and has stains of water, particular below the cornice. It must occur from leaking at the roof.

Figure 61 Interior design of upper floor of Tamnak Klang.

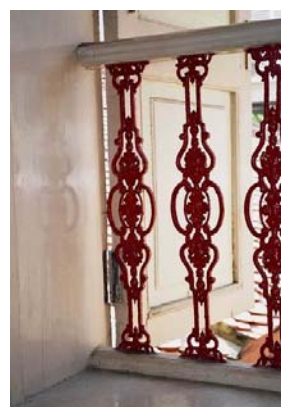
Design of railings is as same as in Thong Phra Rong. Overall condition is good. A little bit damages are stains of lichen and broken line on wood panel. Causes of damage are humid and rain striking from outside.

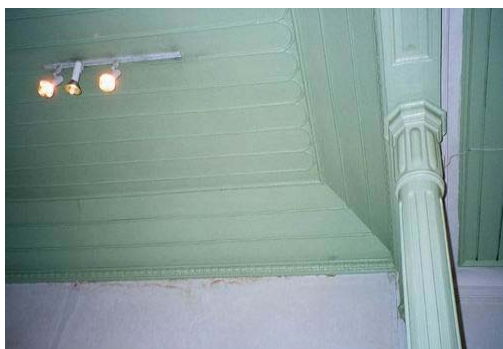
- ◀ Ceiling of upper floor hall (Room no. 5), area near stair hall in the east. The wall below ceiling has brown stains that indicate water leaking from the roof.

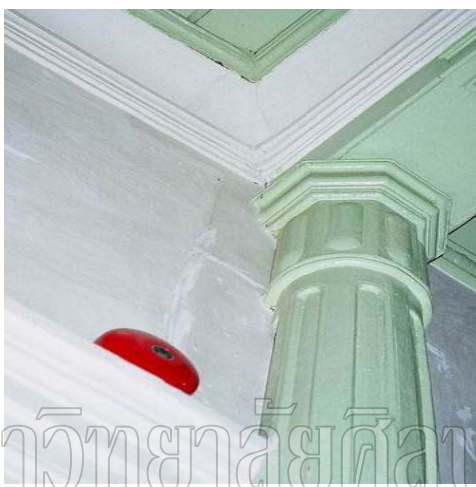
Wall opposite the staircase. Some spoiled conditions are cracks of the ceiling's wood boards and cornice, hairline cracks and color patches on the wall

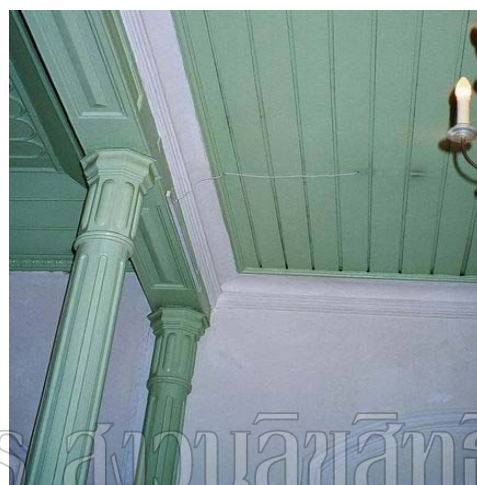
View from opposites the staircase. Design of columns and color are the same as Thong Phra Rong. In the picture shows inappropriate installation of the electrical wire.

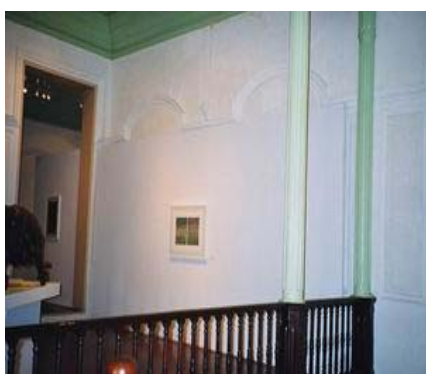
Hall, view from staircase to east elevation. Windows and wall decoration have been covered with temporary gypsum wall-boxes by intention to show wall decoration over the temporary wall.

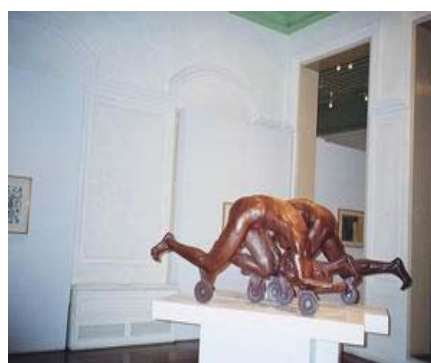
Figure 62 Existing condition of upper floor hall.

Hall, view to the West elevation and the room next to. Air condition was installed with harmonious design to the room. Archway to the room inside has square shape, different design from the basement archway.

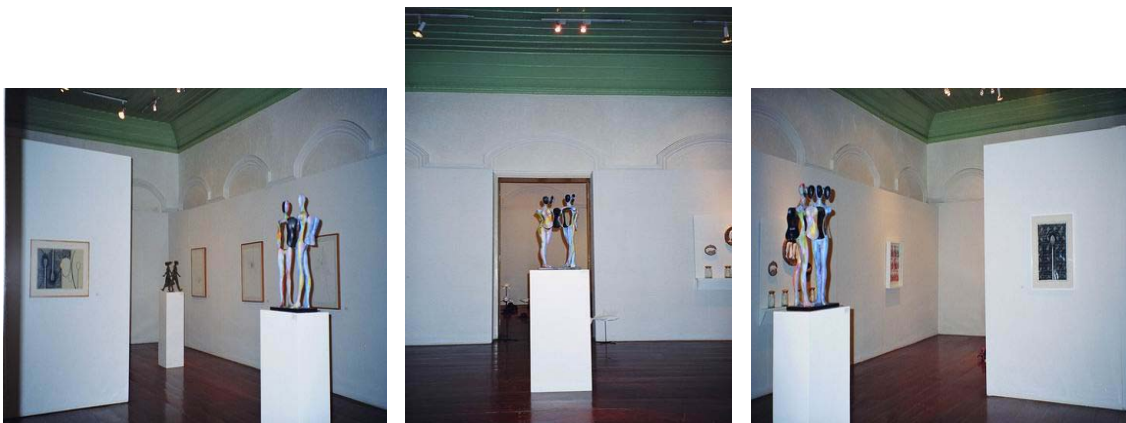
Room no. 6: view from the archway west side, middle and east side, respectively. Wood ceiling has new added light figures and fire safety equipment. The wall has been covered with temporary gypsum wall-boxes, only curves of arches and above are shown.

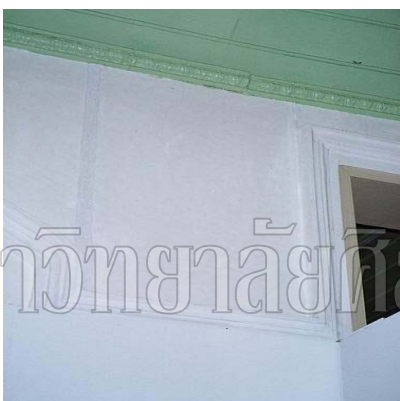
Figure 63 Existing condition of middle section of the upper floor (Room no.6).

Wall next to archway between hall (Room no.5) and Room no.6, cornice above archway had been broken and carelessly repaired. Wall painting shows sign of discoloring.

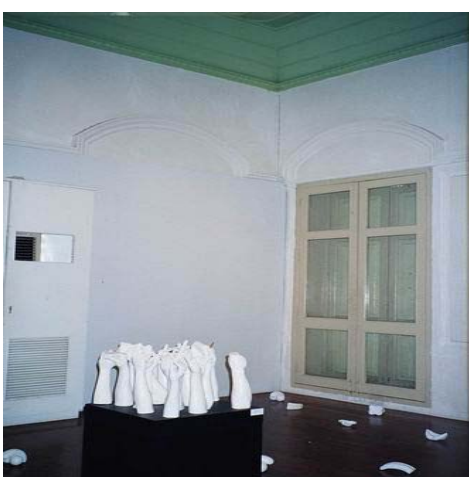
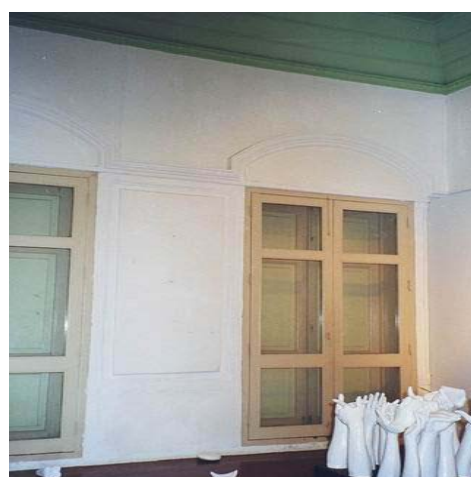
Figure 64 Existing condition of innermost section of the upper floor (Room no.7A).

Room no.7A: view to the back wall. Behind the back wall is the terrace connected to the west building, Tamnak Pannarai, by a platform. The first door from the west occasionally opens to allow visitors to the terrace. Design of room is similar to the other two rooms.

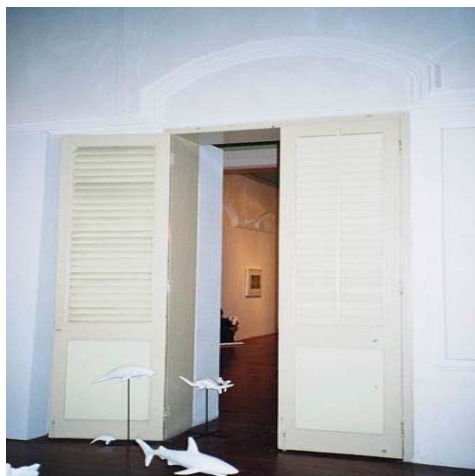
View from middle room (Room no.7B) to the hall.

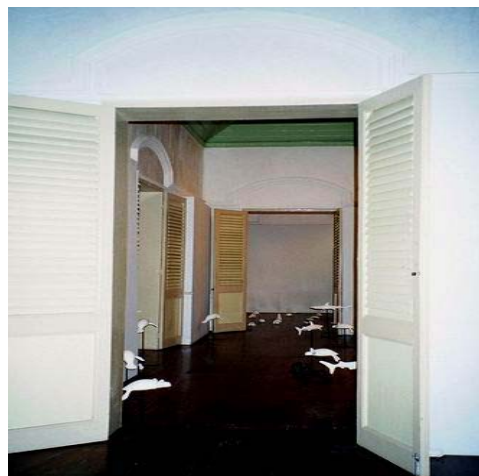
View from east room (Room no.7C) to the west room.

Figure 65 Existing condition of innermost section of the upper floor. The rooms in this section must used to be the private area of Prince Naris because each room has doors for making private space that different from the other section in this building. Connected doors have been opened only one set in each rooms, the rest have been closed and attached with temporary walls.

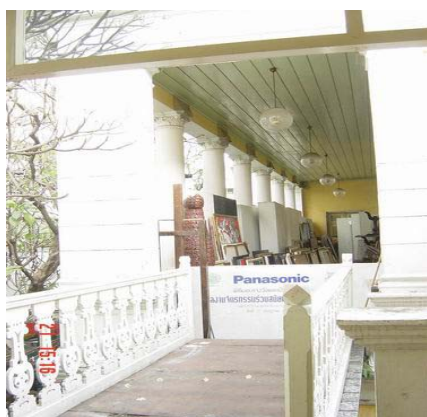
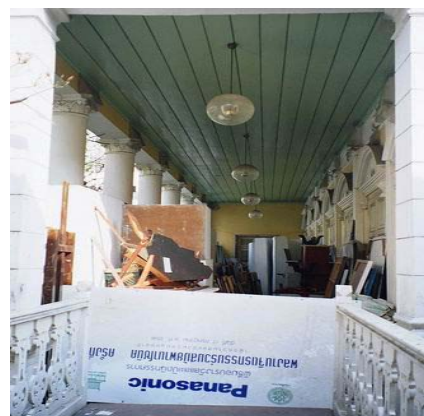
Figure 66 Tannak Klang's terrace view from Tannak Pannarai. The area has been closed and messy with arts pieces and miscellaneous things.
