**THE ARCHITECTURAL HERITAGE MANAGEMENT FOR WANG THA PHRA
AND WANG THANON NA PHRA LAN
: FROM THE PALACES OF BUILDERS AND CRAFTSMEN TO THE ART AND
CULTURAL CENTRE**

Architectural Heritage Management and Tourism

SILPAKORN UNIVERSITY

2003

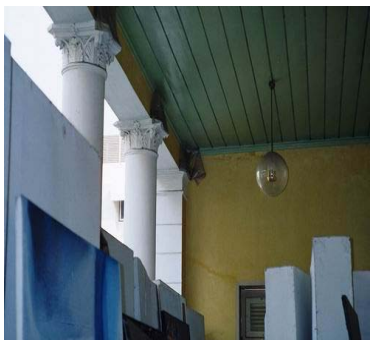
Easterly wall and European style columns; the wall has stains of water below the ceiling and beyond the upper corner of window. It indicates leaks on the roof and cracks in the wall. Moulding head columns have good condition.

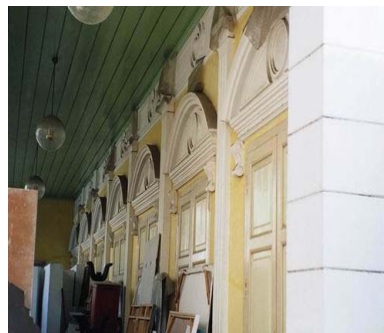
Elaborate moulding lintels have been left alone in the messy things and hide away from people 's view. Their condition, that able to see, are good, some parts still cover with plastic.

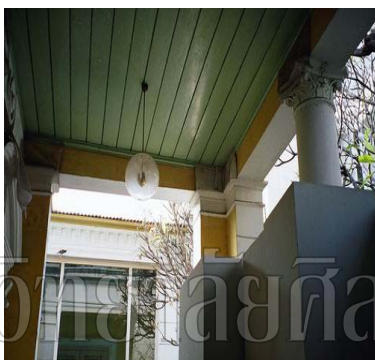
Westerly view of terrace, the far building in this picture is Tamnak Pannarai. Over each column and corner has pieces of plastic or hard paper covered. The reasoning is unable to investigate, may be neglected or protected something from being damaged.

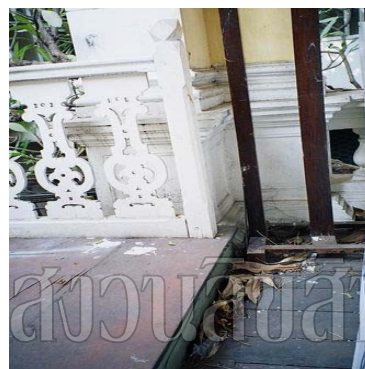
West-end of the terrace connects to Tamnak Pannarai by wooden platform. Sum of dry leaves and sticks indicates negligence take care. Wood boards floor of terrace looks old and dirty as well as floor of platform. Floor of the platform may be leaked, hence covered with plywood.

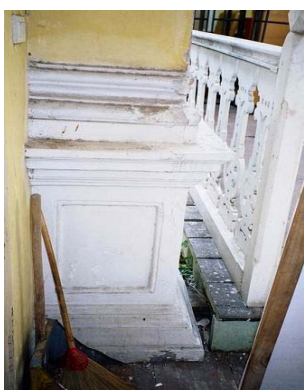
West-end of the terrace; condition of this square column is bad. Edge of column and plaster mouldings decayed and lost. Rain and humid penetrated into the mortar stucco.

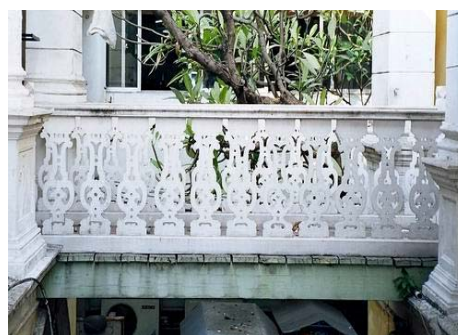
Figure 67 Existing condition of upper terrace of Tamnak Klang.

Platform connecting Tamnak Klang and Tamnak Pannarai; design of wooden curved bars is similar to the metal bars of window rails. Detail of wooden bars is clearly seen. Wood boards floor and construction looks old and rotten.

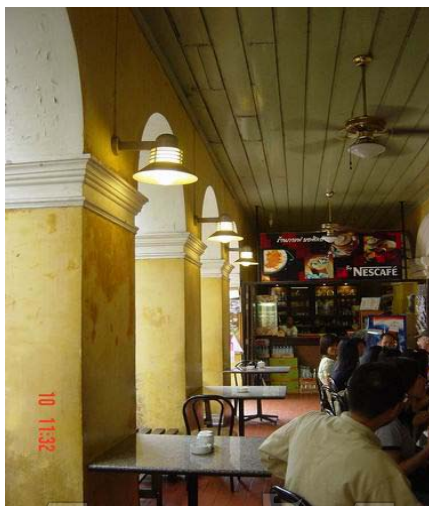
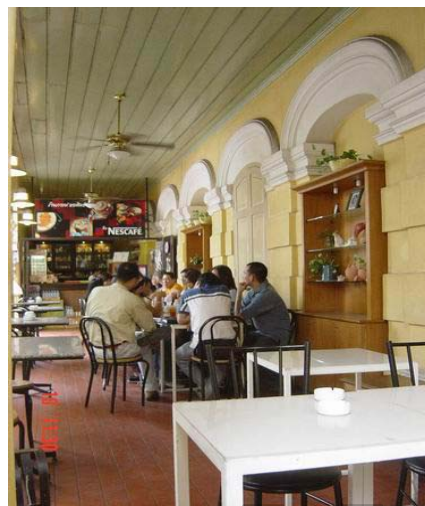
The old corridor turned to be the café gallery, view to the east elevation. The old decoration of building has been conserved, while new facilities and materials were added up such as wall lamps, ceiling fans and lighting, coffee table sets, etc.

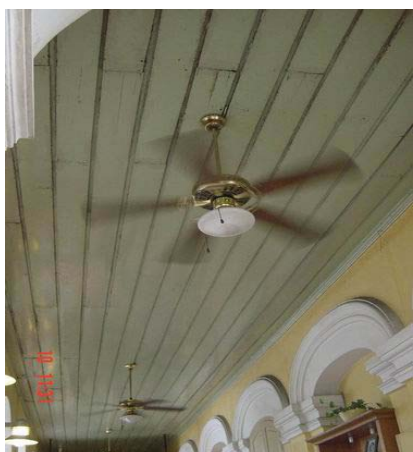
Wood boards ceiling are cracking and staining with fungus. Walls below ceiling have stains of dry water and discoloring.

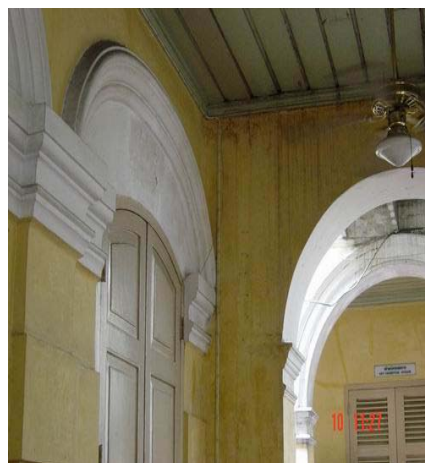
Figure 68 Existing condition of the back corridor (the café gallery).

The West of the room has serious damages of wall and wood ceiling. Large brown stains on the wall below ceiling, fungus stains and peeling color on ceiling, for instance. Major cause of the damage is leaks from the upper terrace.

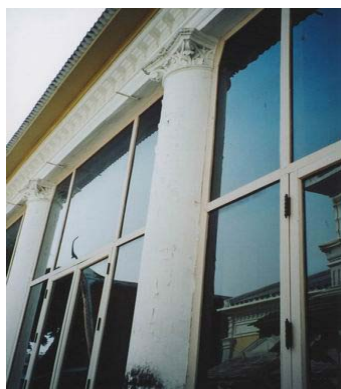
Front of building, decorated with European style plaster moulds. Form and head of column is similar to Tamnak Klang. Between columns added with glass panels and windows.

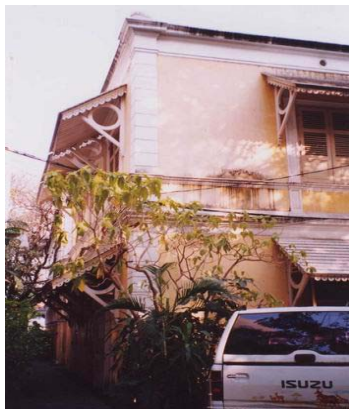
View of Northwestern corner and west elevation of the building. Deteriorated fabric clearly seen, especially on the wall of closed terrace where there is no sunshade.

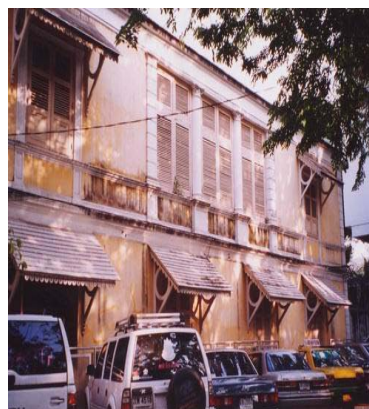
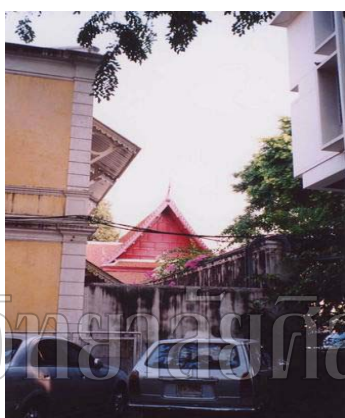
View of west elevation; A disturbing vision of the heritage place, disorder electrical wires, dirty stains on fabric of buildings, for instance.

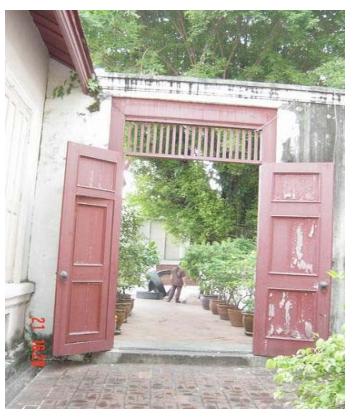
The only one left red old door and the residential area wall, view from inner court to the front of palace. Condition of wall is bad. Its materials are full of cracks and gigantic fungus stains. Condition of wood frames and panels of the old door is quite good except for color scratches and patches.

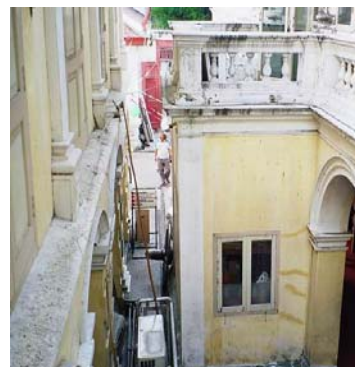
Deterioration of Pannarai building shows clearly. Cracks of walls and stains of fungus and lichen are the major damage of this building. In this picture shows spots of bird's waste on the edge of Tamnak Klang. It is one of many causes of the building deterioration

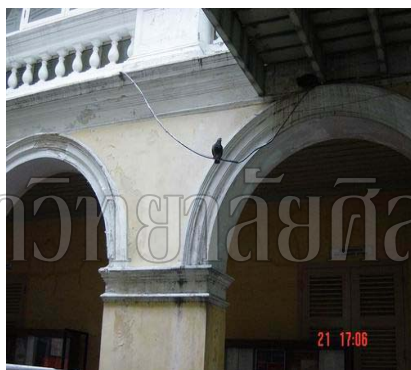
View of the front of Pannarai building under the platform. The plaster arch has been decayed and lost. Disorder main electrical wire has been left carelessly.

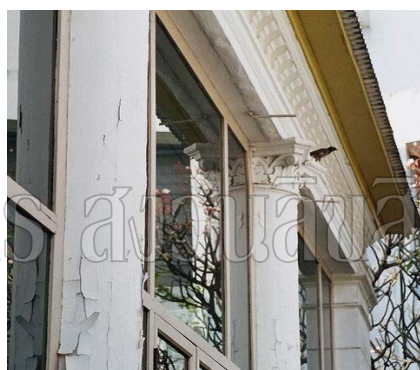
Columns on the upper floor terrace views from balcony. Columns' color painted scratch and peeled.

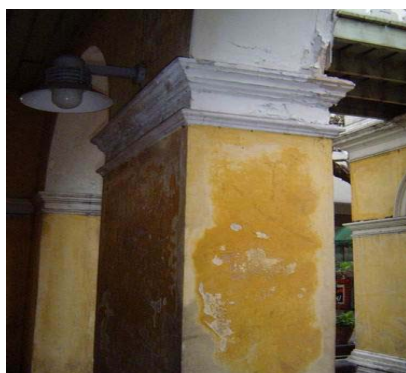
Arch wall of corridor, front of the building, the edge of cement wall and plaster moulding decays. Wall painted discolors and scratches.

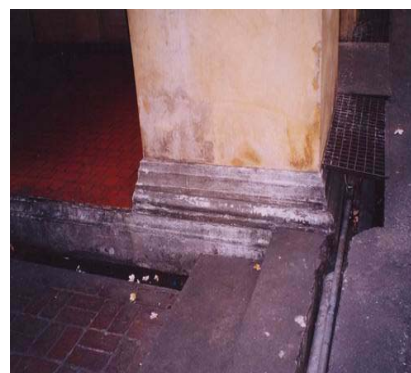
Figure 71 Existing condition of Tamnak Pannarai.

Base of building views from the front. Front and north side of the building has water drains. In the front drain has water in spite of not raining. It indicates drain problem. Base of arch wall and outside cement pavement decay.

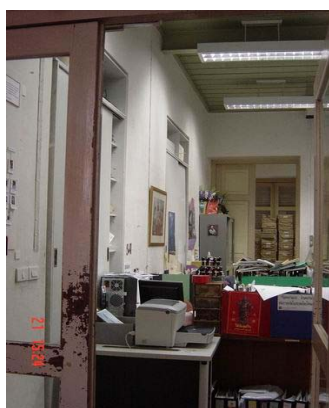
The art gallery's office, view from the door. Connecting doors between rooms have been closed and redesigned to be storage cabinet.

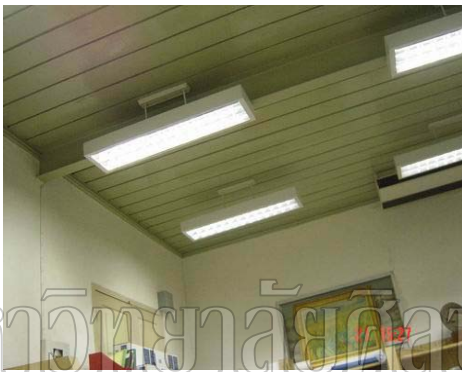
In the office (Room no.1). Show metal I-beam at ceiling.

Ground floor of this building was adapted to use for the art gallery's office, art shop and Silpakorn University Alumni. Some built-in furniture was added as well as facilities such as air-conditions, electrical equipment, etc. Metal I-beams were added to strengthen upper floor construction.

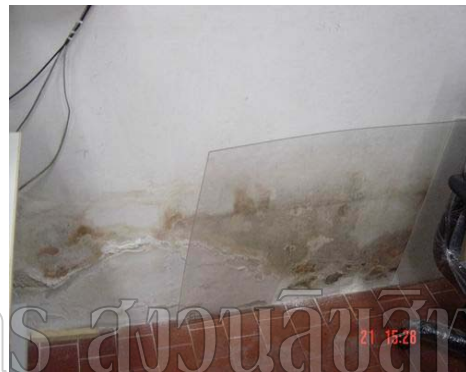
Deterioration of wall in Room no.1, wall stucco cracked and lost. has brown stains of dried water, and powder.

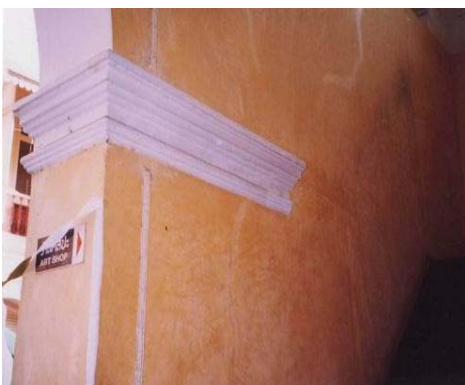
Figure 74 Existing condition of Tamnak Pannarai.

Staircase wall, view from ground floor. Condition of wall painted is bad. Discolor and color patches are clearly seen. Design of direction signs is out of date and uninterested.

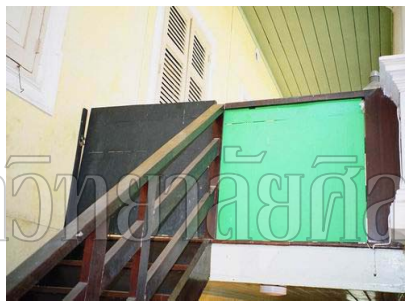
Figure 76 Existing condition of the upper floor of Tamnak Pannarai.

Poor condition of door, View from staircase to upper floor

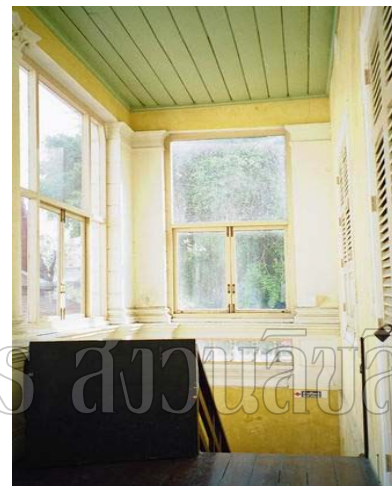
Staircase hall , view from upper floor.
There is a paper direction sign on the wall, but it is old and uninteresting.

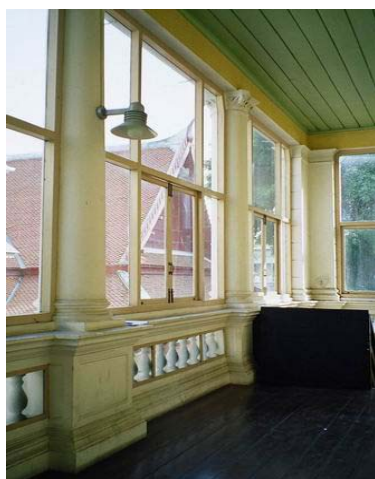
Upper floor terrace, view to staircase. Glass panels and windows have been added for function with harmonious design to the old building.

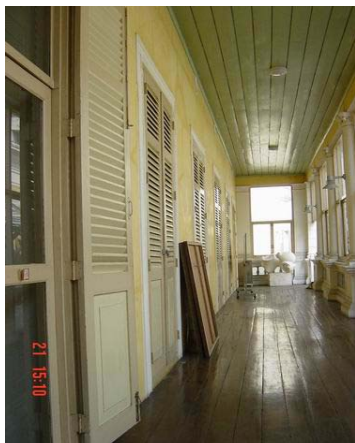
Figure 77 Existing condition of the upper floor of Tamnak Pannarai.

Terrace view from staircase. Overall condition is satisfactory.

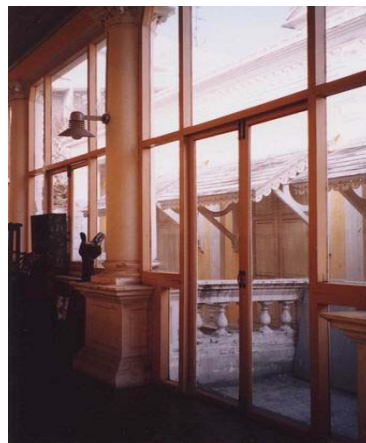
Upper floor balcony has been abandon in bad condition.

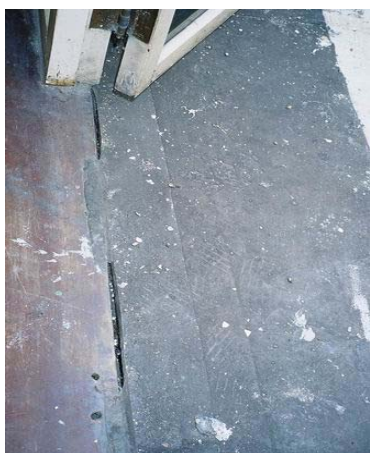
Floor at the door opened to balcony, cracks between rubber sheet and wood floor is a result of raining water leaking into the building.

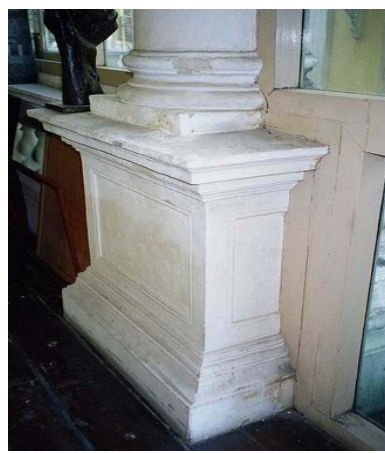
Base of column, view from the door opened to balcony. It has bad condition some part broke and lost.

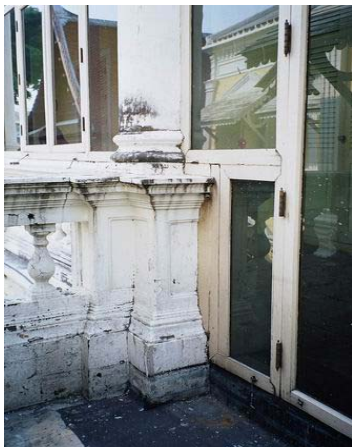
Figure 78 Existing condition of the upper floor of Tamnak Pannarai.

The balcony has bad condition of color scratch and peel. It dirties with fungus stains and waste from birds.

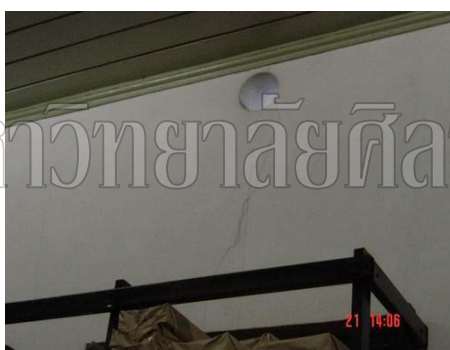
Figure 79 Existing condition of the upper floor of Tamnak Pannarai.

Back wall of storage room behind Room no.4. There are many long hairline cracks on the wall. This problem also happens to the others rooms.

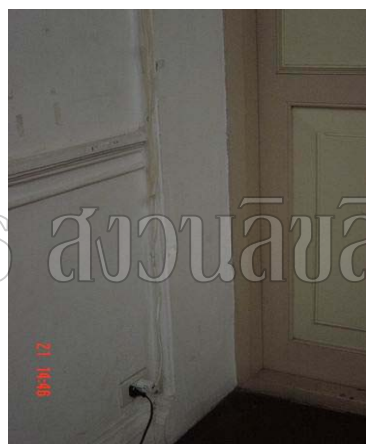
View from inside middle room. The upper floor rooms in this building have poor electrical wire installation and inconvenient uses.

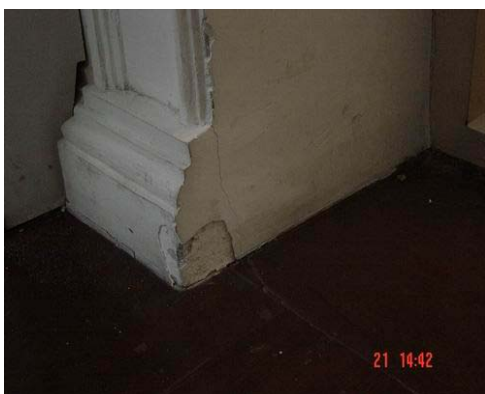
Plaster architrave cracked and scratched, view from the middle room.

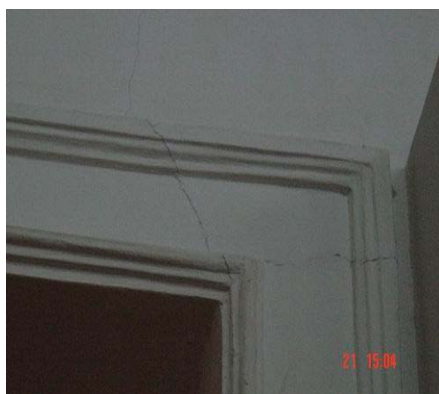
Corner of plaster architrave cracked, view from the middle room.

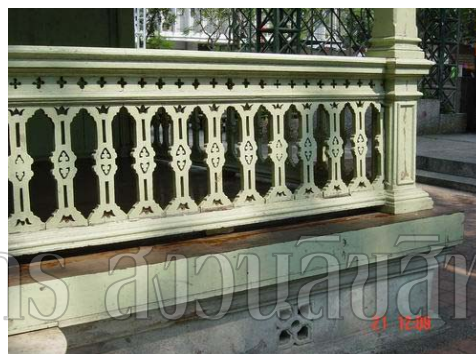
Figure 81 Existing condition of the music paviloin in Suan Kaew.

Wood fretwork fence around the pavilion, view from the west side. Condition of wood fence is good. But wood floor and cement base have some damages.

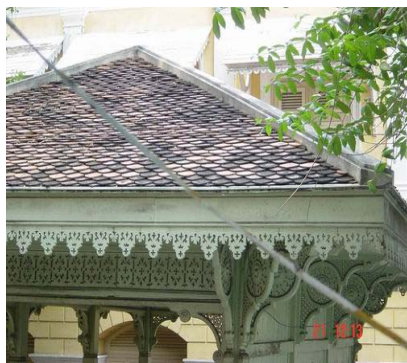
Figure 82 Existing condition of the music pavilion in Suan Kaew.

Roof of the pavilion view from the east back. Backed clay roof tiles seem old and decayed, it should be investigated.

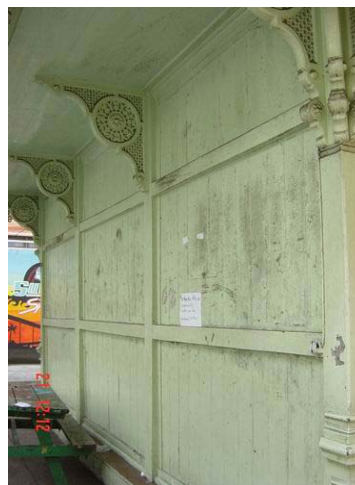
The rare panel view from behind the pavilion. Both sides of board wood panel are full of fungus stains. Color painted scratches and peels. And having inappropriate treat like stick up a notice.

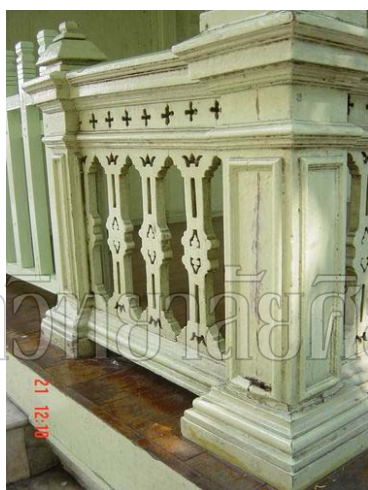
A front column of the pavilion view from the west. This column is in bad condition, wood panel and border are moulded and rotten, it might have insects in side the wood board.

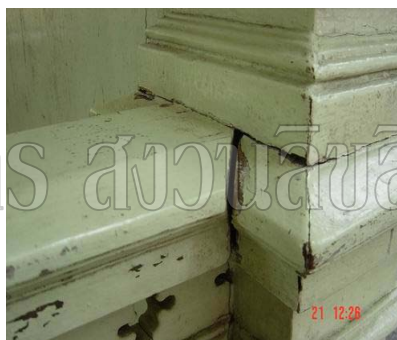
Cracks of wood joints view from the east back column.

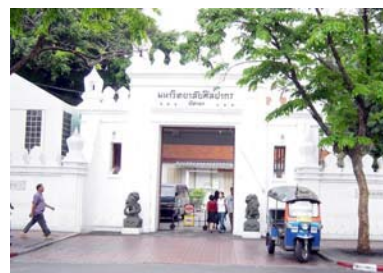
A crenellated wall and front gate are in good condition and of significance design and character. Along the wall, has occasionally been attached with some cloth hangings or the university's announcement plates. Those attached labels may be acceptable because they do not block the significant design and damage fabrics of the wall but it should be arranged in order by fashion.

Figure 83 A crenellated wall and front gate view from in front of the university.

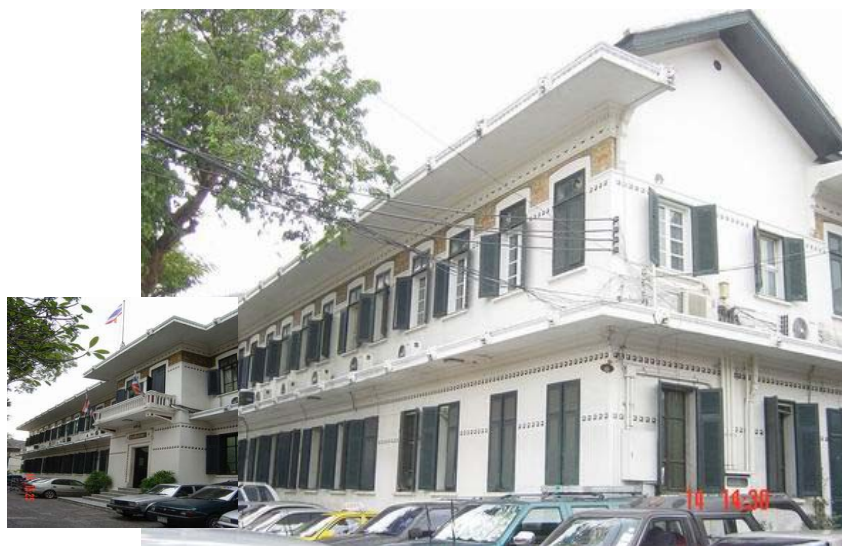
Figure 84 The Department of Fine Arts's building, view from the north. Significant design of the building remains. However, elegance of the building is decreased because of messing electrical wires and air condition equipment.

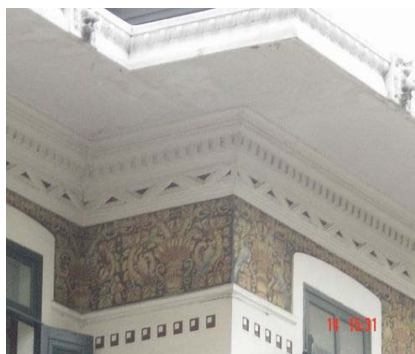
Figure 85 The significant decoration details of the building.

View of decoration details on the upper part of the front elevation. Exquisite fresco painting, graphic plaster moulds, and lion faces at the edge of sunshade are in good condition and clear features.

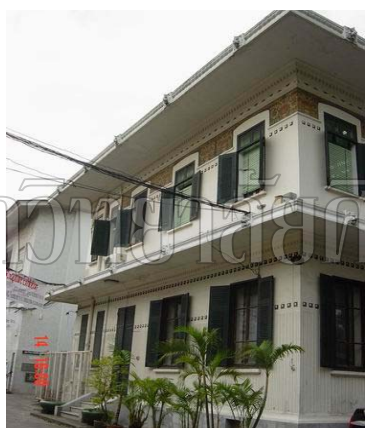
South elevation, opposite Professor Silpa Bhirasri's Museum.

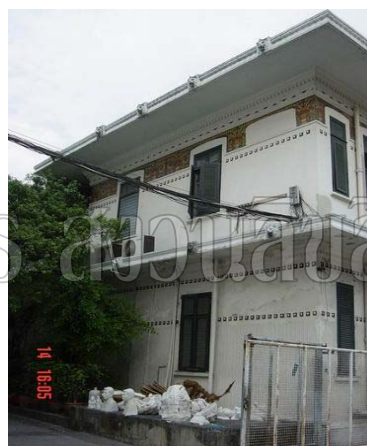
Back of the building near the gate between the Department and Silpakorn University

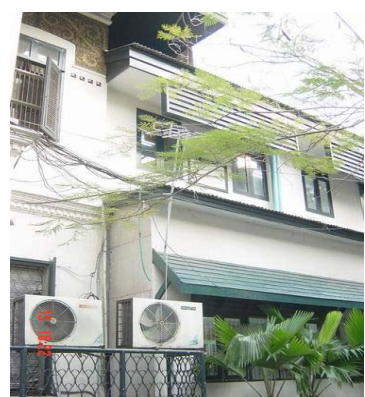
Back of the building, north wing, views inside Silpakorn university. This north wing close to the building of Faculty of Fine Arts, Sculpture and Printing

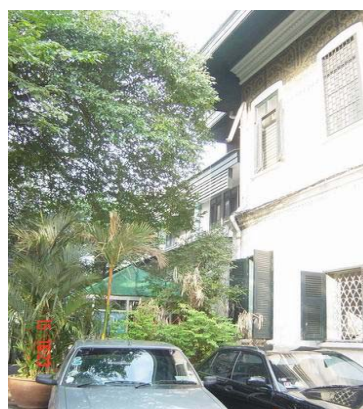
Back of the building, show the added rooms, which decrease aesthetic value of the building.

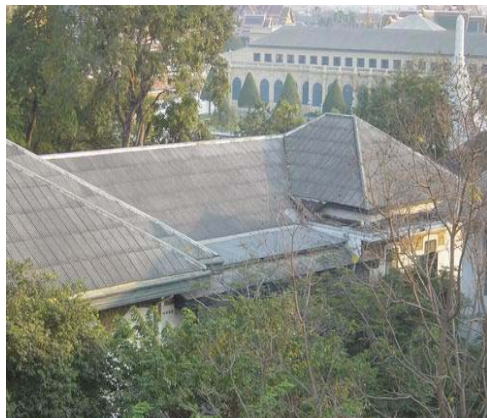
Roof of the Department's office building view from the sixth floor of the faculty of Architecture's building. Joint between roof might have some leaking problem, due to having zinc sheets cover. Added roof over terrace can be identified.

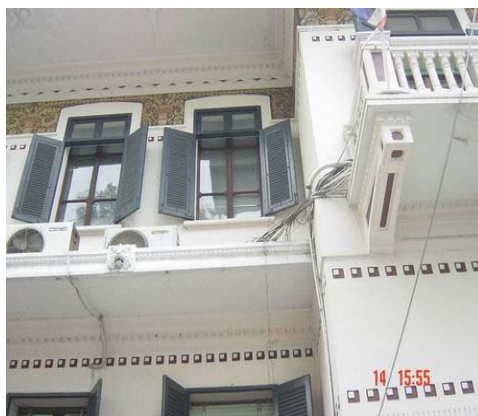
View of front elevation. Varied designs of new added glass windows discourage the beauty of the building.

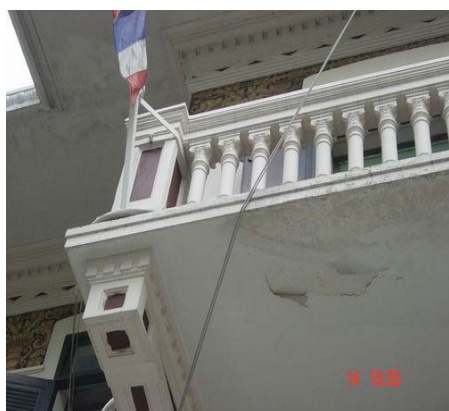
View of front elevation. Under the balcony and sunshade has deterioration of cement stucco caused by rain and may be water leaking on the top of sunshade.

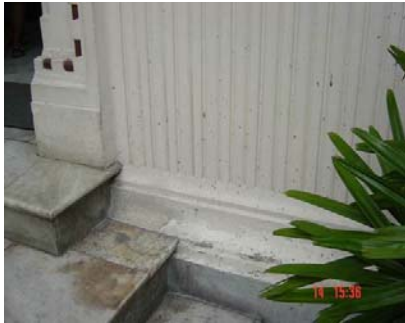
Marble stair in front of the building, has brown stain and dirty surface.

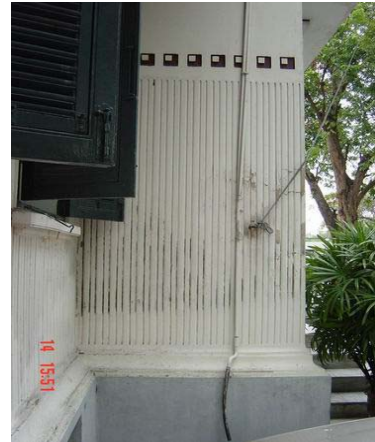
Many parts of the front wall discolor and stain with fungus and wet water. Color painted scratches and peels.

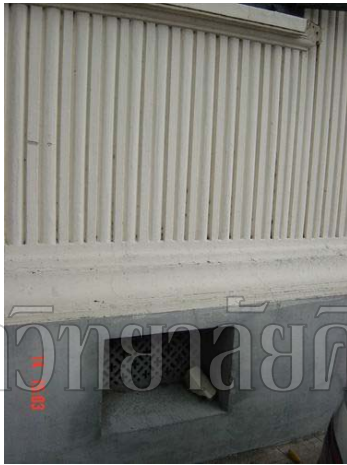
View of front elevation. Damage of wall and window-sill, Window-sills in the pictures seriously damaged, its color scratched and peeled to show lime mortar inside.

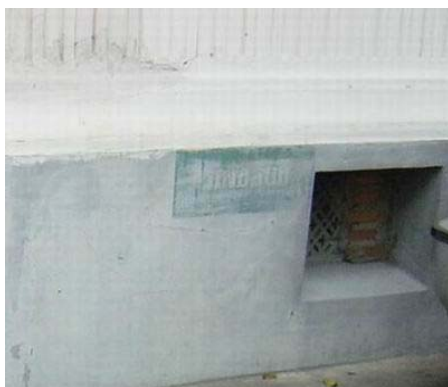
Inappropriate treats to the old building : color screened and ventilation covered. (efflorescence effect).

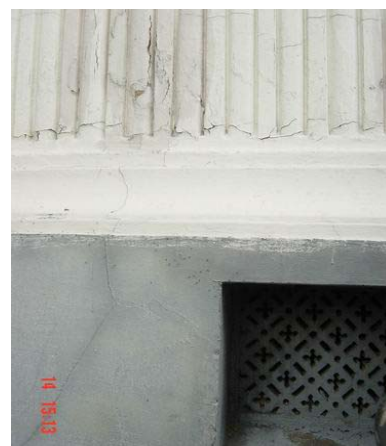
Hair line cracks on the wall, discolor and having powder on the base of building.

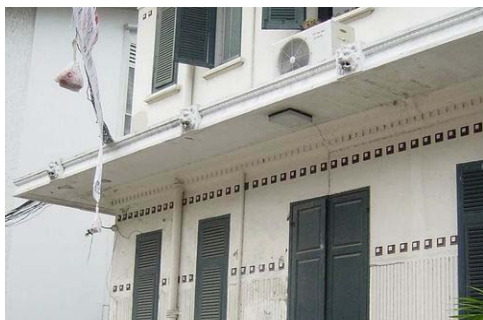
South elevation of the building, lower part wall has bad condition. Cement stucco cracks and exposes. Some parts of plaster decoration lost and has salt powder. Beneath the sunshade has bad condition too. Wall around the end of main pile decay.

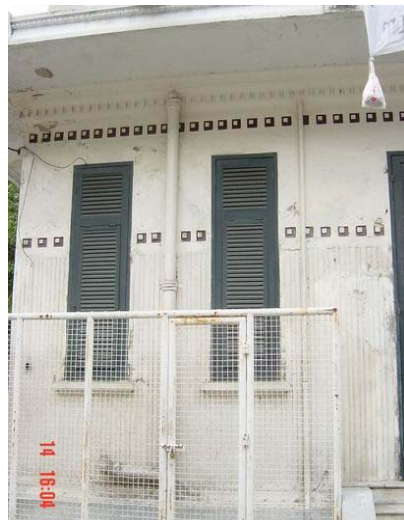
South elevation of the building, upper sunshade has problem of water penetrated, and lion faces rain drains show sign of decays.

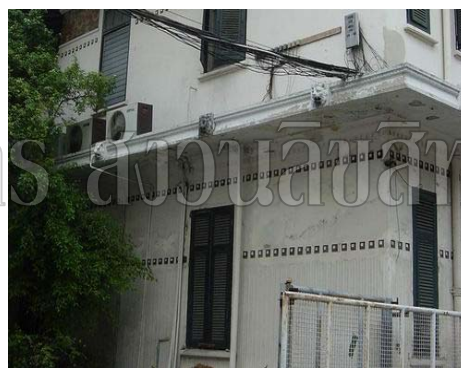
Back of the building, the south side, wall and sunshade are in bad condition.

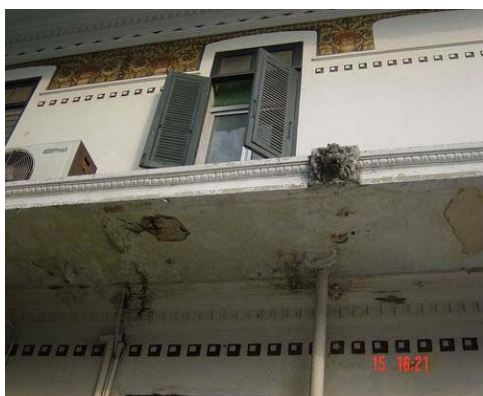
Back of the building show serious damages of wall and sunshade. Some significant decoration lost.

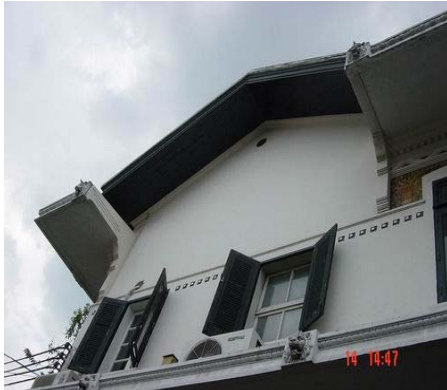
North side of the building has different form of roof and upper sunshade from the south side.

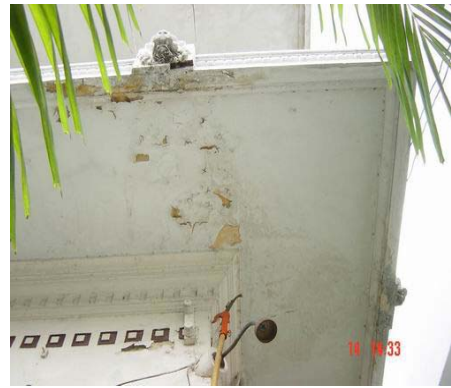
Lower sunshade view north back of the building. Condition of sunshade and wall are bad.

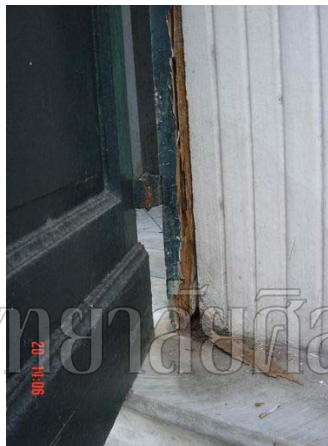
Sub-entrance door on the north side. Door frame cracked and broke in big pieces.

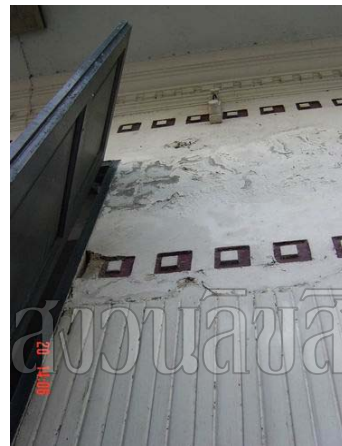
Wall around the upper part of the door. Wall has bad condition such as cracks, exposed cement surface, fungus stains and salt powder.

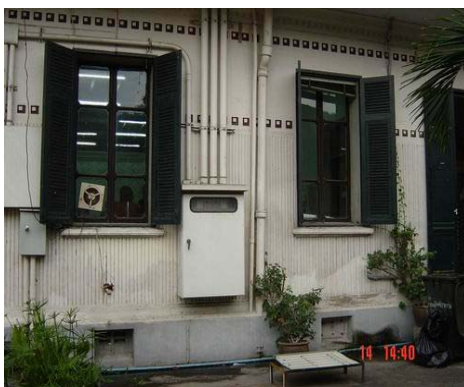
First floor wall in the north side, some electrical equipment was disorder installed. New material was added carelessly, cement block fixed ventilation void at base of building.

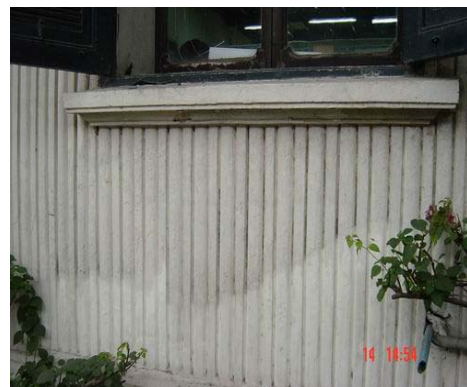
Large water stain on the wall, view from north side of the building

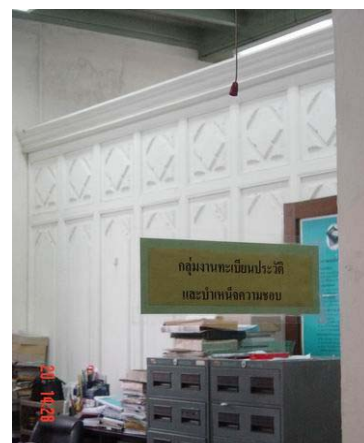
Decorated wood partition in side the room. Cement wall has stains of damp.

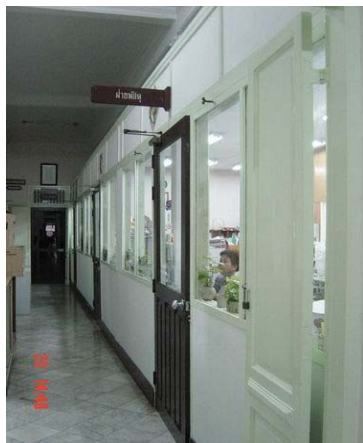
Added office rooms built with light construction. Has gap between ceiling and room partition.

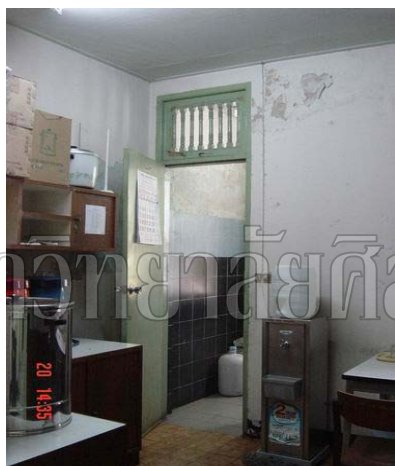
Pantry: the old door remains while new materials were added to wall and floor. Wall has damage of color painted peels and water stains

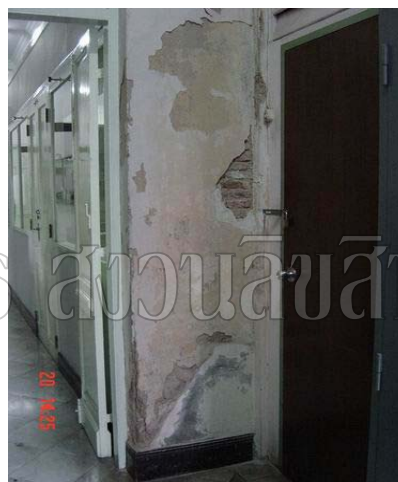
Wall near storage room view from north sub entrance door. Condition of wall is extremely bad. Cement stucco cracked and broke to show bricks construction inside. All the color peeled and has stain of fungus.

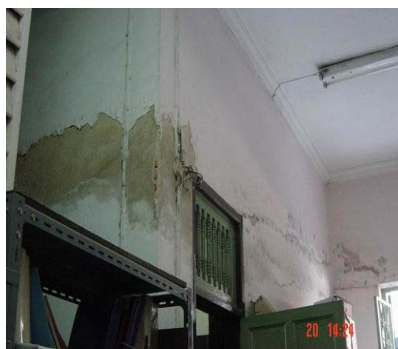
Outside wall of the rest room has bad condition of color peels and stains of fungus.

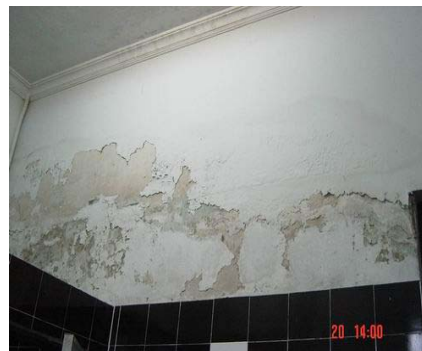
Wall inside lady rest room has damages of painted scratches and peels caused by humid.

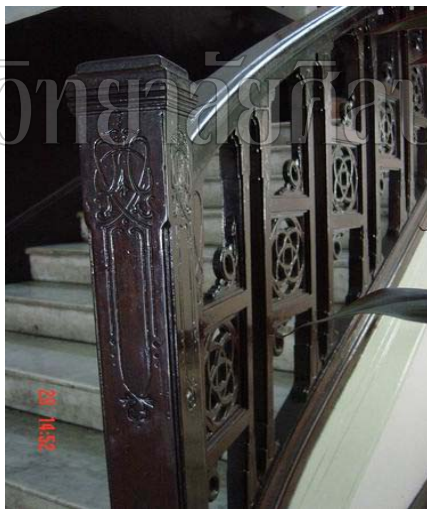
Detail of stair rail, sweet pattern of wood engraved and fretwork

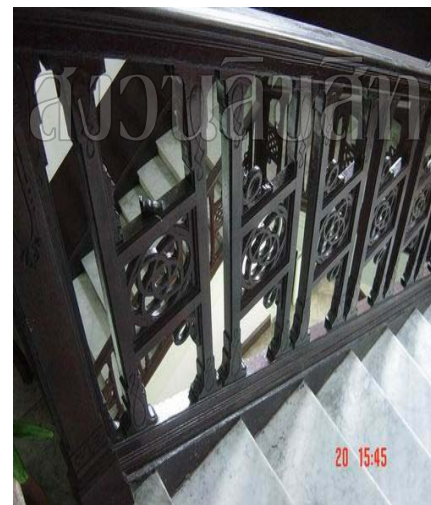
Some detail of wooden rail bar broke and lost

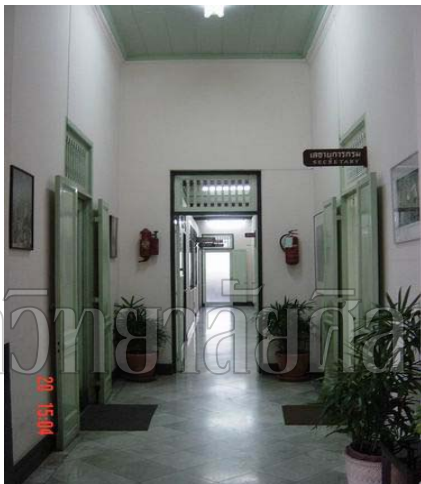
North corridor to the director room in the far end. First room in the east is a gentleman rest room.

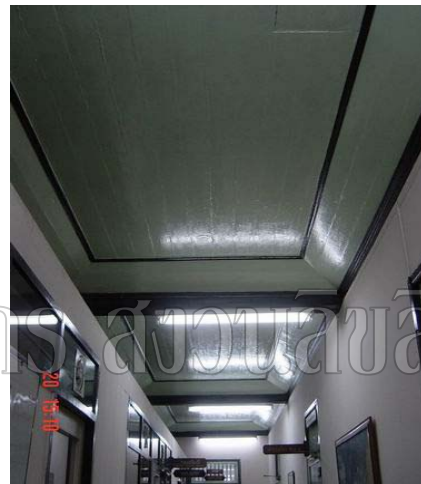
Ceiling over corridor

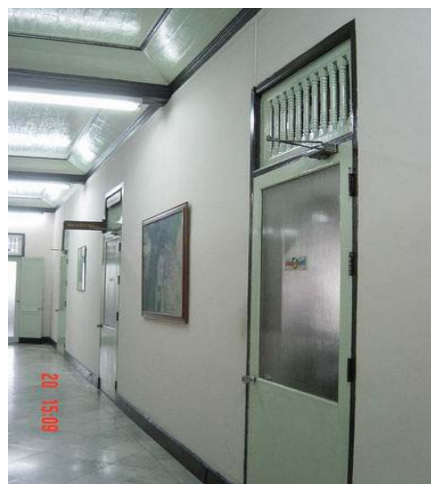
The old wall and doors

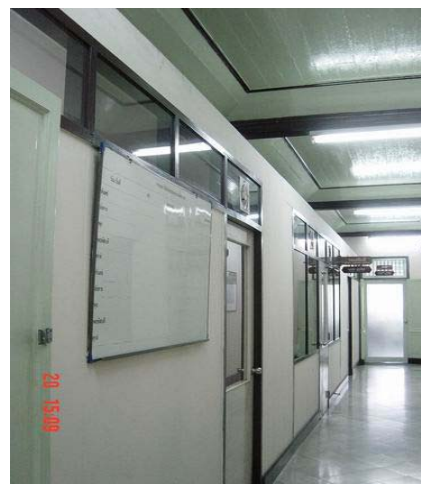
Added room on the terrace. Has gap between ceiling and panel

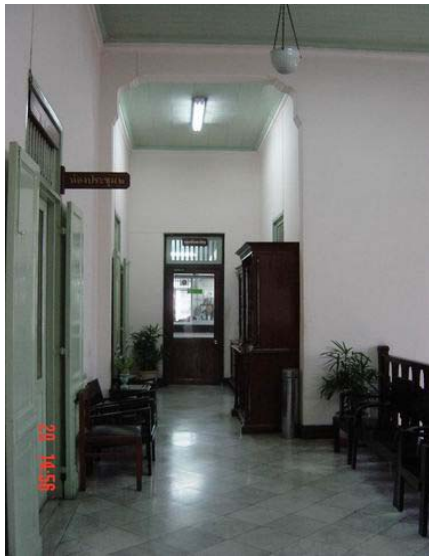
Corridor to office in the south

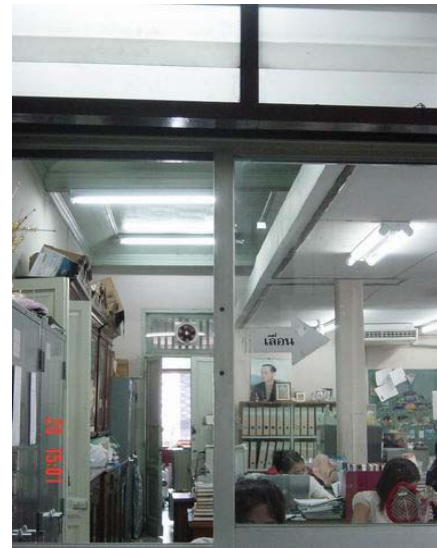
Inside the office room, the old column and beam of the terrace show in the room.

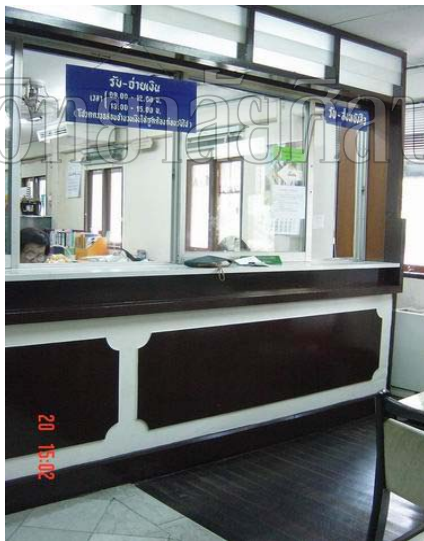
Inside the office room show the different floor material between marble floor in corridor and wood board in the back terrace.

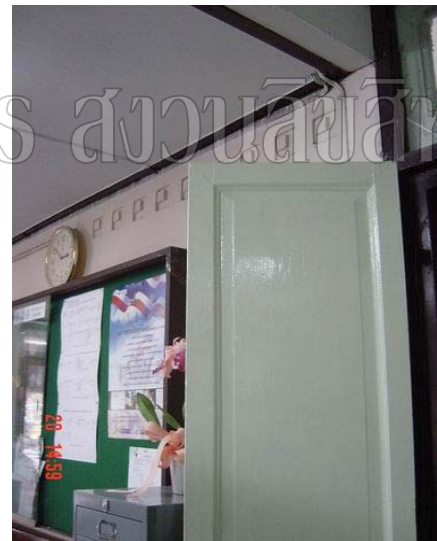
Inside the office room view from in front of counter. The wall next to the door has been decorated with square dots like outside of the building.

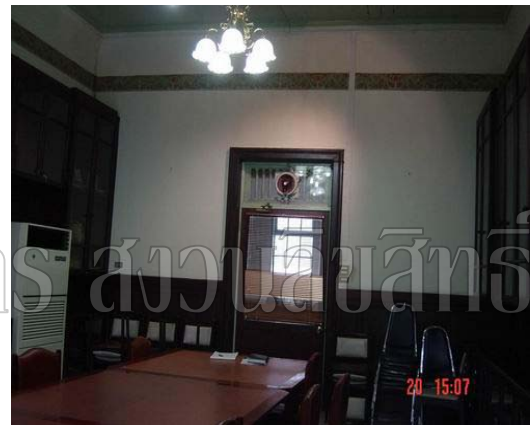
The conference room 2., inside of the room has redecoration and electrical installation

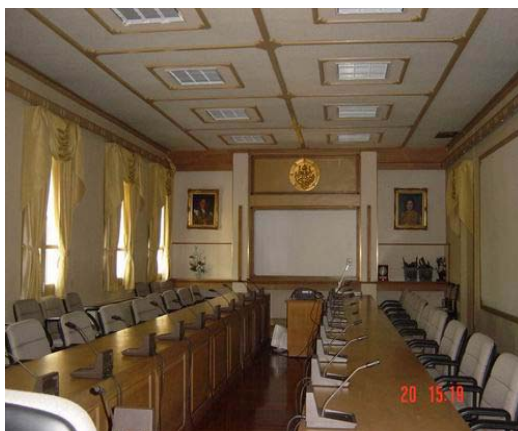
Conference room 1., this room is bigger than room 2. and has elegant decoration.

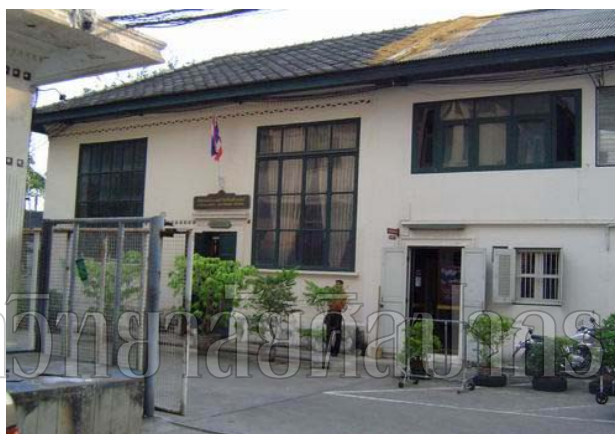
In front of the building, the inappropriate added up of new building is obviously seen.

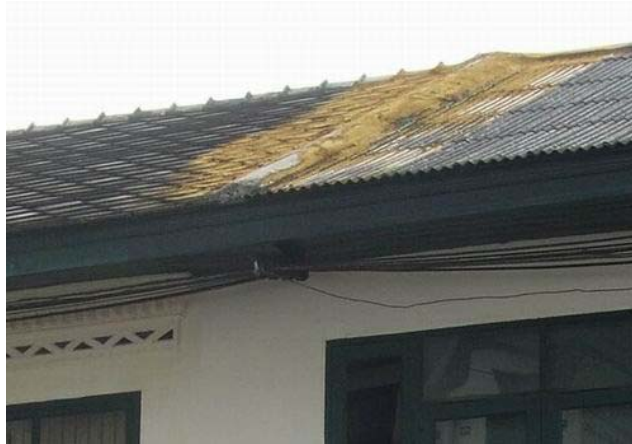
Joint between roof of two parts of building might has some problem of leaking, due to the differential of materials and building constructions

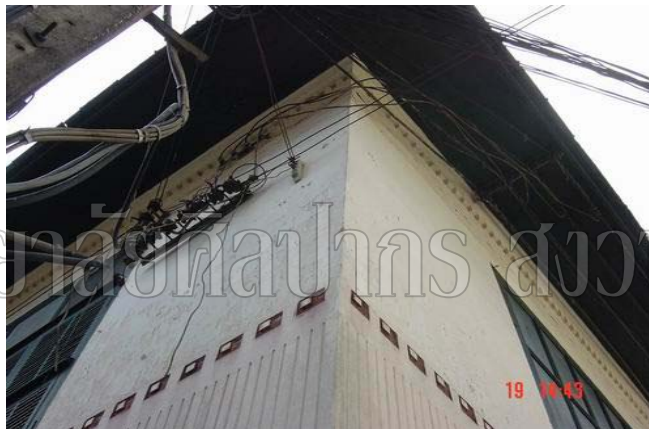
Disorder of electrical wires, it is not only affecting to the beauty of building but also causing of hazardous.

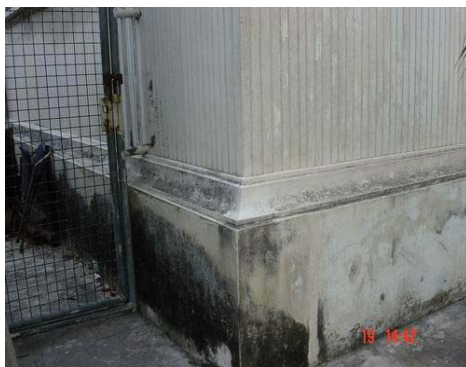
Large fungus stains and color patches, it is occurred by humid from ground water.

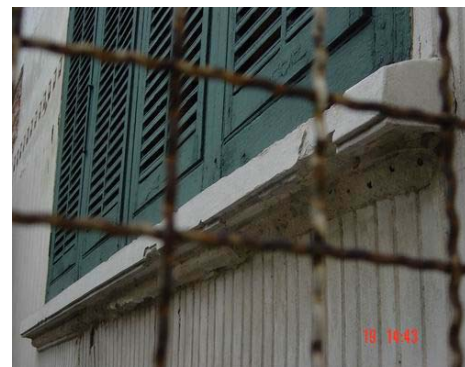
A hornet's nest under the lintel is one of the causes that damage fabric of building

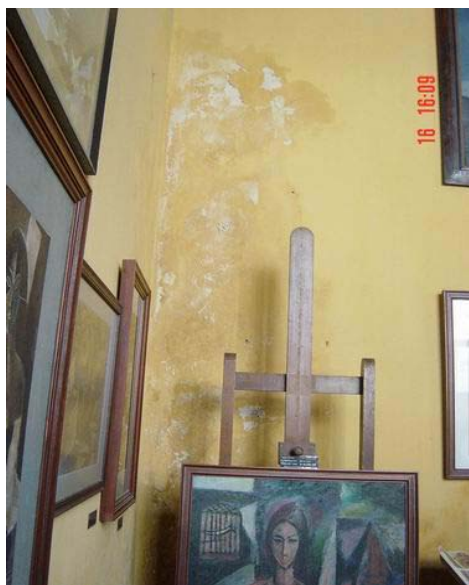
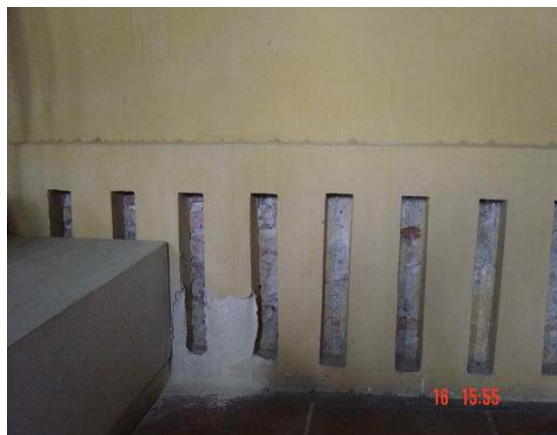
Wall painting is scratching and peeling. The serious problem is lime stucco corrosion.

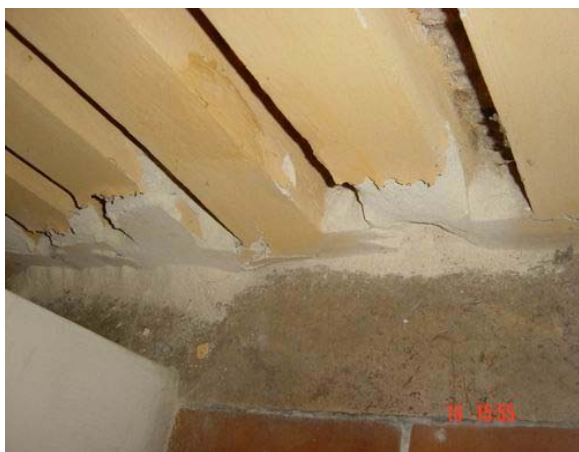
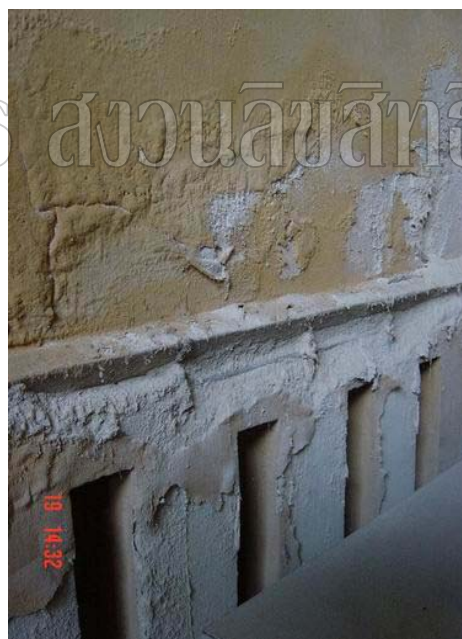
Lime wall explosion and having efflorescence effect

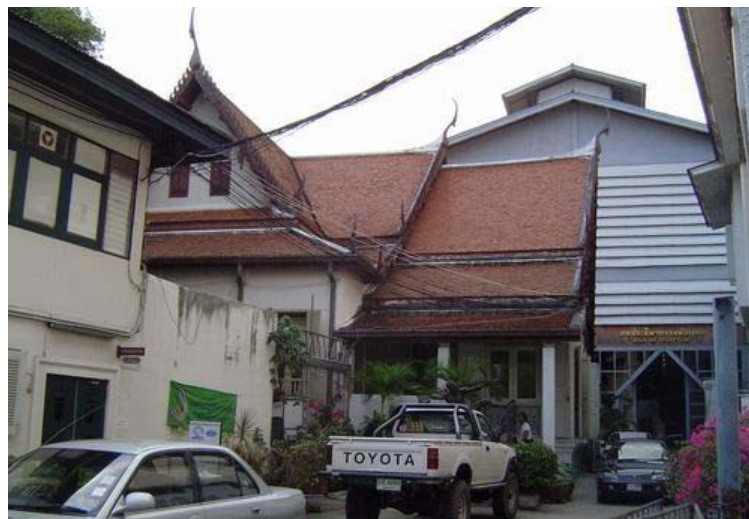
Figure 106 Thong Phra Rong Wang Klang.

The roof tile has good condition except some missing tiles at the back side of the building. All the cement border of the roof is filthy with the black and green stain of fungus. All the carved woods which decorating the eaves of gable roofs such as Chofah, Bai Raga, Hang Hongsa are discoloring, crack and peeling, the same condition as the eaves at the end of the roof.

Color of frames and panels of wooden doors and windows are scratch and peeling. It is clearly seen in the front side or the building where have not had the sun shed.

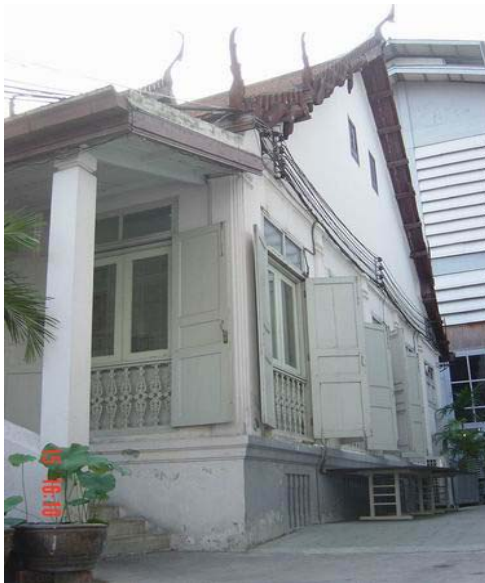
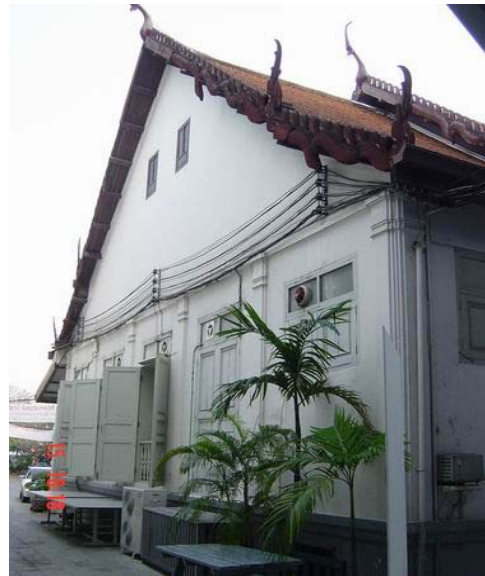
Figure 107 The front of the ThongPhra Rong.

Base of the front side of building has four ventilation holes with cement bars. Its position is under each window. In the basement was adapted to be a storage room but the room is not in-use. The ventilation holes are cover with mosquito net panels but all of them are ripped.

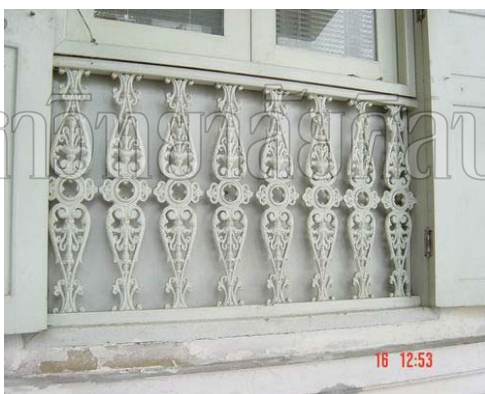
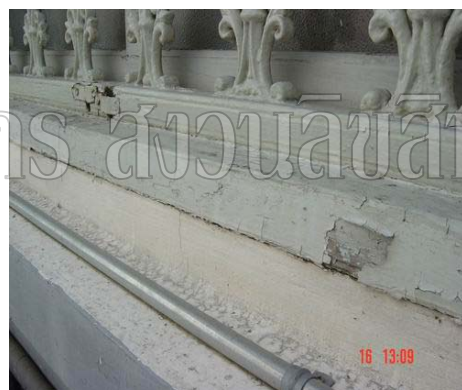
Figure 108 Beautiful metal curved railing is in a good condition but wall plaster moulding and wooden frames of window are in bad damage of color peeling and scratch.

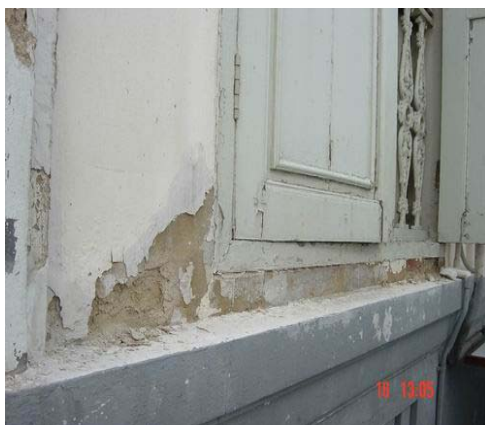
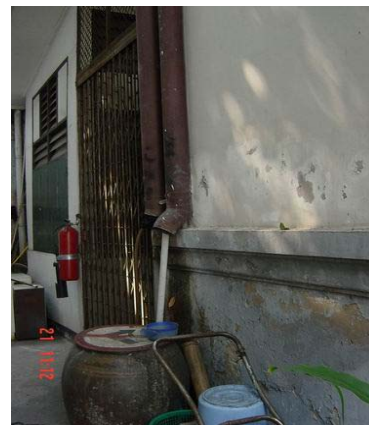
Figure 109 Bad condition of exterior walls.

Condition of the wall is bad particularly in the lower level of the building. Serious damage of the wall is clearly seen in the area over the basement wall. Some surfaces of these areas are exploded to reveal the brick construction. The cause of damage is the moisture from rain. At the base of the building has scratch and peeling of color painted and some area such as the East wall has an explosion of the stucco and white powder. The causes of damage are water from rain and moisture from the ground. West of the building has two areas of damages, both of them are the wall of the toilets inside the building. This will be one cause of damp stains and color scratch in this side.
