**THE ARCHITECTURAL HERITAGE MANAGEMENT FOR WANG THA PHRA
AND WANG THANON NA PHRA LAN
: FROM THE PALACES OF BUILDERS AND CRAFTSMEN TO THE ART AND
CULTURAL CENTRE**

Architectural Heritage Management and Tourism

SILPAKORN UNIVERSITY

2003

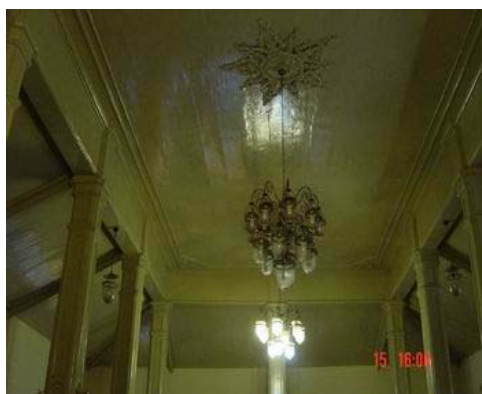
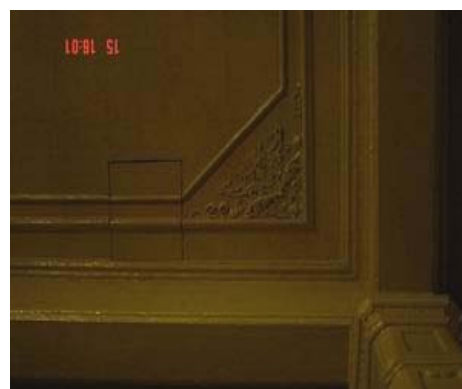
Figure 112 Beautiful wood carving decoration of the ceiling.

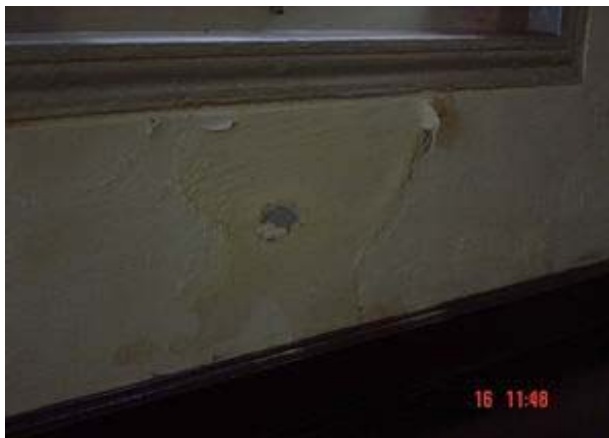
Figure 113 Serious damage of wall inside Thong Phra Rong, view to the wall in the east side. Color painting scratch and peeling in the large stain.

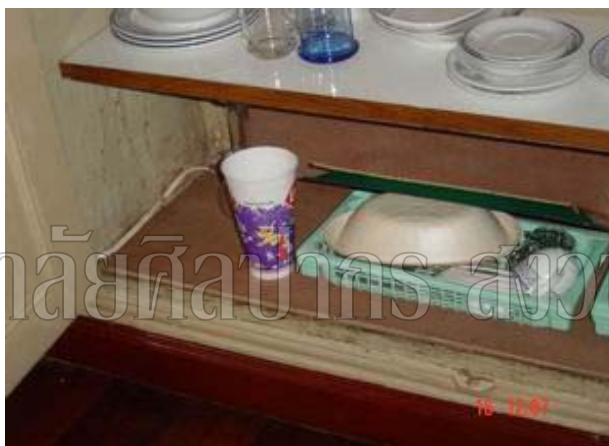
Figure 114 Fungus stain in a pantry cabinet. Cause of problem might be humid or leak of wall or floor of the adjacent toilet.

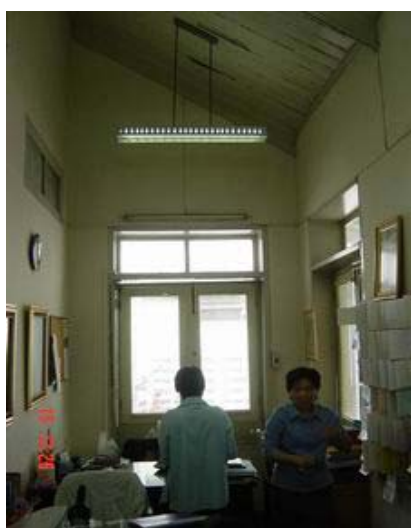
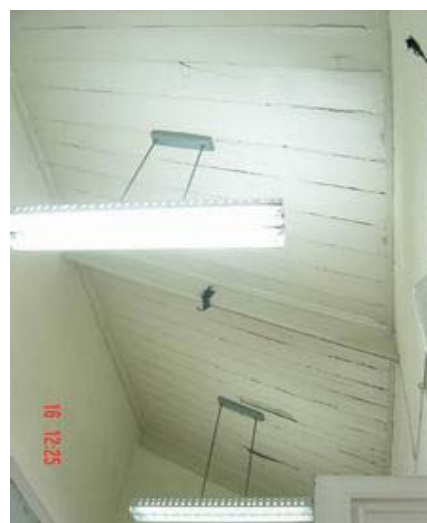
Figure 115 Office room in the front part of building. Its condition is old, having stains of damp, color peeling. Wood board ceiling crack.

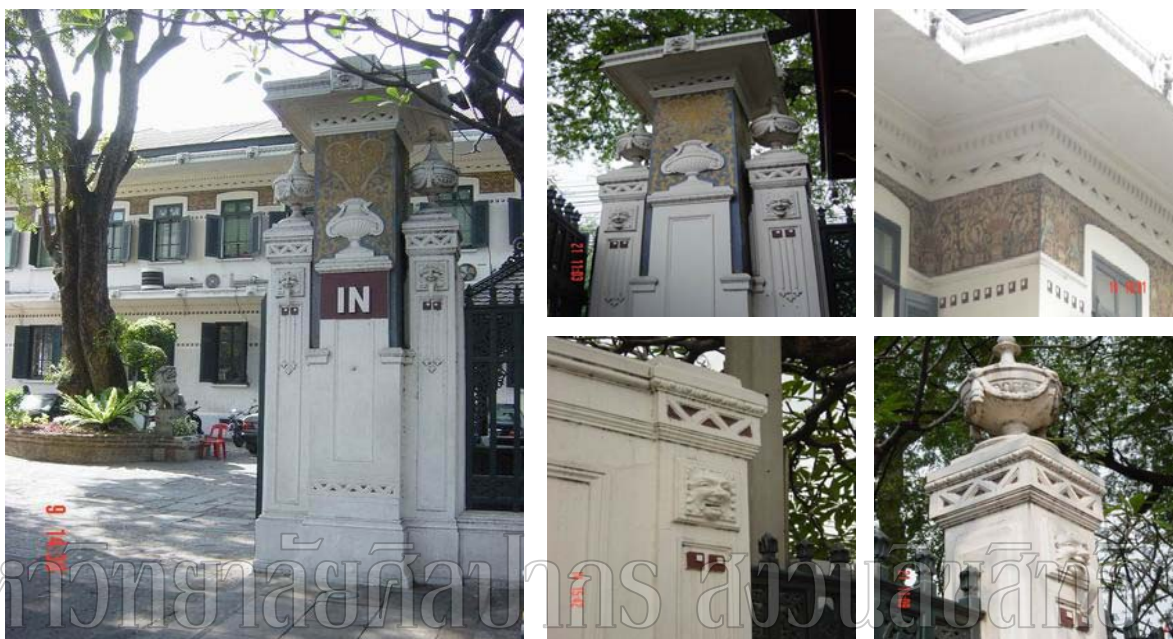
Fresco painting, lion face plaster moulds and graphic pattern grooved wall, are the beautiful outstanding design of the office building. Fence of this area has the same decoration as the office building but more decorated with plaster sculptures. The unity of decoration between fence and building make this place exquisite.

Figure 121 Beautiful and unity design of the office building and fence.

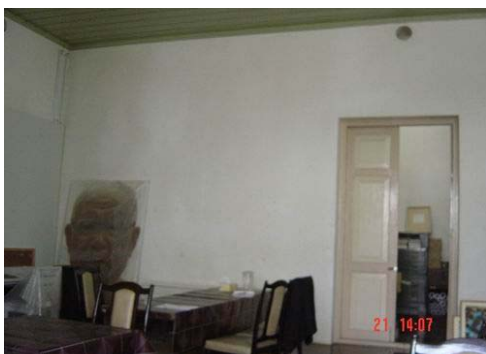
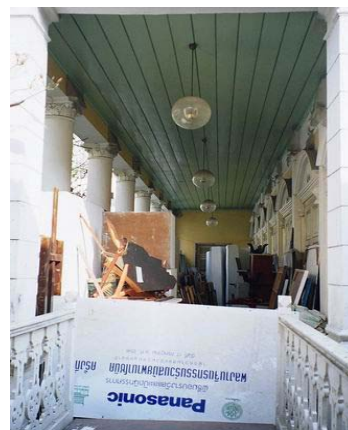
A room on the upper floor of Tamnak Pannarai has been used for staff's meeting

Back terrace on the upper floor of Tamnak Klang has closed and stored art 's props.

Figure 123 Usage condition of the prince's residence in Wang Tha Phra.

Space utilization of the prince's residence in Wang Tha Phra is inappropriately use to serve the values of the buildings. Some rooms have been rarely used or even closed. For example, rooms on the upper floor of Tamnak Pannarai have been used for exhibiting temporary art occasionally, but closed normally. Another example is the back terrace on the upper floor of Tamnak Klang, connectable area to Tamnak Pannarai and full of pretty plaster moulds decoration. That area has been closed and stored many art props, so not much of the space and facilities available have been fully used and the beauty of the building has no

opportunity to be admired, either. These spaces are not only left uselessness but also deteriorated by negligence.

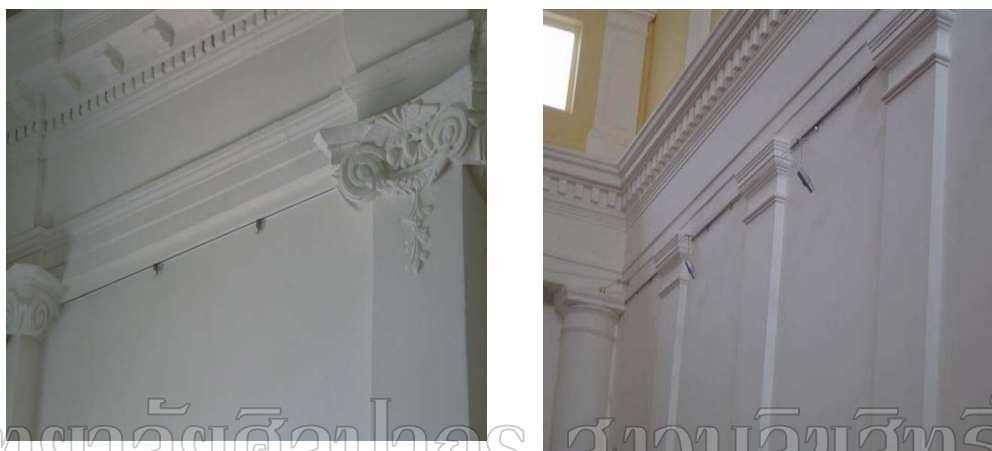
Figure 129 Accessory for exhibiting art pieces; picture hooks or lighting figures with metal slings; using in Asian Civilisations Museum, Singapore

- removing some parts of the attached gypsum board boxes of the interior wall to reveal design of the building;
- Suggest that, to design the art gallery, the manager should consult with museum designers. Adding gypsum board boxes for exhibiting art should concern to esthetic of the building. To exhibit art pieces, appropriate accessories should be introduced to install. At the back terrace of the building, all art props should be removed to store in appropriate place and open that area for using in art exhibition and connecting to Tamnak Pannarai.

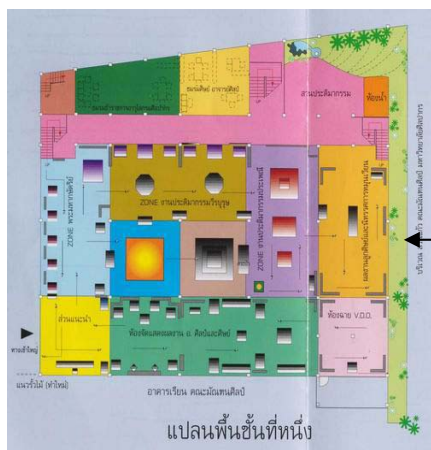
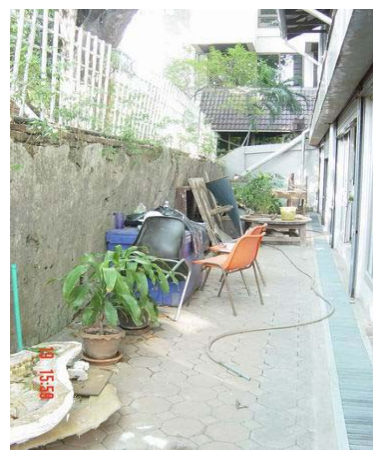
Layout plan that present in brochure. Showing the rest area in the improvement planning.

The area between building and the old Wall of Wang Tha Phra, view from the area to a building of Faculty of decoration.

Figure 131 Existing condition of Hall of Sculpture that should be improved.

The existing condition of building is good since it was improved a few years ago. Some damages that might be repaired are broken tiles on upper floor and wall cracked in some parts building. The area between back of the building and the old wall of Wang Tha Phra should be improved to be a resting area as in the planning. In improvement, the old wall
