REVEALING ILLUSION: BAN MO PALACE

A Research Project Submitted in Partial Fulfillment of the Requirements for the Degree

Architectural Heritage Management and Tourism

SILPAKORN UNIVERSITY

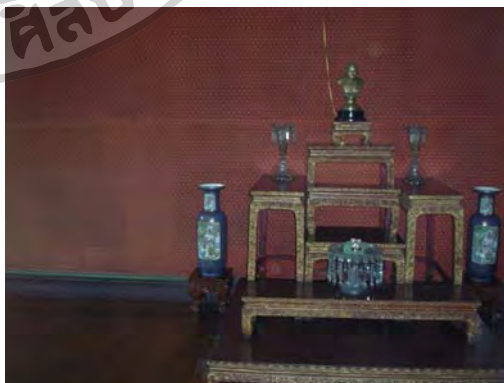
condition.	
➤ Painting on partition	Medium, High authenticity	Evidence of moisture on the corner close to the window causing discoloration on the partition painting.	Medium
4. Window	See figure 11		
➤ Teakwood window	Good, High authenticity	The original material is in intact condition.	Low
➤ Painting on window	Good, High authenticity	Re-painted the same color as the wall. (Evidence found previously show different painting on the decoration part of the window but the color has faded away and has been re-painted in the same color as the wall).	Low

Figure 13 Discoloration on the partition of the Main Hall

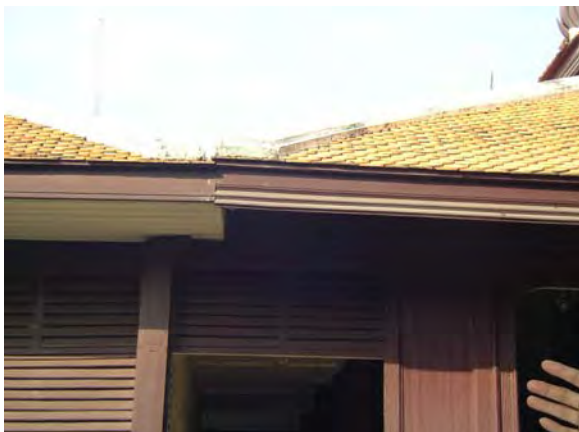
Figure 14 The roof of the original part (on the right) & Additional part (on the left) of the Audience Hall

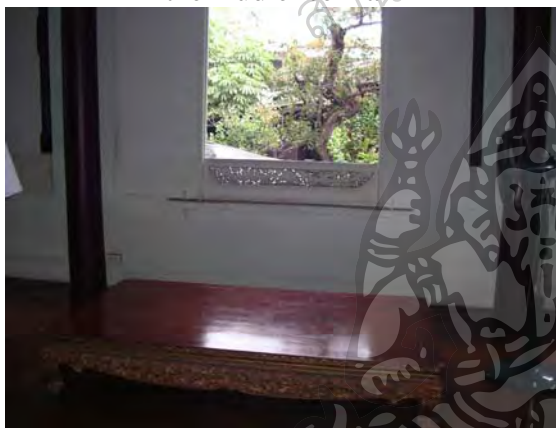
5. Door	See figure 15,23		
➤ Teakwood door	Good, High authenticity	The original material is in intact condition. The old scar on top of the main door affects only the aesthetic view on the surface of the material on the door.	Low
➤ Painting on door	Good, High authenticity	The old painting on the door shows evidence of the previous painting hidden behind it.	Low
6. Floor	See figure 15		
➤ Teakwood floor	Good, High authenticity	The original material is in intact condition and it was coated with shellac.	Low
7. Column	See figure 16,22		
➤ Teakwood column	Good, High authenticity	The original material is in intact	Low

condition.	
➤ Painting on column	Good, High authenticity	Re-painted close to the original color but different chemical formula.	Low
- The Sub-main room			
1. Ceiling			
➤ Board ceiling	Good, High authenticity	The original material is in intact condition.	Low
➤ Painting on ceiling	Good, High authenticity	Re-painted color as close to the oldest color as the owner of the Palace could remember (up to 50 years ago)	Low
2. Wall			
➤ Teakwood wall	Good, High authenticity	The original material is in intact condition.	Low
➤ Painting on wall	Poor, High authenticity	One side of the peeling color wall which is continuous	High

Figure 16 Repainting inside of the Main Hall

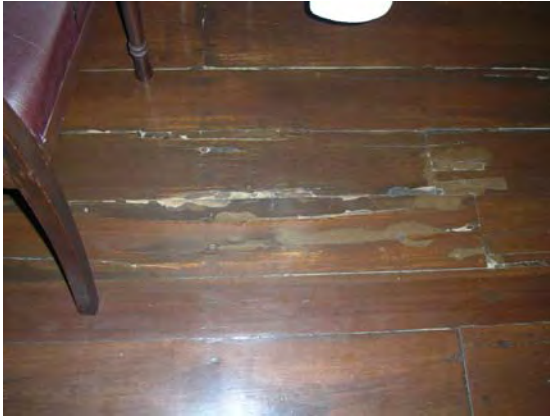
3. Window	See figure 20		
➤ Teakwood window	Good, High authenticity	The original material is in intact condition.	Low
➤ Painting on window	Good, High authenticity	Re-painted close to the original color but different chemical formula.	Low
4. Door			
➤ Teakwood door	Good, High authenticity	The original material is in intact condition.	Low
➤ Painting on door	Good, High authenticity	Re-painted close to the original color but different chemical formula.	Low
5. Floor	See figure 26		
➤ Teakwood floor	Good, High authenticity	Coated with shellac. Some scars on the surface of the floor caused by accidents.	Low
6. Column	See figure 20		
➤ Teakwood	Good, High	The original	Low

Figure 26 Scratch on the floor

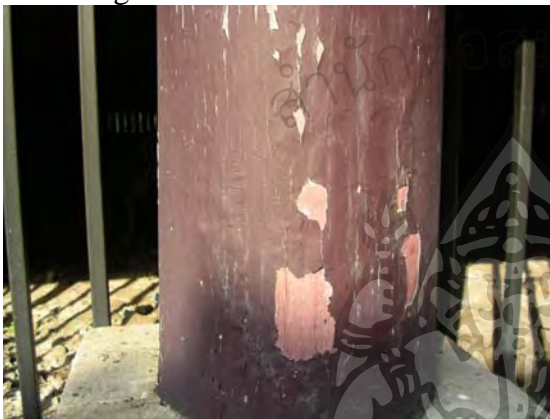
chemical formula. Peeling color and discoloration appear because of moisture on the ground.	
- Steps	See figure 24		
1. Cement cover with plaster steps	Medium, High authenticity	Intact original material but evidence of moisture apparent on the ladder due to deterioration of the original material.	Medium
- Exterior Gutter	Good, High authenticity	The exterior gutter is located on the ground and still functions efficiently.	Low
Interior			
- The Main hall			
1. Ceiling	See figure 22		
➤ Board ceiling	Good, High authenticity	Intact original material.	Low

Figure 28 Peeling color & discoloration on the column

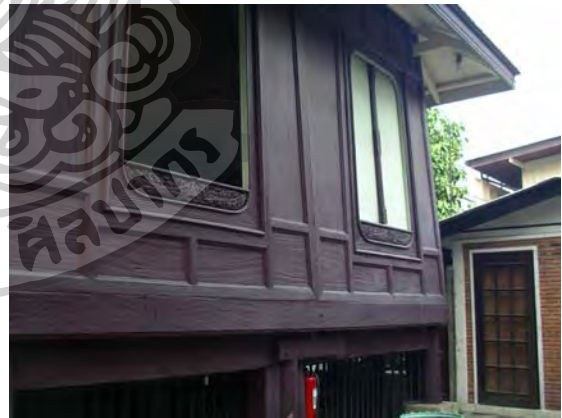
Figure 31 Fire extinguisher hanging on the Audience Hall

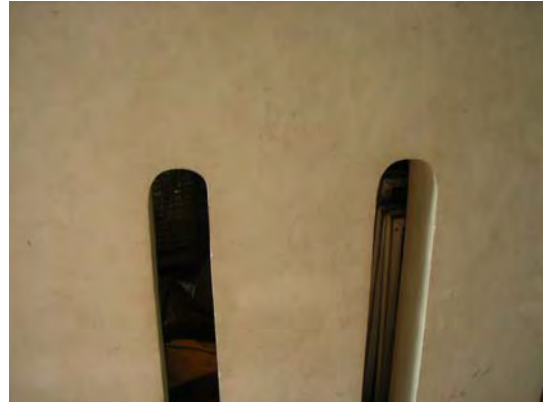
Figure 33 Ventilation vent on the rising platform

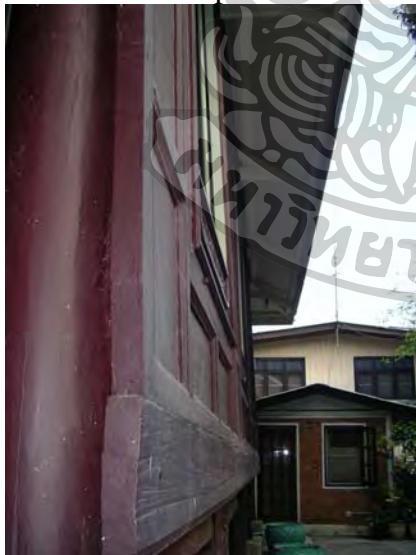
Figure 36 Slightly bent in wall of the Audience Hall

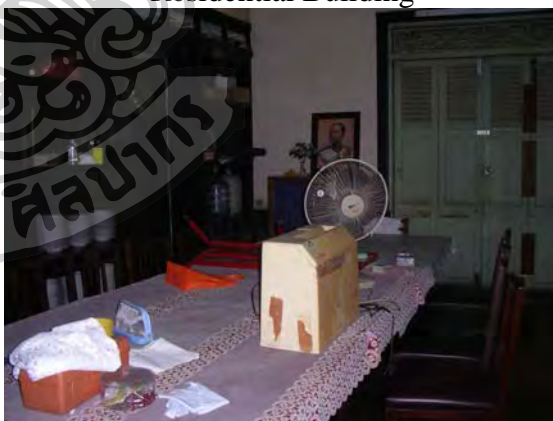
Figure 43 Close door and discoloration of the first room

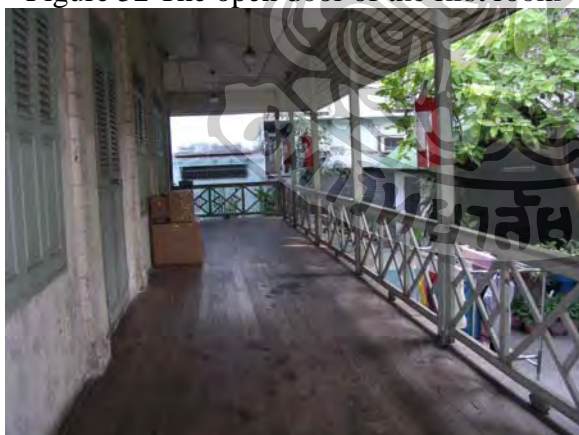
Figure 541 The balcony & the fire extinction hanging on column

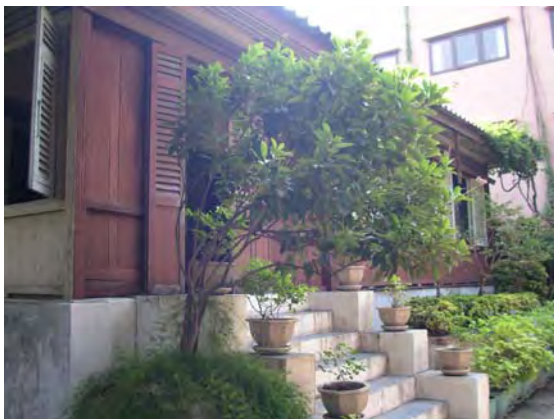
wall.	
- Ladder	See figure 62		
1. Cement cover with plaster ladder	Medium, High authenticity	Evidence of moisture apparent on the plaster surface.	Medium
- Exterior Gutter	Good, High authenticity	Exterior gutter on the ground is still intact and functional.	Low
Interior			
- First room from the front door			
1. Ceiling	See figure 46	A new style of electric ceiling lamp has been added on the ceiling and is out of order.	
➤ Board ceiling	Poor, Low authenticity	Broken plywood and evidence of rising damp on the ceiling.	High
➤ Painting on ceiling	Medium, Low authenticity	Discoloration and fungi on the ceiling.	Medium

Figure 62 West side (front) of the Residential Building

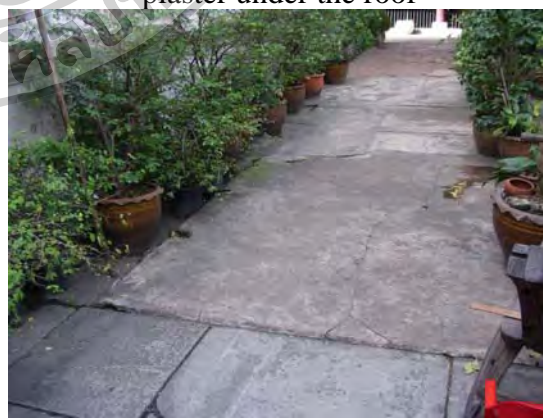
Figure 73 Contrast between an old pavement and the new concrete pavement
