REVEALING ILLUSION: BAN MO PALACE

A Research Project Submitted in Partial Fulfillment of the Requirements for the Degree

Architectural Heritage Management and Tourism

SILPAKORN UNIVERSITY

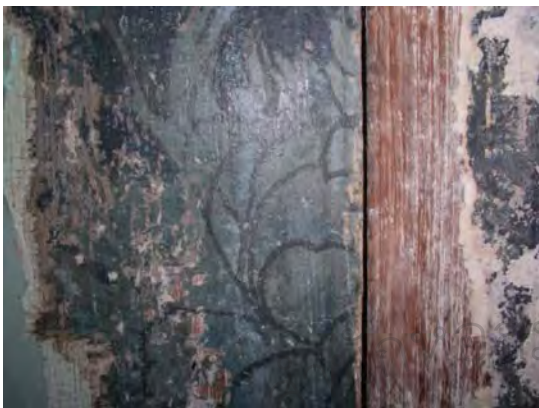
➤ Painting on ceiling	Medium-High, High authenticity	Discolored in one area on the ceiling because of rising damp.	Medium
2. Wall	See figure 8,15		
➤ Teakwood wall	Good, High authenticity	The original material is in intact condition.	Low
➤ Painting on wall	Poor, High authenticity	Peeling color on the surface of the wall shows the hidden painting through the layers of time. (Most of the peeling color caused by human action).	High
3. Partition	See figure 13	Assumed to have been built before the reign of King Rama the 6 th . ⁴	
➤ Teakwood partition	Good, High authenticity	The original material is in intact	Low

- The audience hall has been conserved in very good condition. The original teakwood is still intact. The exterior & interior walls have been re-painted, using a color similar to the original but with a different chemical color mixture, except one side of the wall (An exquisite figure has been discovered behind the peeling color of this wall) which is still not re-painted. The additional part of the audience hall was built around the year 1945 to provide more functions used in the audience hall.

Figure 8 Hidden Painting in the Main Hall

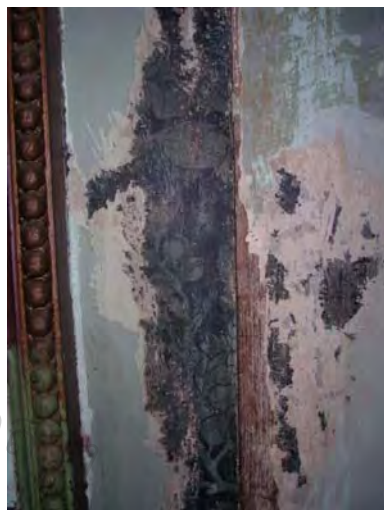
condition.	
➤ Painting on column	Good, High authenticity	Re-painted close to the original color but different chemical formula.	Low
- The Sub-main room			
1. Ceiling			
➤ Board ceiling	Good, High authenticity	The original material is in intact condition.	Low
➤ Painting on ceiling	Good, High authenticity	Re-painted color as close to the oldest color as the owner of the Palace could remember (up to 50 years ago)	Low
2. Wall			
➤ Teakwood wall	Good, High authenticity	The original material is in intact condition.	Low
➤ Painting on wall	Poor, High authenticity	One side of the peeling color wall which is continuous	High

Figure 9 Hidden Painting in the Sub-main Hall

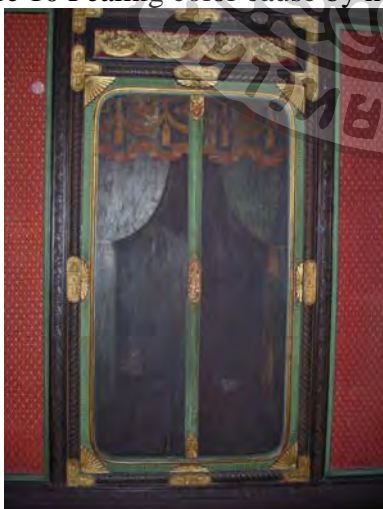
from the main hall also shows the hidden painting.	
3. Partition	See figure 12		
➤ Teakwood partition	Good, High authenticity	The original material is in intact condition.	Low
➤ Painting on partition	Good, High authenticity	Re-painted close to the original color but different chemical formula.	Low
4. Window			
➤ Teakwood window	Good, High authenticity	The original material is in intact condition.	Low
➤ Painting on window	Good, High authenticity	Re-painted the same color as the wall. (Evidence found previously show different painting on the decoration part of the window but the color has faded	Low

Figure 12 Painting Door on the Sub-main hall

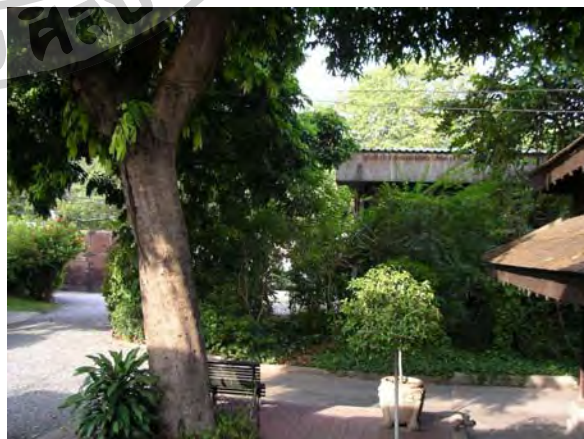
Figure 19 Vegetation around the Wooden Pavilion and the Audience Hall

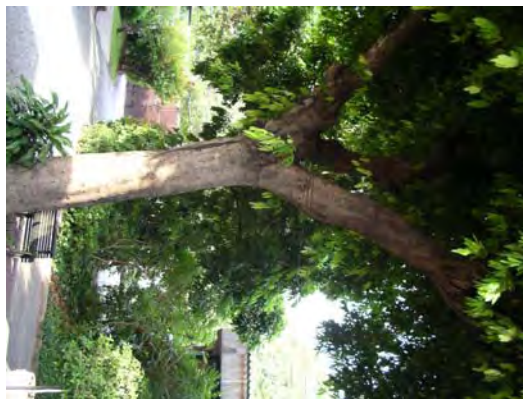
Figure 21 An old tree beside the Wooden Pavilion

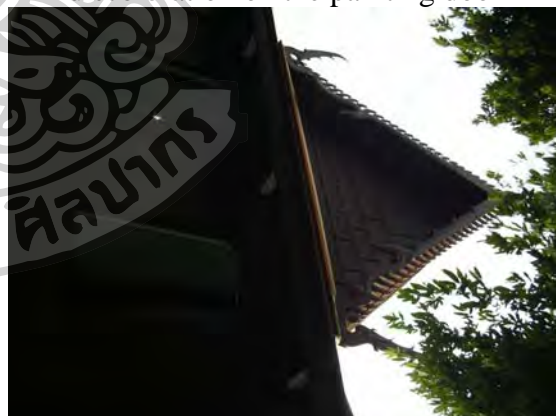
The Audience Hall	Existing Condition, Degree of Authenticity	Description	Works Priority
Exterior			
- Roof	See figure 25,34		
1. Terra cotta tile	Good, High authenticity	Coated with Urethane.	Low
2. Roof decoration	Good, Medium-High authenticity	The top of the decoration has been renovated, the rest has been re-painted.	Low
- Wall	See figure 24,31		
1. Teakwood wall	Good, High authenticity	Intact original material.	Low
2. Painting on wall	Good, Medium authenticity	Re-painted close to the original color but different chemical formula.	Low
- Windows	See figure 24,31		
1. Teakwood window	Good, High authenticity	Intact original material.	Low
2. Painting on window	Good, Medium authenticity	Re-painted close to the original color	Low

Figure 25 Roof decoration of the Audience Hall

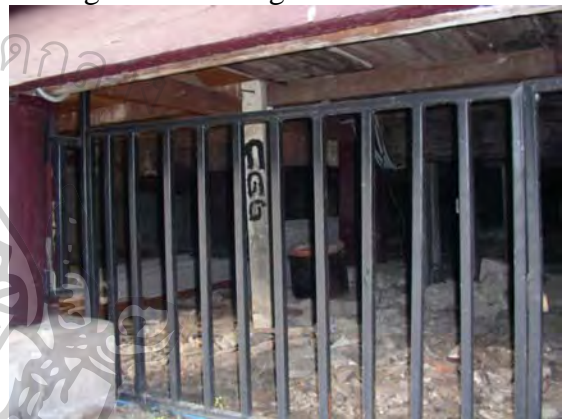
Figure 29 Rising platform of the Audience Hall

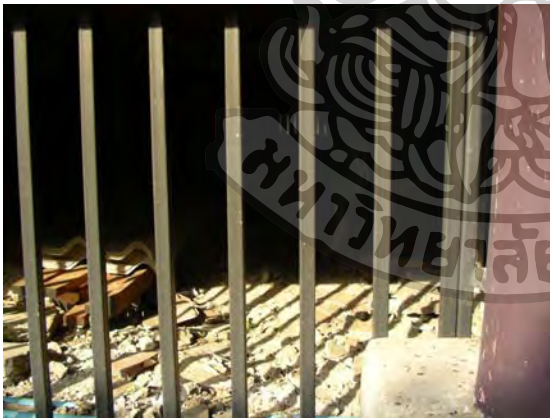
Figure 30 Rising platform of the Audience Hall

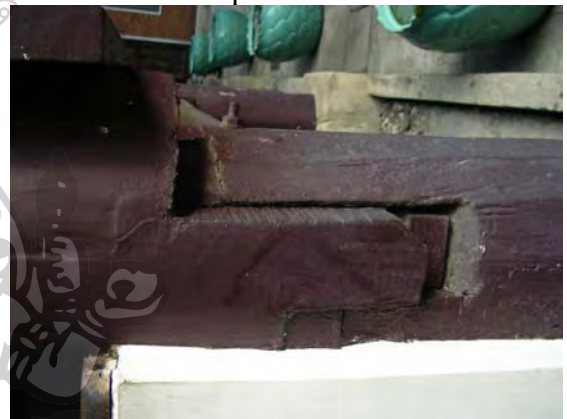
Figure 35 Jointed column

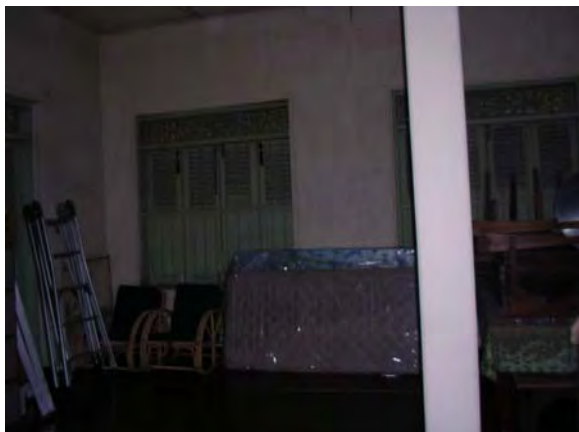
➤ Painting on wall	Medium, Medium authenticity	Peeling color and evidence of moisture on the wall.	Medium
3. Window	See figure 50,51		
➤ Teakwood window	Good, High authenticity	Closed and out of order.	Low
➤ Painting on window	Medium, High authenticity	Discoloration on window.	Medium
4. Door			
➤ Teakwood door	Medium, Medium authenticity	New door knob was added to the door.	Medium
➤ Painting on door	Medium, High authenticity	Discoloration on the door.	Medium
5. Floor			
➤ Teakwood floor	Medium, High authenticity	Scratches on the original teakwood floor.	Medium
- Fourth room on the south next to the first room			
1. Ceiling	See figure 60		
➤ Board ceiling	Poor, Low authenticity	Evidence of moisture, rot and	High

Figure 50 Interior of the third room

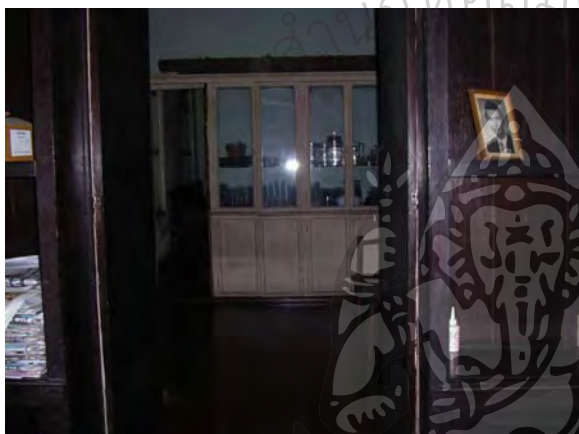
door	authenticity	door.	
5. Floor	See figure 52		
➤ Teakwood floor	Medium, High authenticity	Evidence of scars and holes on the original teakwood material.	Medium
- Third room behind the second room			
1. Ceiling		Additional board on the ceiling, renovated around the year 1985.	
➤ Board ceiling	poor, Low authenticity	Evidence of rising damp on the ceiling.	High
➤ Painting on ceiling	Medium, Low authenticity	White color painting on the ceiling has been discolored and is peeling because of moisture.	Medium
2. Wall			
➤ Concrete wall	Medium, Medium authenticity	Evidence of cracks on the upper part of the wall.	Medium

Figure 52 The open door of the first room
